Building and Pest Inspection Reports

In accordance with AS 4349.0 and AS 4349.3

56 Postwar Street, Sample Town

26th July 2012 at 12:30pm

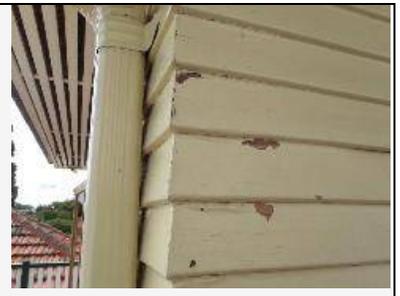
Paint is deteriorating to various sections of previously painted external surfaces. This can expose the building element to the weather and result in accelerated deterioration and increase the costs of repair and re-painting. I recommend you consult a licensed Painter about the necessity and cost of repainting.

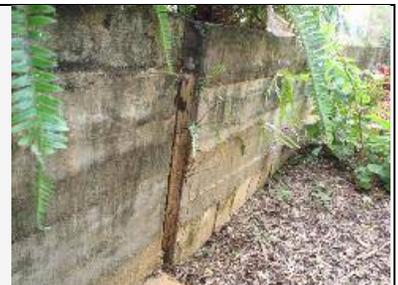
There are concrete and concrete block retaining walls. The concrete wall to the right hand side boundary has rotated (leaning towards the house) in sections. The wall only supports the fence and does not affect the house. This defect may continue to deteriorate and eventually collapse. Repair or replacement is required. I note that you the client have obtained a quotation to

replace the badly damaged section of retaining wall.

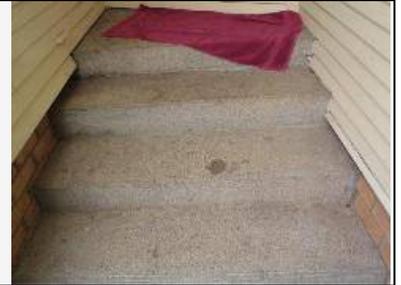
The stairs are constructed primarily from concrete to the RHS elevation. The overall condition of these stairs is good. Refer to sample photo.

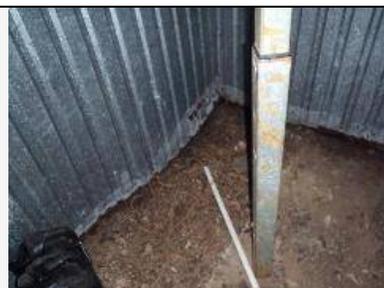
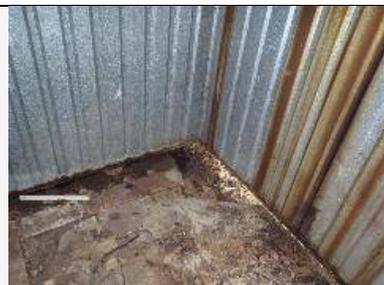
The structure is generally in a poor condition. Section of slab floor missing.

Refer to sample photo.

Severe rust to sections of walls. Repair or replacement is required. Consult a licensed tradesperson about the scope of works and cost to rectify.

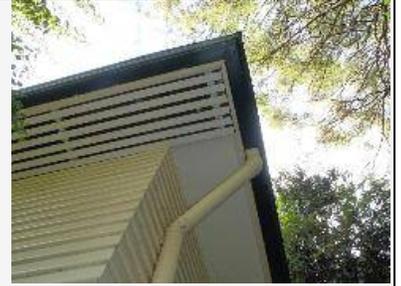
Gutters and downpipes appear to be in serviceable condition. Leaves and debris are present in gutters and downpipes. These should be cleared. Gutters and downpipes should be kept clear of leaves and other obstructions otherwise water may cause damage to other components of the building. Recommend trimming back overhanging trees/vegetation and installing good quality 'gutter guard' to prevent build up of leaves and other obstructions.

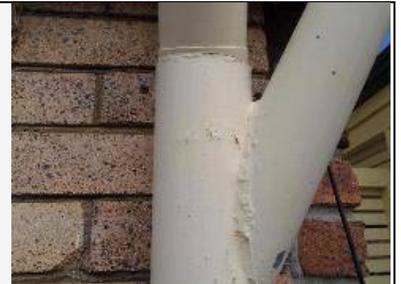
Some minor rust noted. Refer to sample photo. Repair or replacement is required. Consult a licensed tradesperson about the scope of works and cost to rectify.

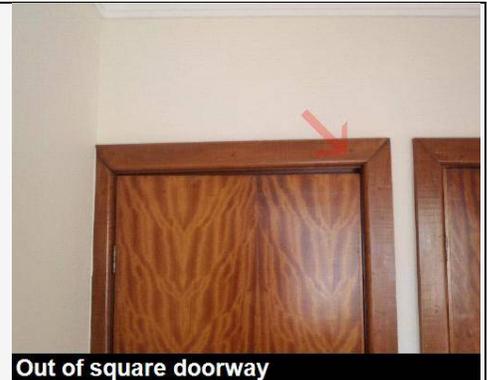
Foundation movement has caused floors to be slightly out of level, walls to be slightly out of plumb, door and window openings to be slightly out of square, ceilings to sag slightly and a few small hairline appearance cracks to appear in ceilings and walls. The damage is generally very minor and is to be expected for a house of this age and type of construction. There is always a possibility with any building that future movement will occur again and therefore some further damage could happen. If you are planning renovations at this property be aware that the house being slightly out of level can affect the materials and methods used. Please consult a licensed Builder if future renovations are possible.

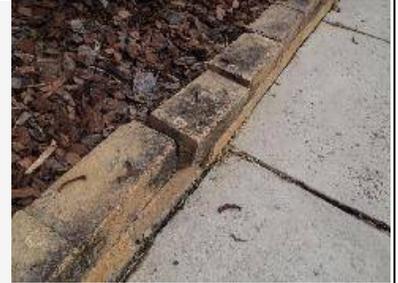
Brick garden edging/planter boxes are damaged in sections. This is a Minor Defect. Repair or replacement is required. Consult a licensed tradesperson about the scope of works and cost to rectify. Refer to sample photo.

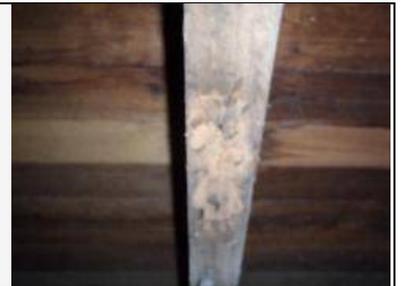
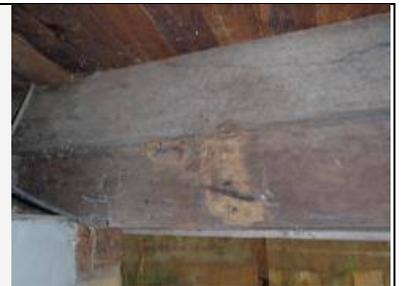
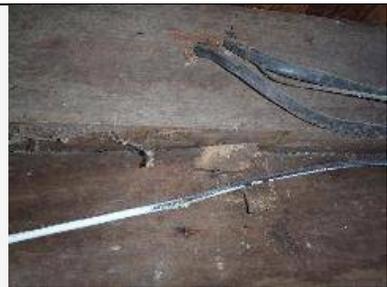
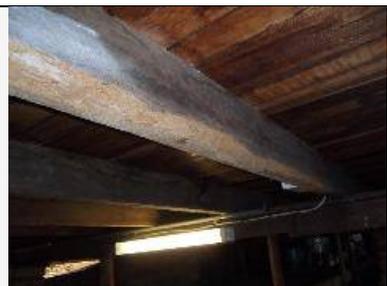
Yes - Inspection revealed currently inactive termite attack (termite workings only) within this area including but not necessarily limited to the following timbers and the areas listed below.

bearers, floor joist/s.

RHS area of the subfloor (where the old bathroom was removed).

Visible timber damage appears minor. Refer to the definitions section of this report - Section 1.6 - Timber Damage.

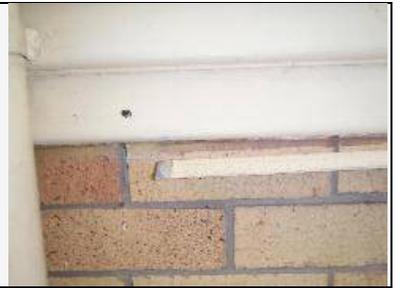
Generally the Ant Caps or Termite Shields are considered to be Inadequate. I recommend that you refer this matter to a licensed Builder to determine a scope of works to repair existing or install new Ant Caps or Termite Shields.
