Building Inspection Report

In accordance with AS 4349.1

Lot 24, 5 Smith St, Sampletown

7837

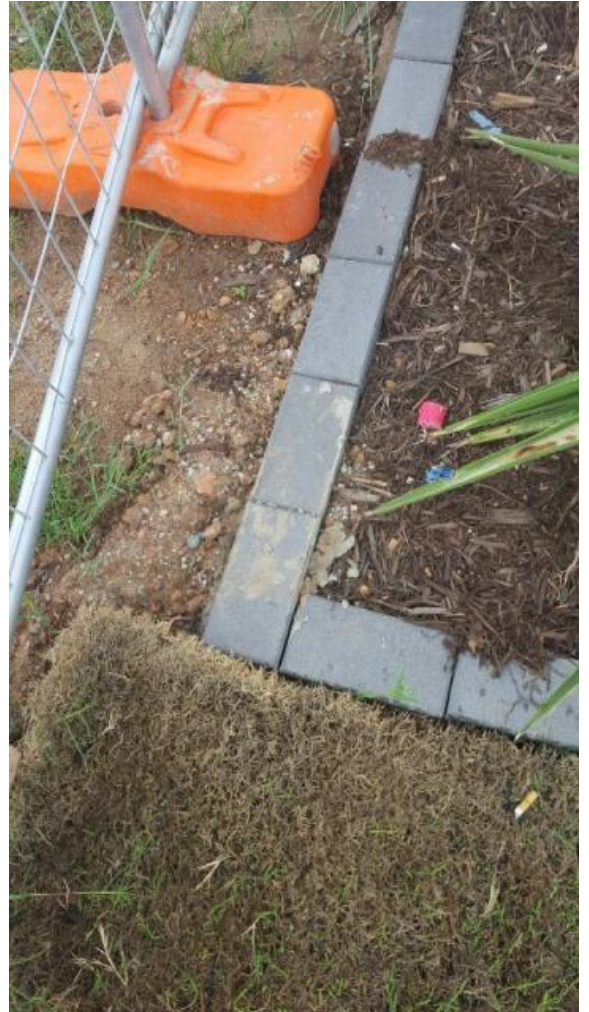
Clean all concrete paver garden edging.

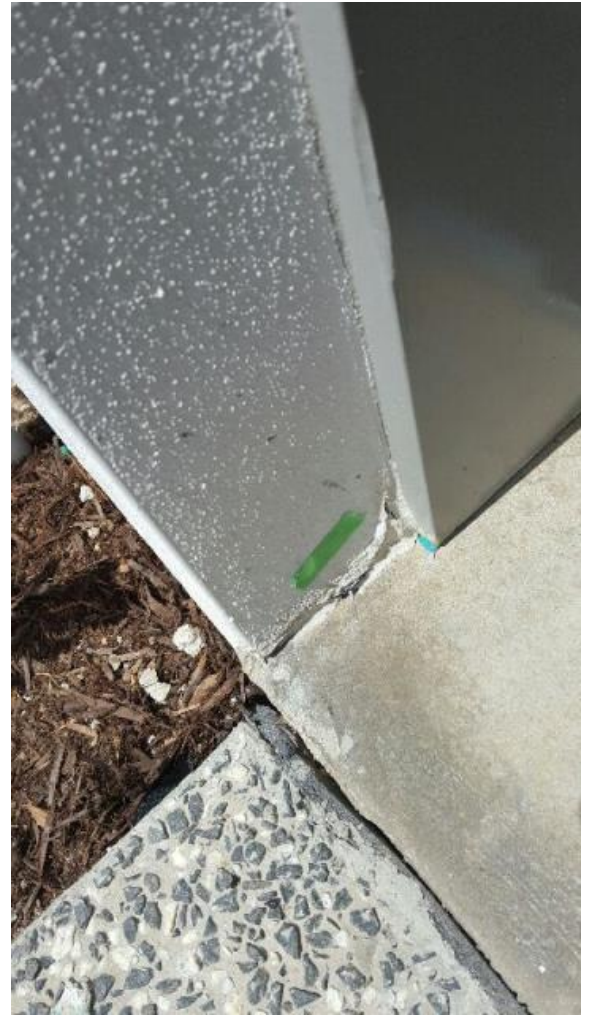
Repair Render at bottom
of Garage door, both
sides

Clean Garage door.

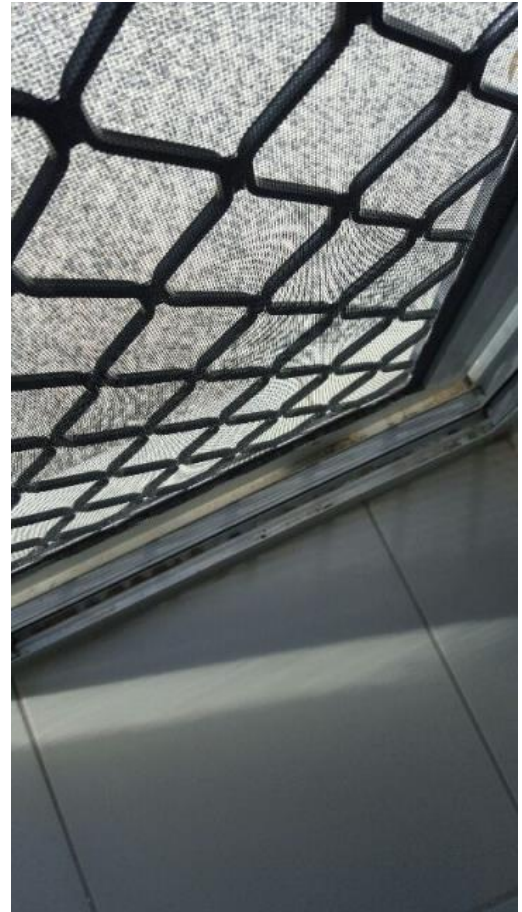
Clean all sliding door sill tracks.

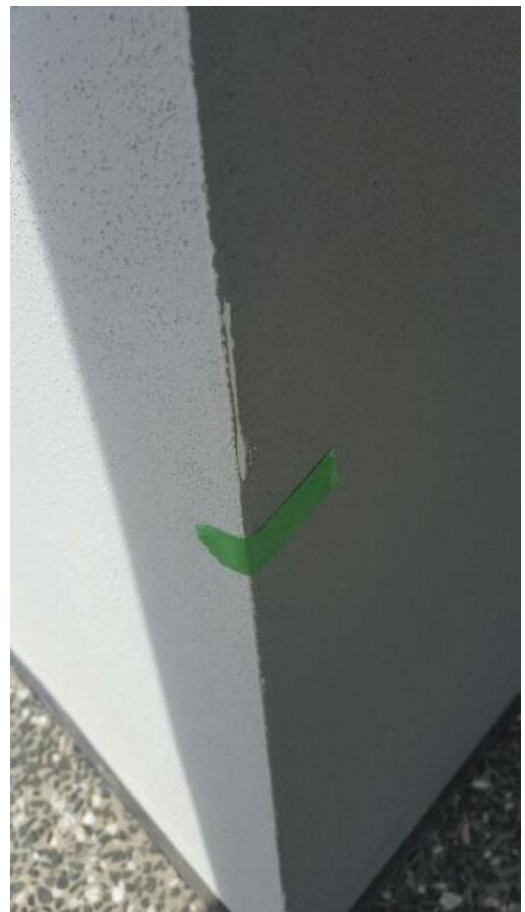
Repair chipped corners to Entry Porch corner, and left front pier.

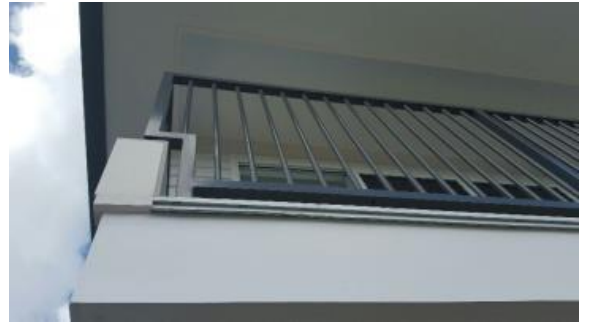
To Front Balcony,
provide finish paint coat
to timber beading, and
repair damaged tile
flashing.

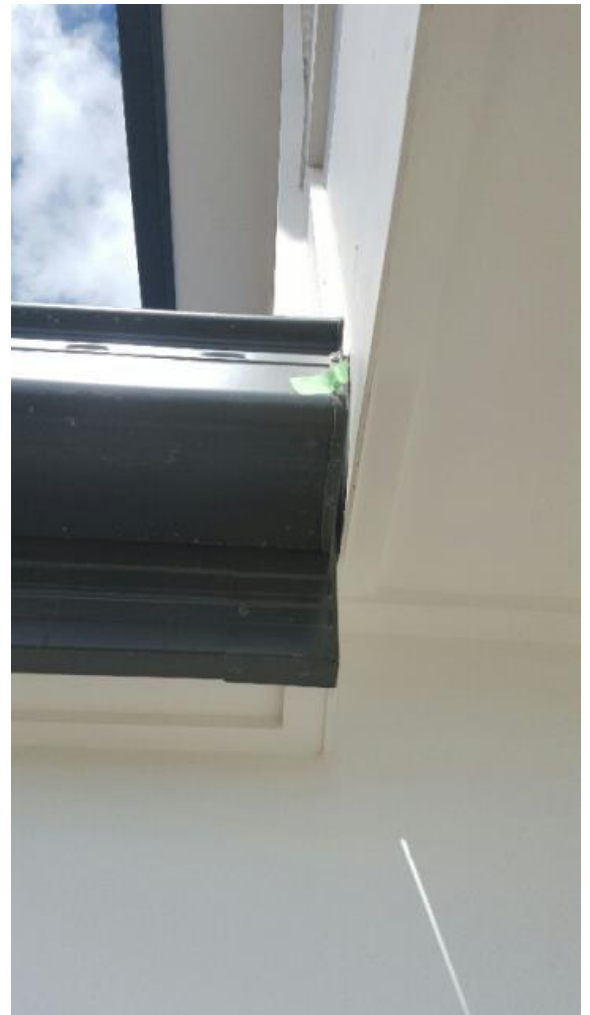
Front left, provide wider
flashing (full width of
gutter) above Garage
door.

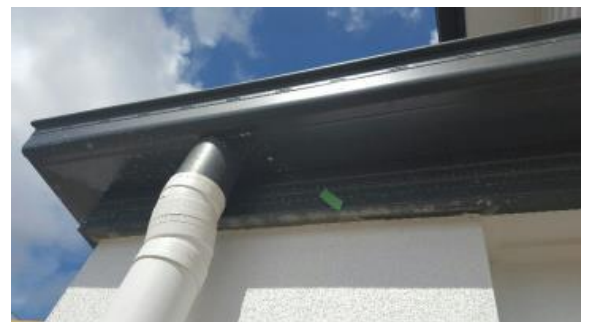
Clean gutter / fascia to
left corner of Garage
door.

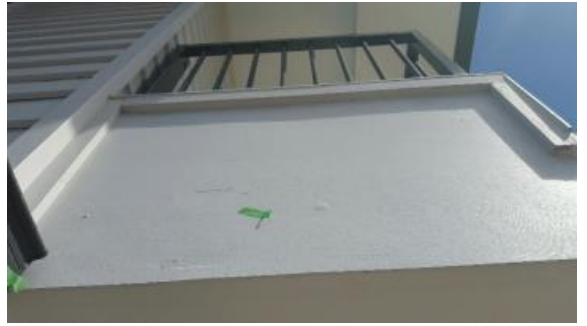
Repair gouges/lumps to
left side of front balcony.

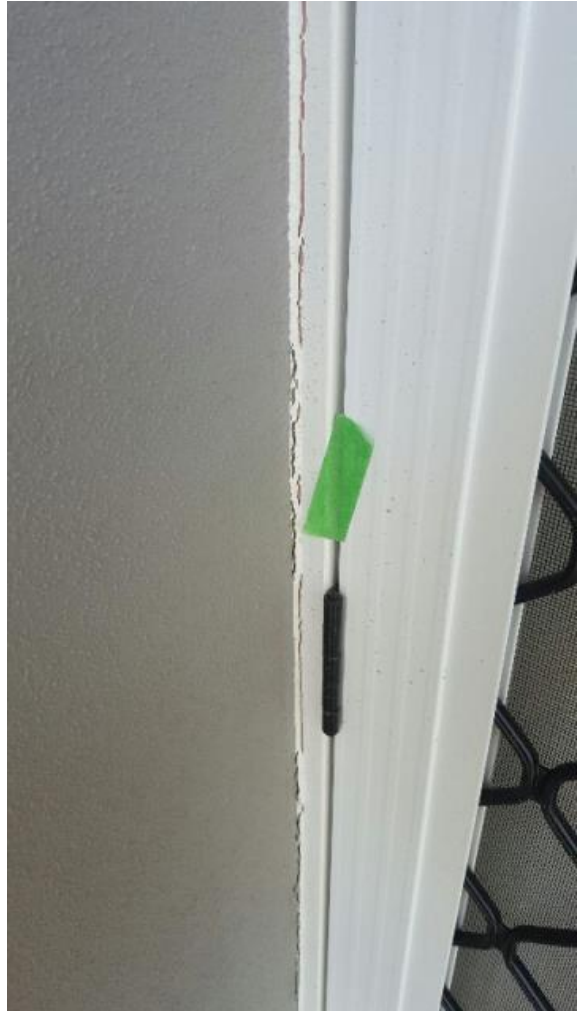
Repair sealant to left of
Entry Door, full height.

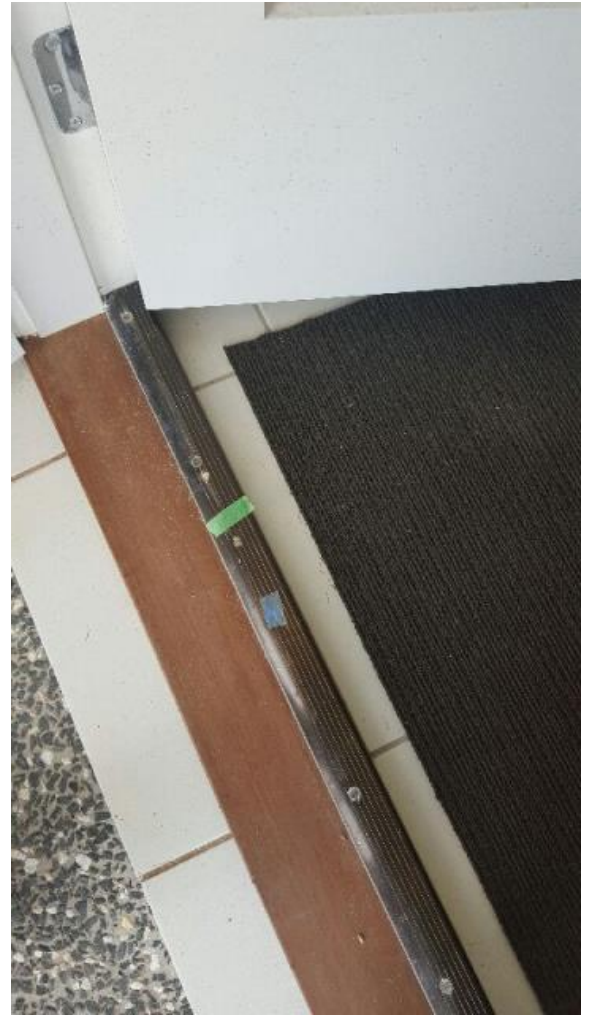
Clean Entry Door
threshold.

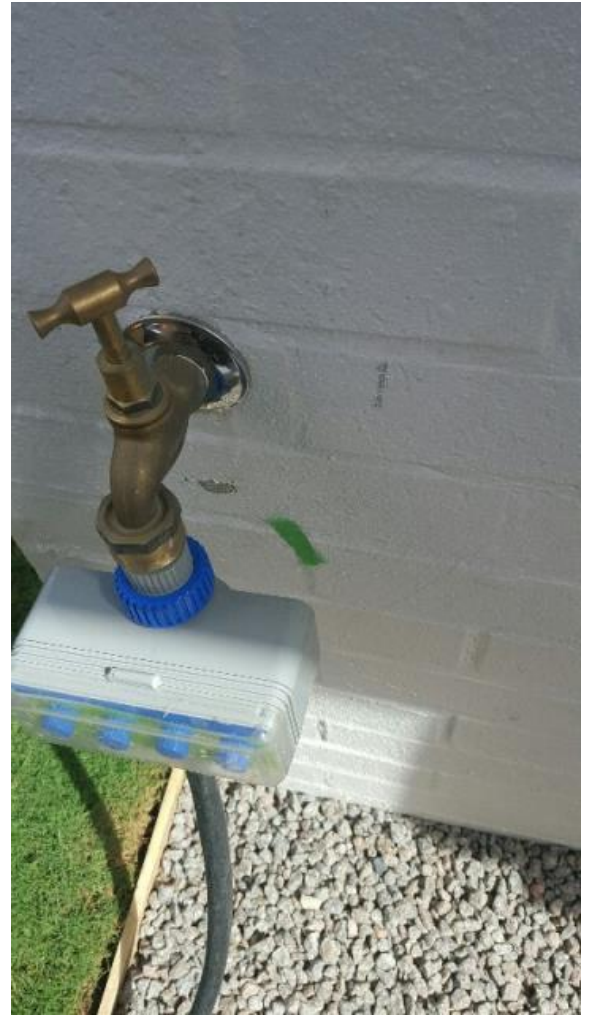
Repair numerous paint defects to left wall, near back corner.

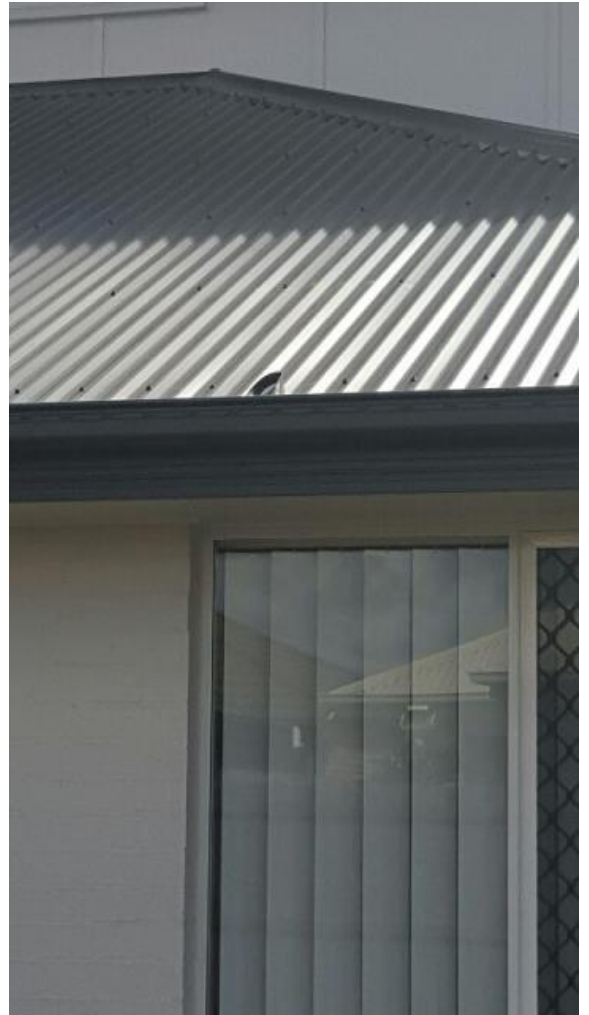
Remove debris to roof at rear.

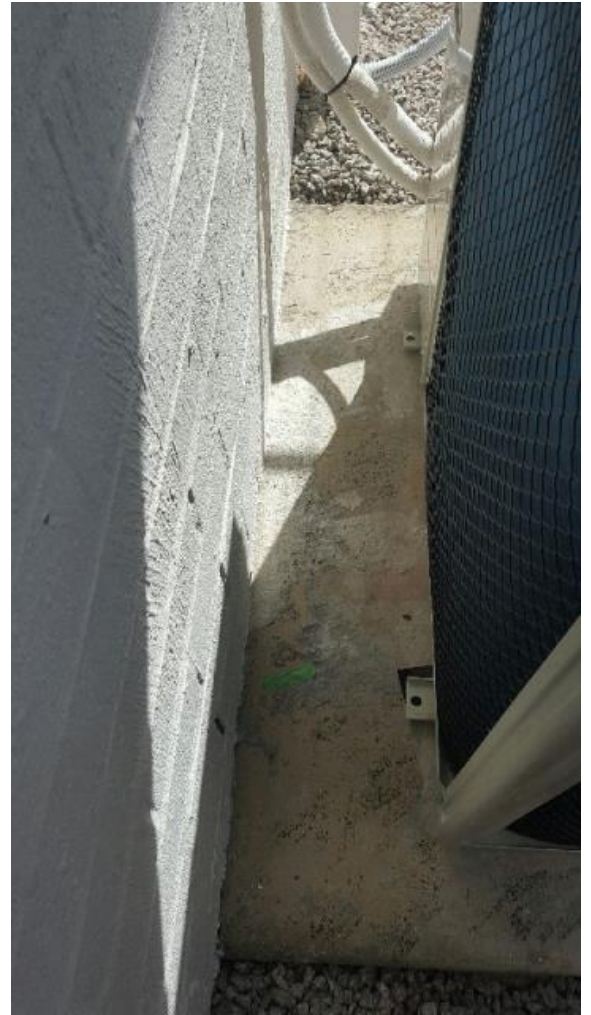
Clean excess mortar /
cement behind aircon
condensing unit, left
side.

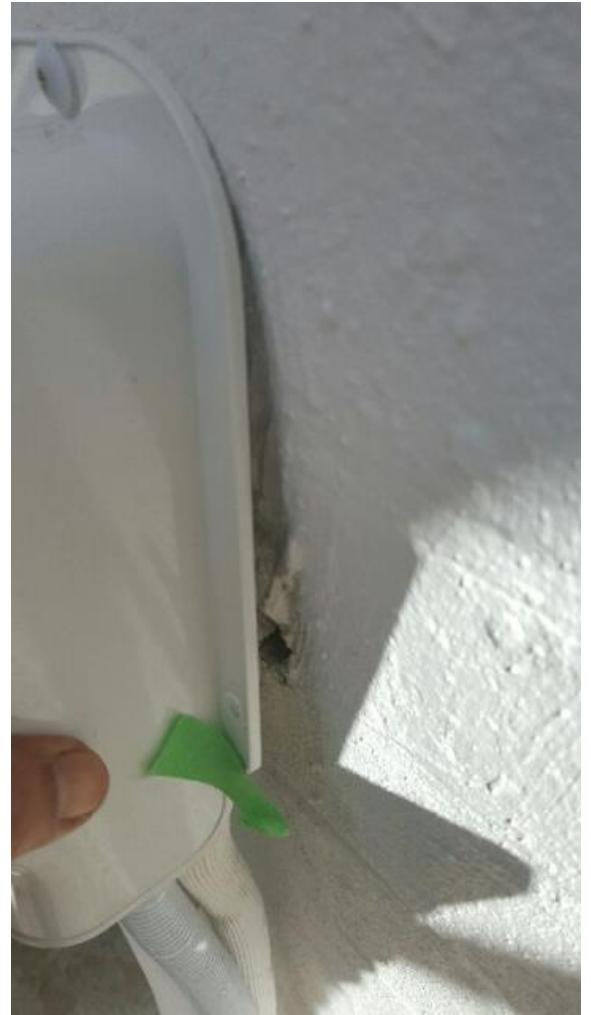
Seal around both aircon
conduit penetrations,
behind covers.

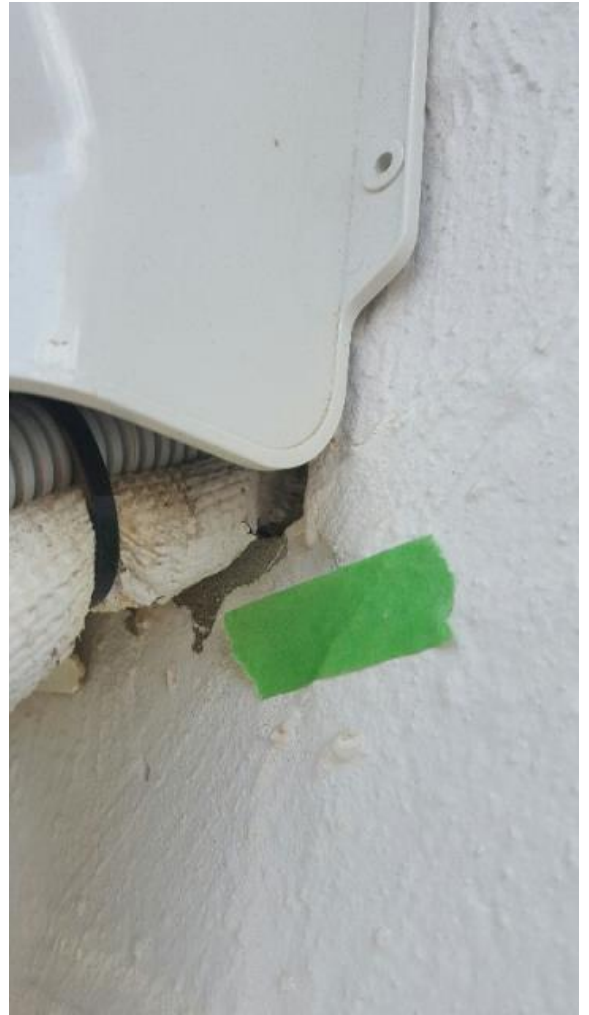
Touch up paintwork to
higher aircon conduit
penetration, left side.

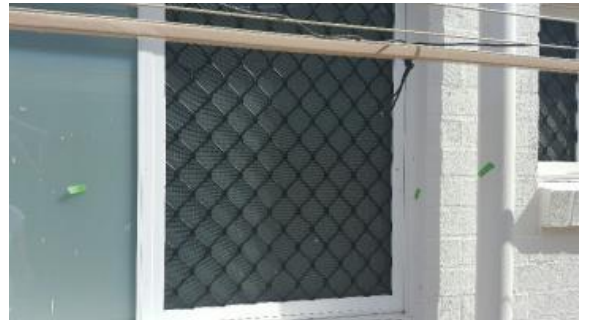
Remove plaster splatter
to window / wall /
downpipe, at left side.

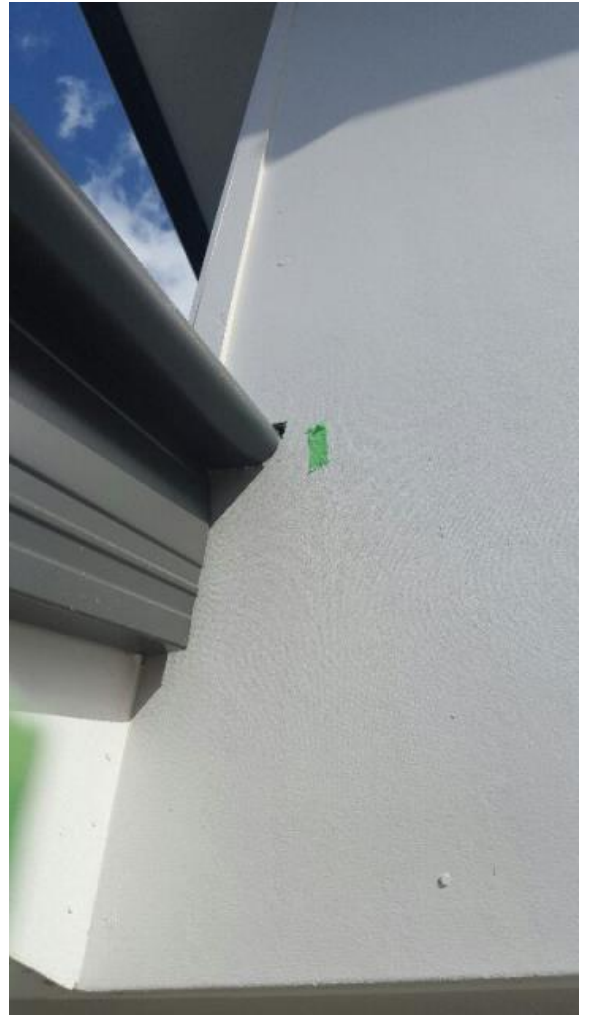
Seal hole at top of barge
roll, left side.

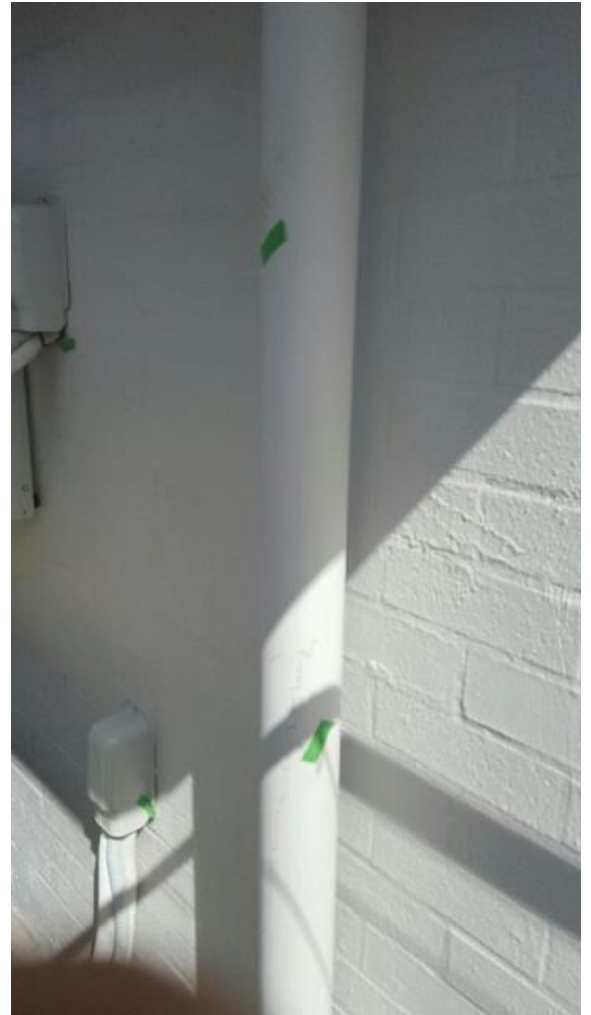
Repair paintwork and
clean Downpipe, left
side.

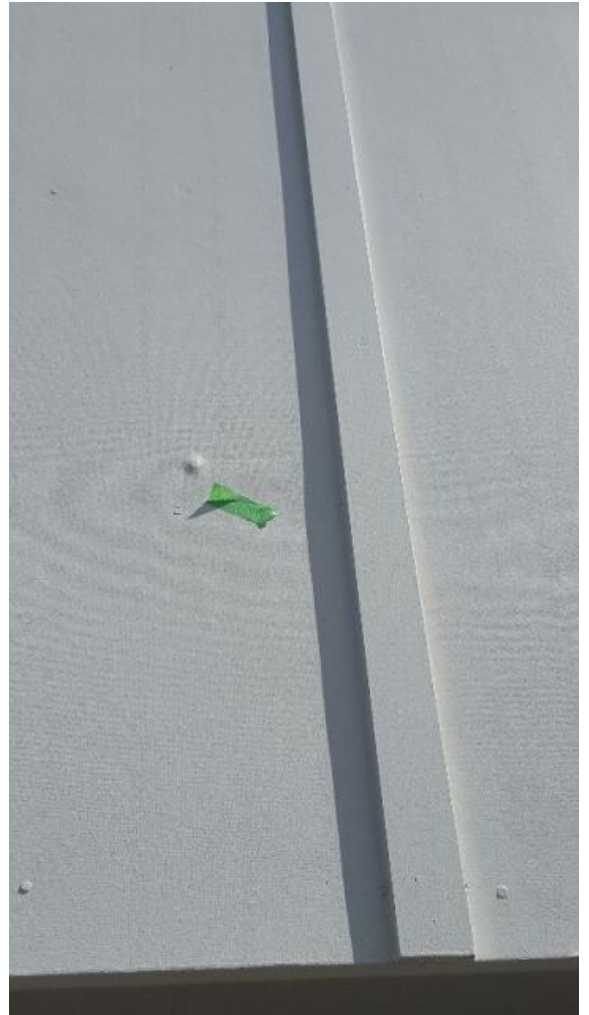
Repair lump to wall
cladding, left side.

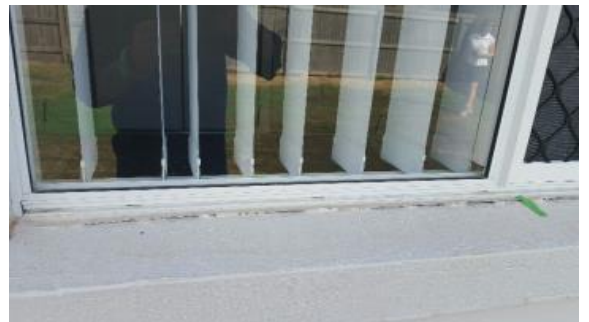
To 2 rear windows and
window at left side,
remove excess mortar
under weather seal to sit
flat, or seal for full
length.

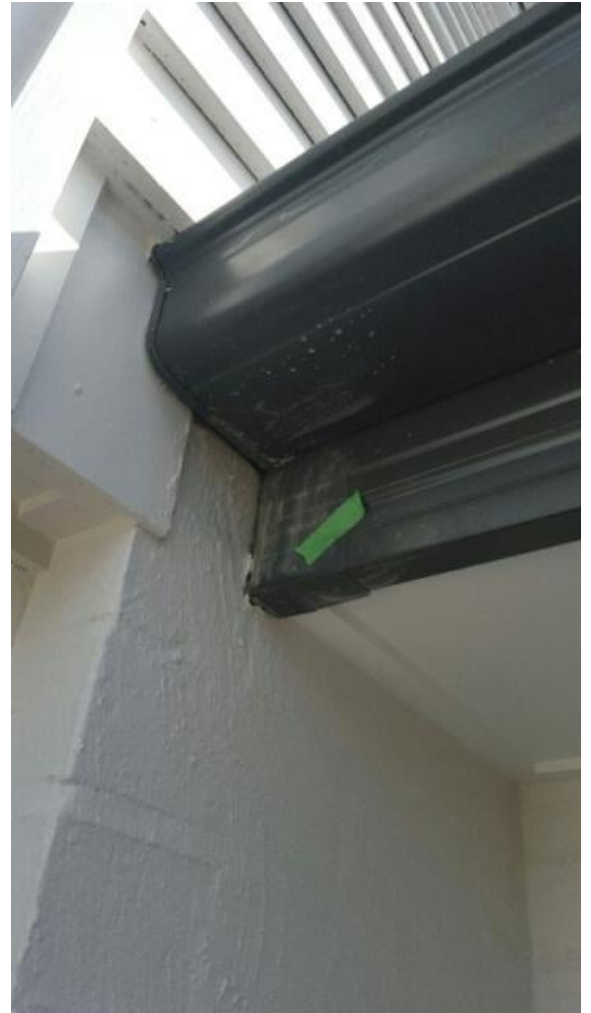
Clean gutter/fascia to
roof/wall junction, left
side.

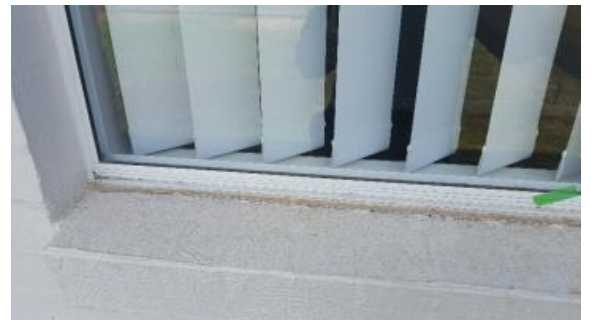
Clean rear right window
sill.

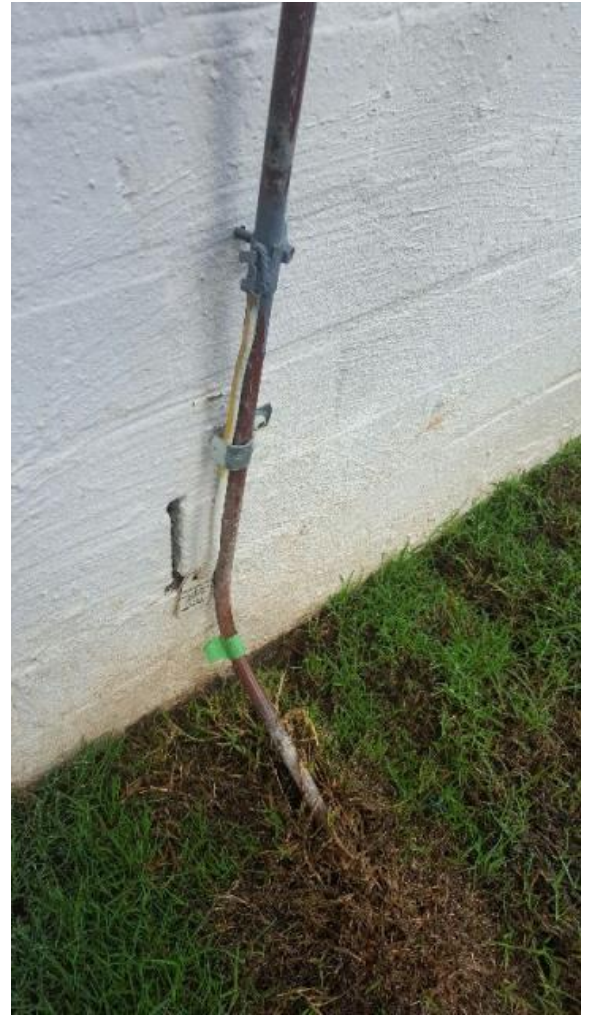
Earth rod at angle from wall, right side.

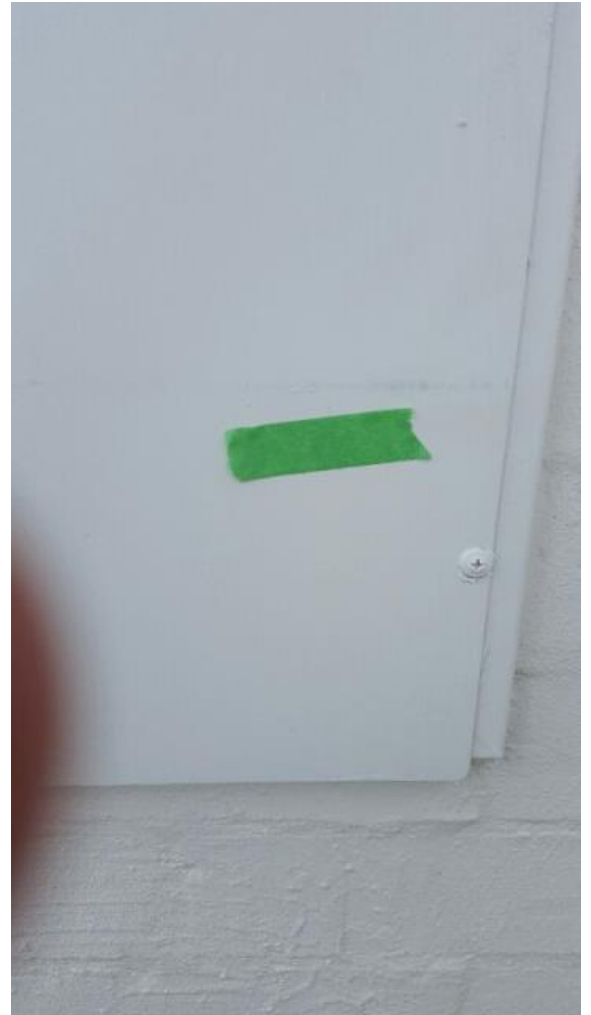
Touch up paintwork to
Hot Water Unit, right
side.

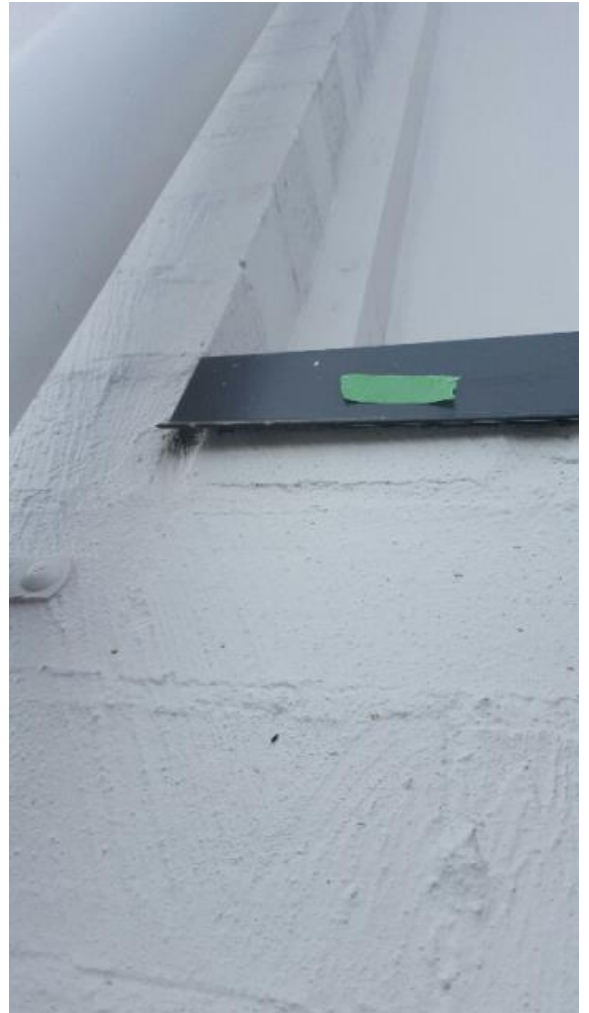
Seal gap to parapet
flashing, right side, left
of patio roof.

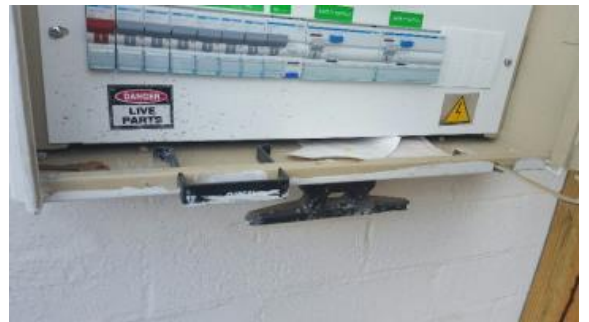
Tidy up cutting in to Elec
Meter box, right side.

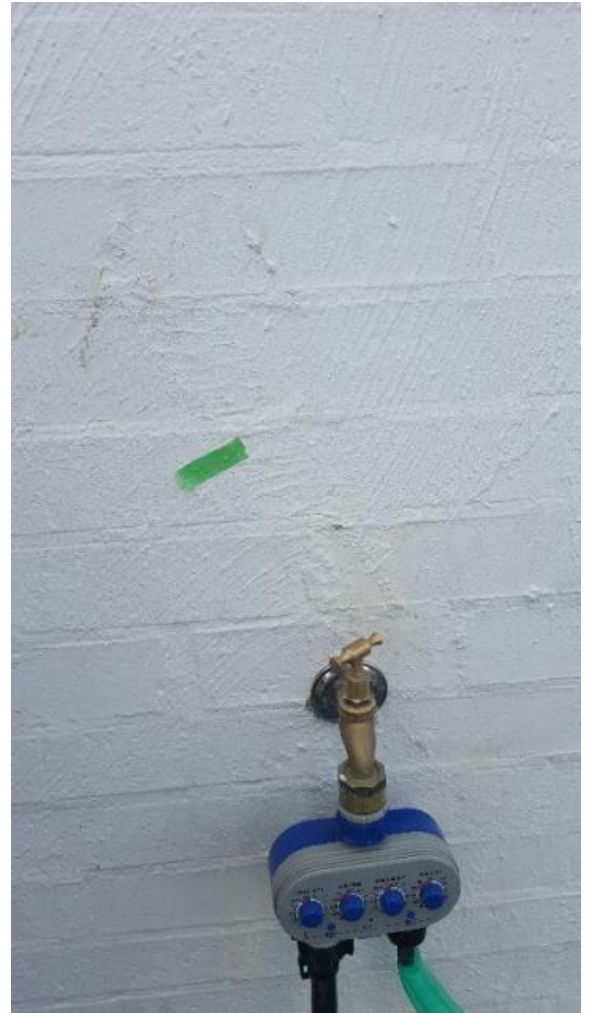
Clean paintwork near
hose cock, right side.

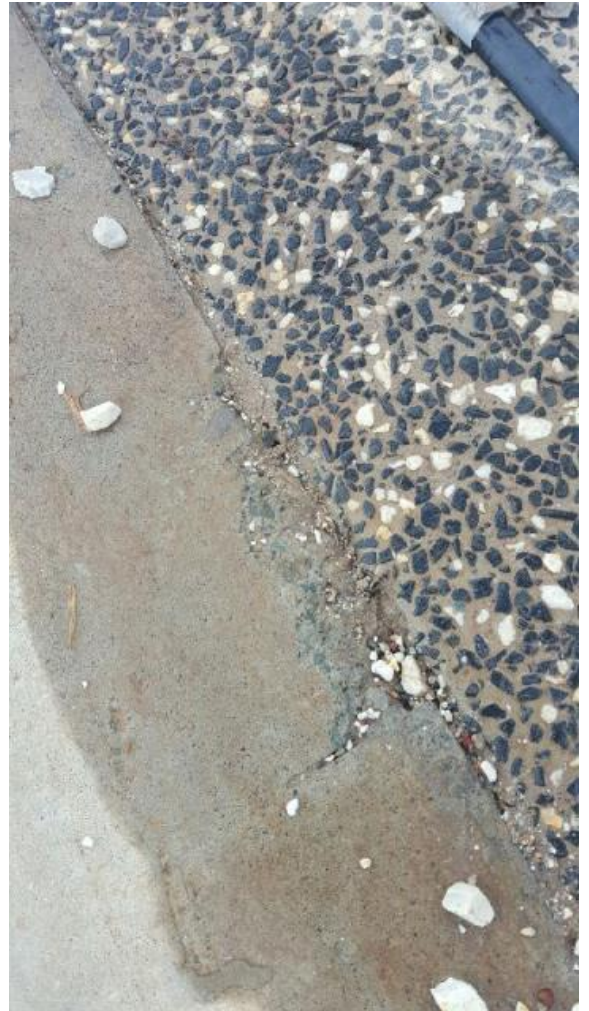
Repair kerb at Driveway.

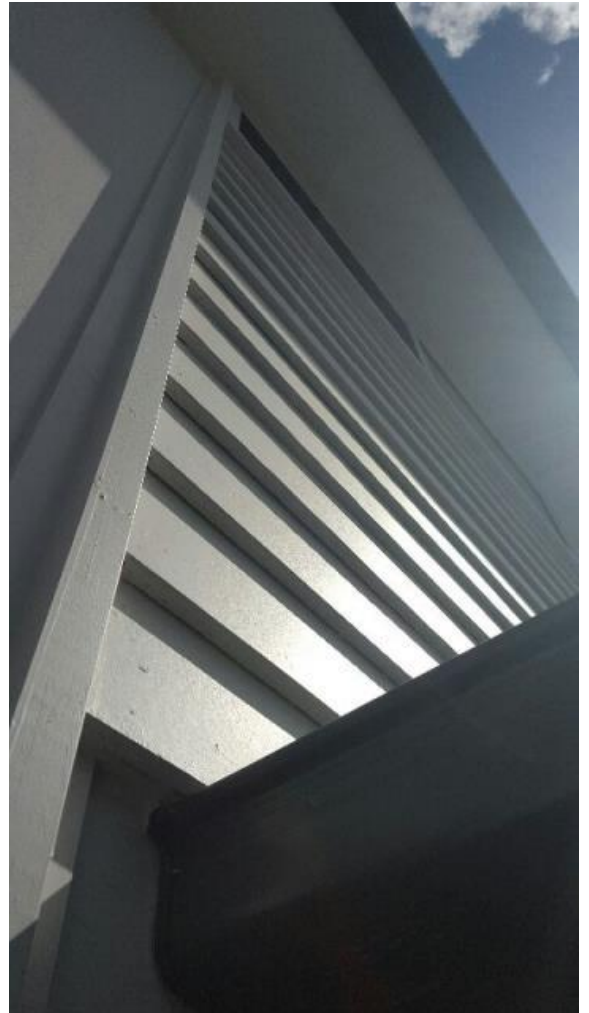
Gaps to underside of weatherboards, to left side, require sealing.

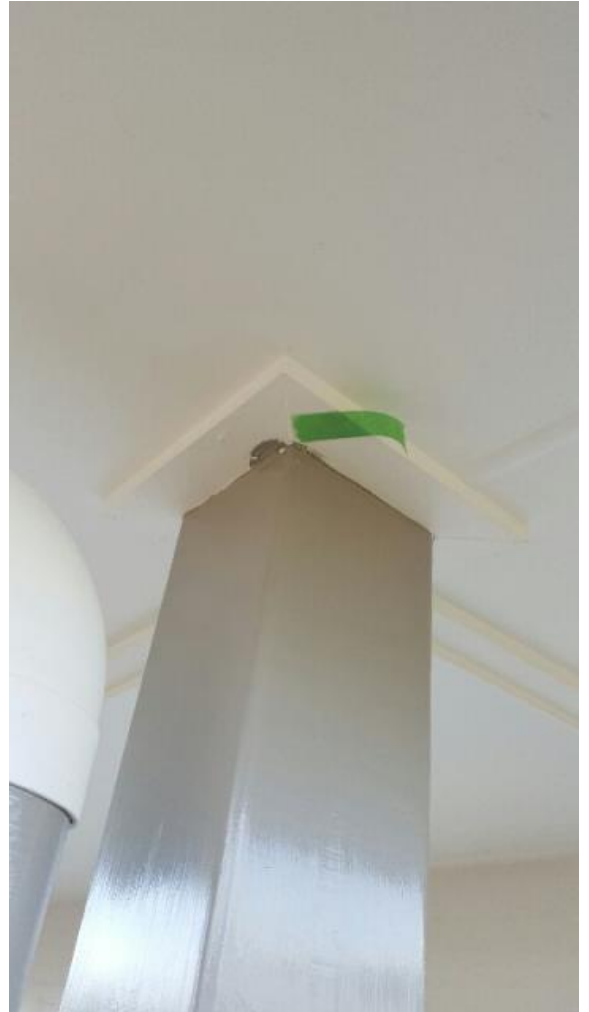
Repair paintwork to top of far column.

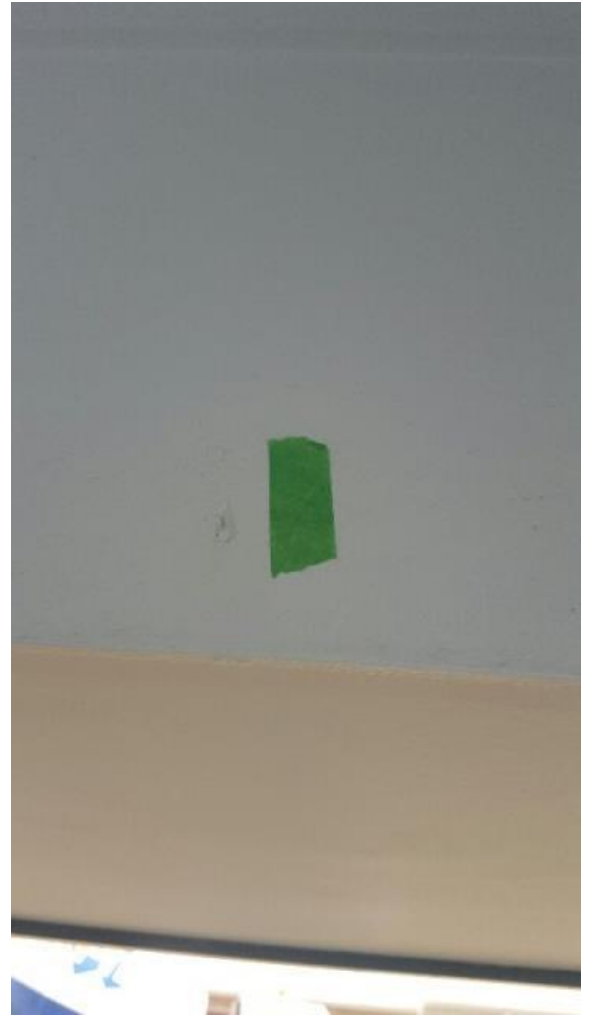
Repair gouge to
bulkhead.

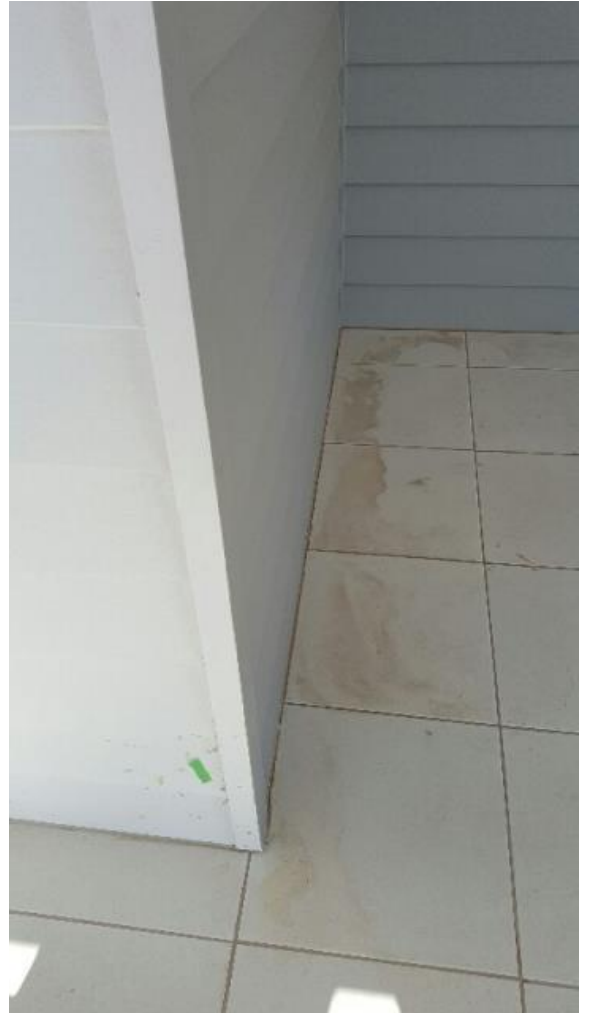
Clean weatherboards and floor tiles to Front Balcony.

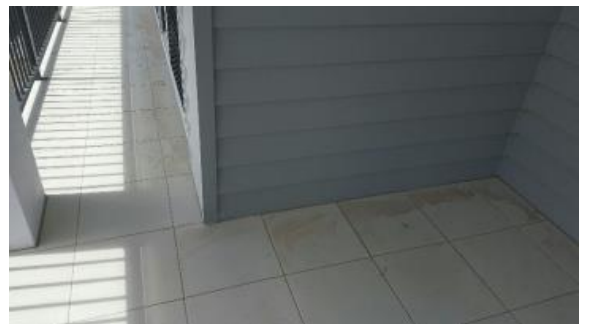
Adequate falls do not appear to be provided at Front Balcony.

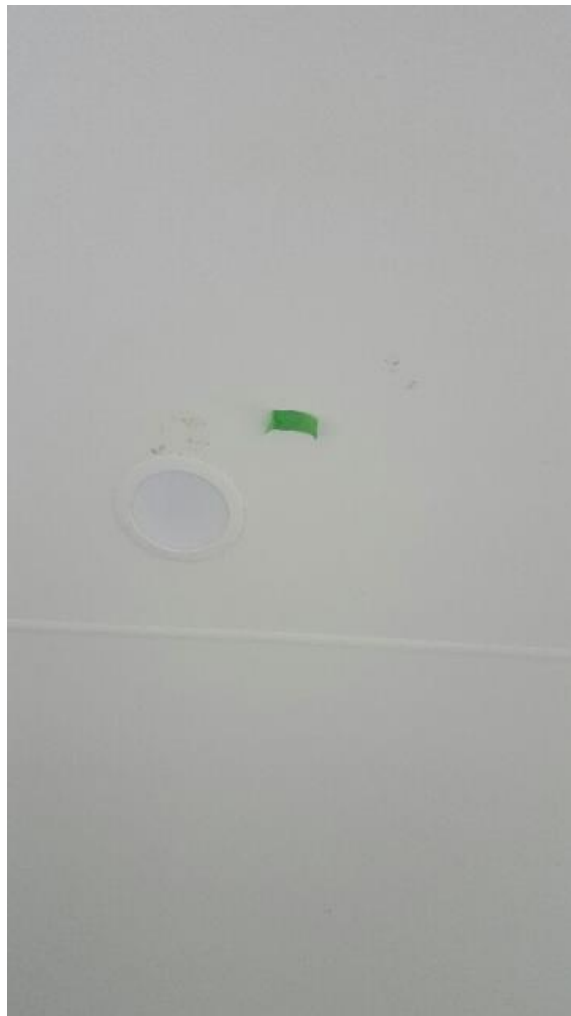
Clean ceiling at Entry
Porch.

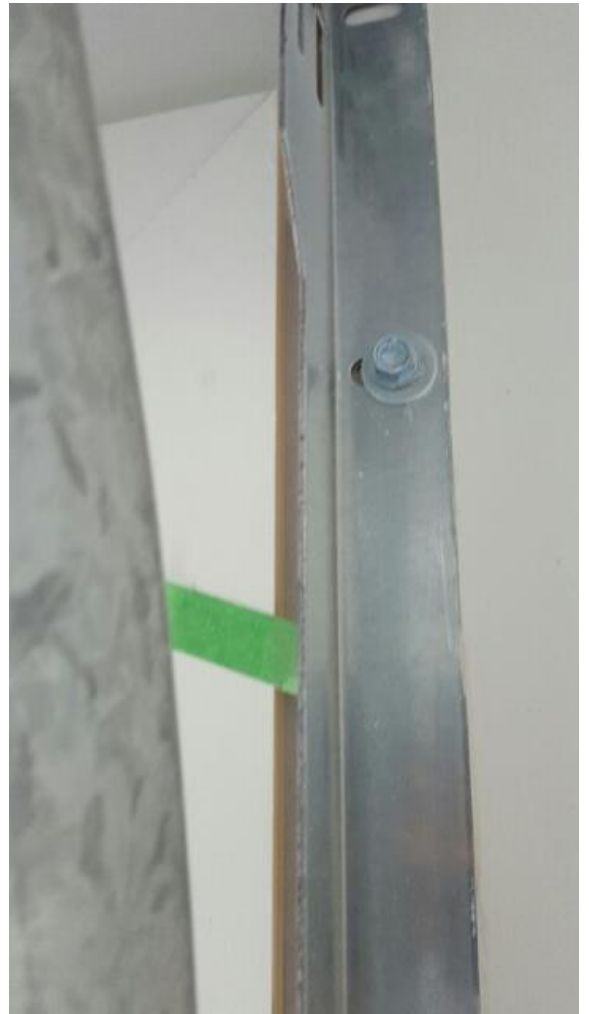
Provide paint finish to reveal edges, near top of Garage door, both sides.

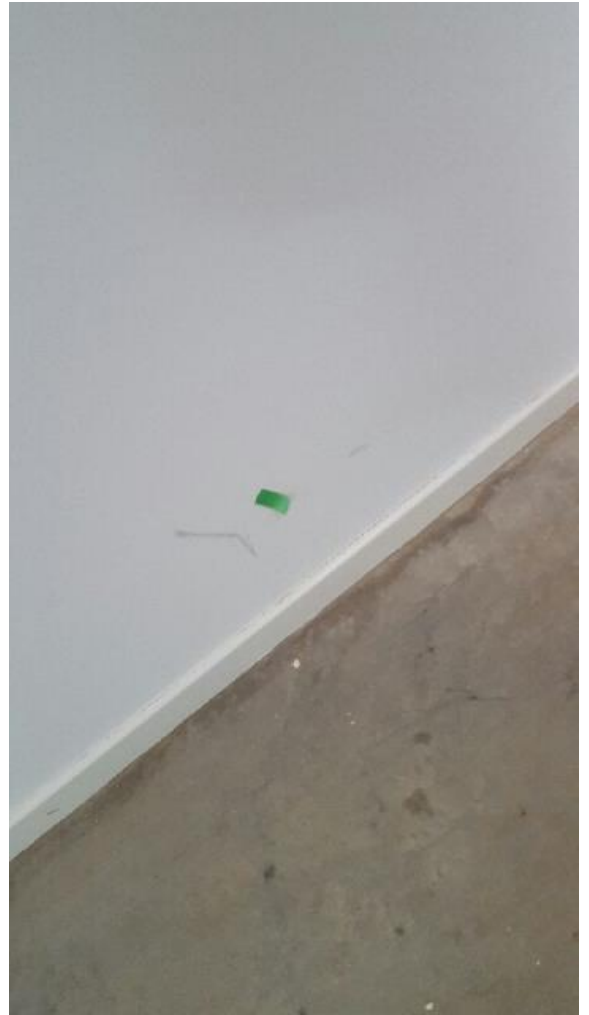
Repair paintwork to right wall.

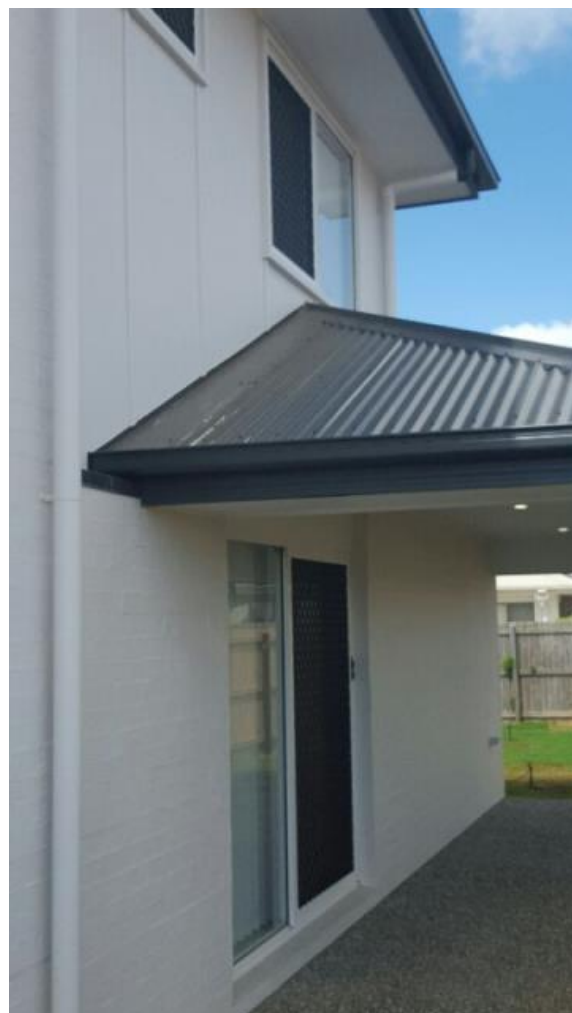
Clean roof AND gutter, to
Patio, right side.

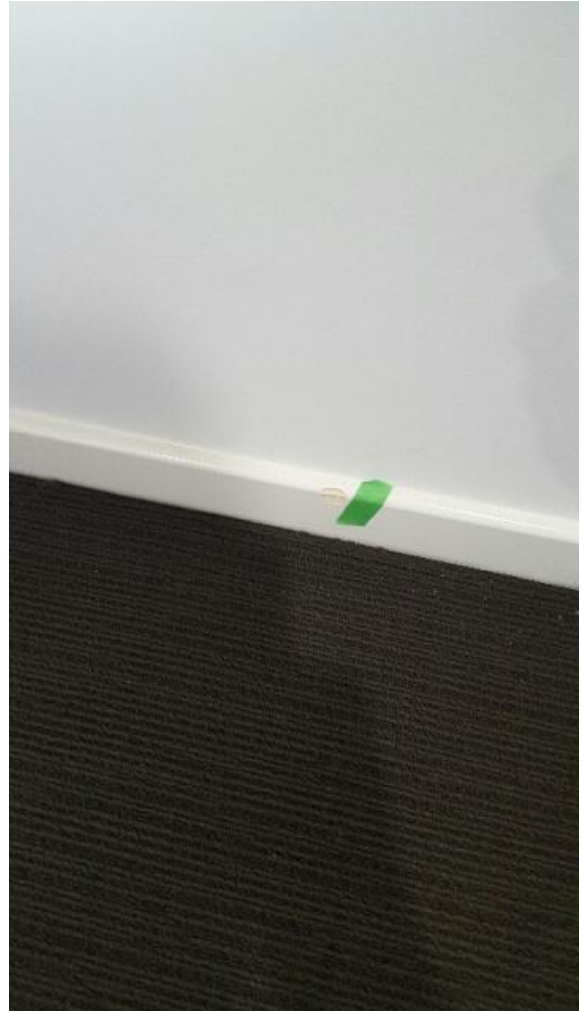
Repair gouge to skirting at Walk In Robe and numerous touch ups required.

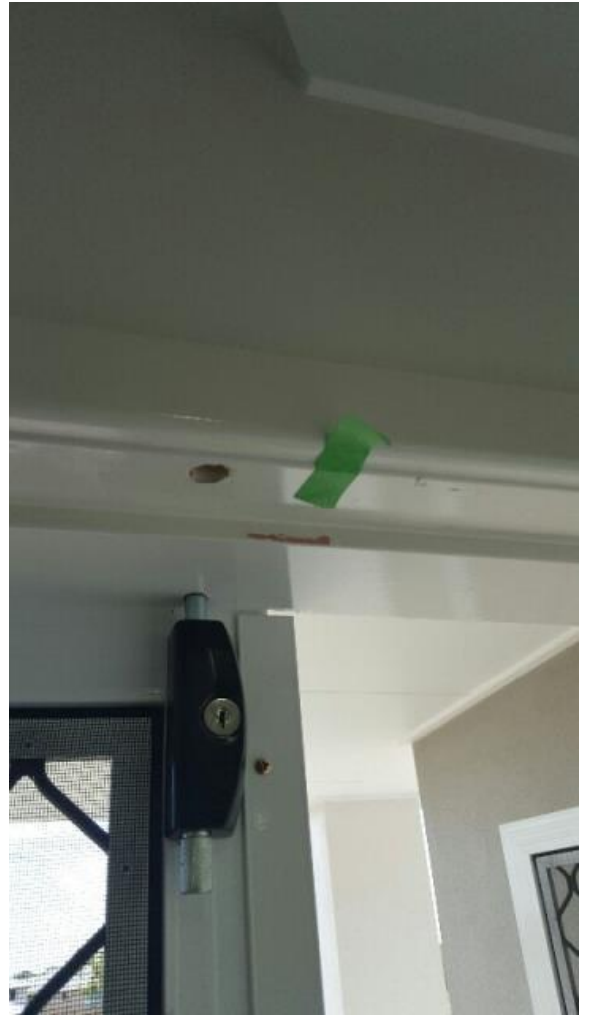
Repair paintwork to top of Entry Door head & door, and provide cover plate to flush bolt hole.

The following doors are rattling: door to Garage off Hallway, Ground Fl Toilet door, Left rear Bedroom door. Requires adjustment.

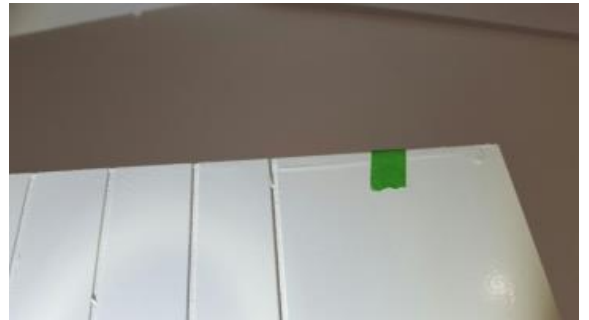
Repair paintwork to rear back Bedroom door, on inside.

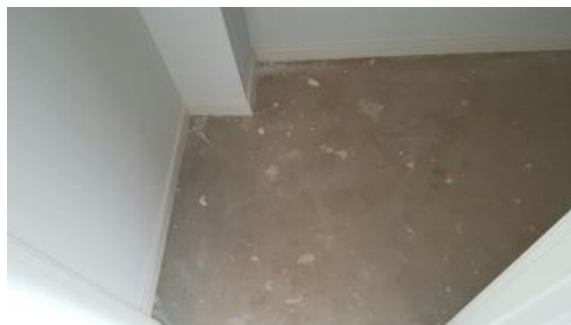
Remove paint / plaster
in storage area under
Stairs.

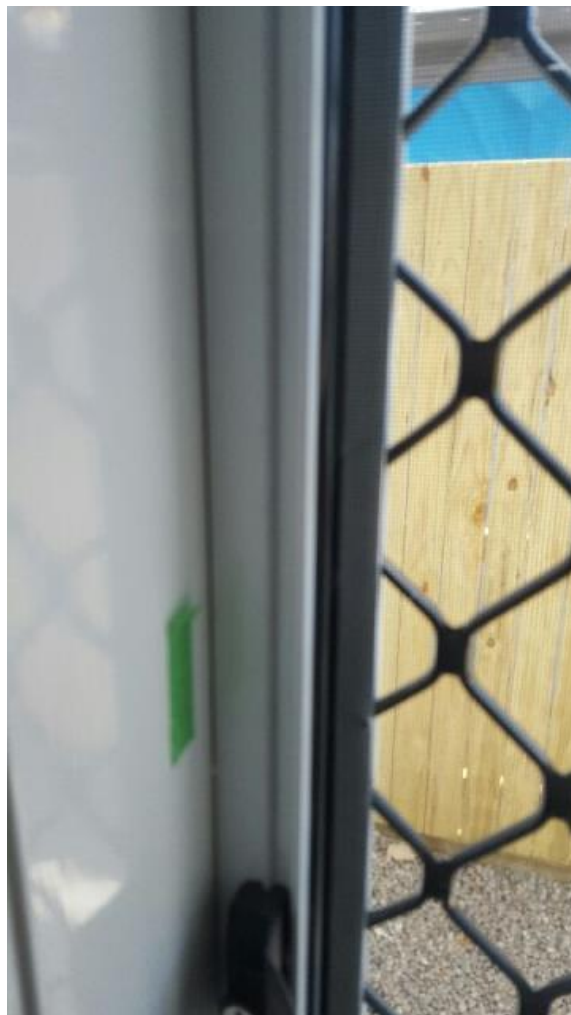
Seal window jamb, left
front bedroom.

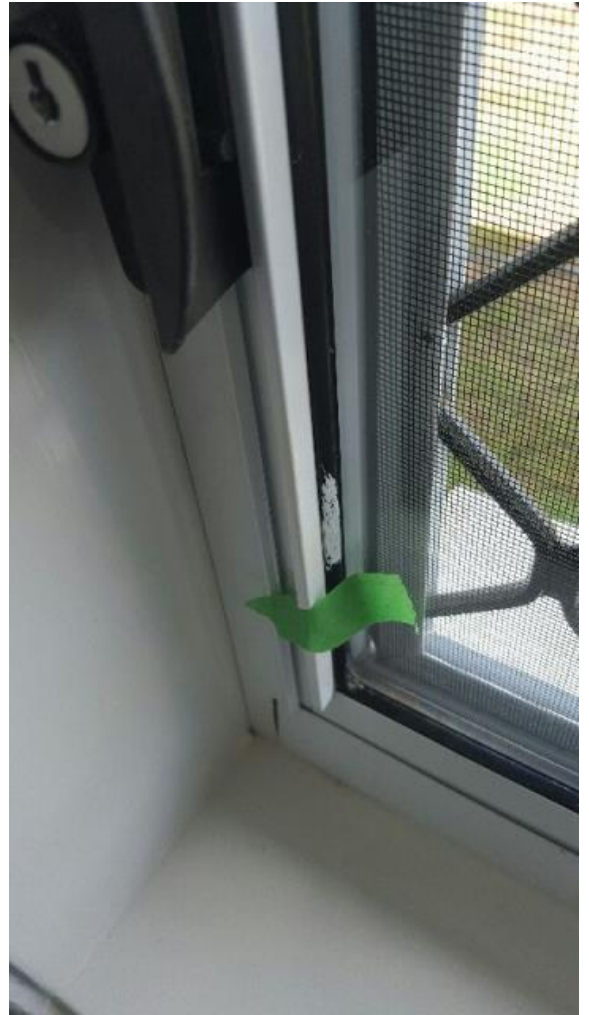
Remove paint to rear left
Bedroom window.

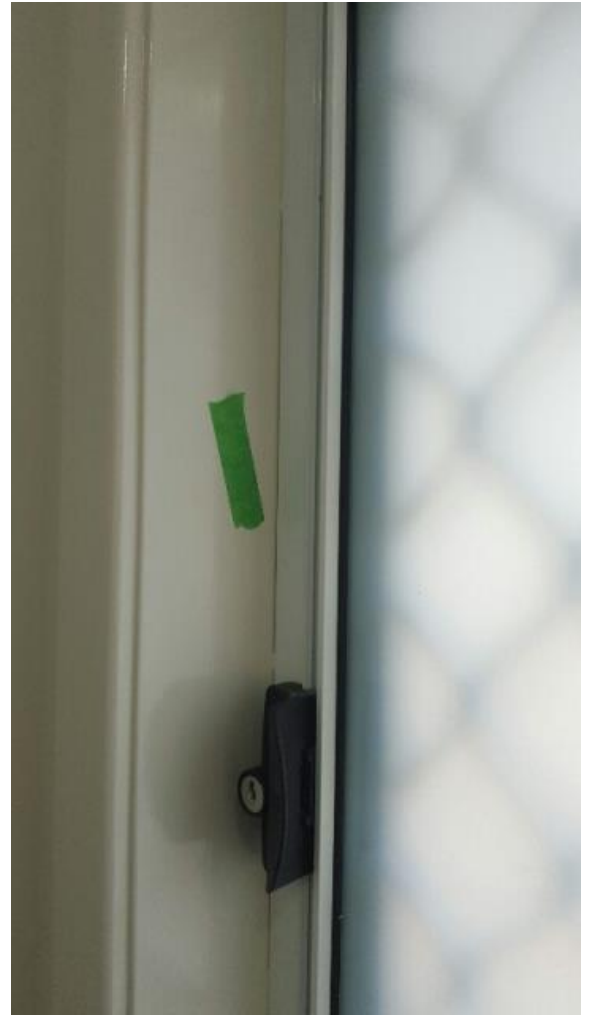
Seal left side to window
at First FI Toilet.

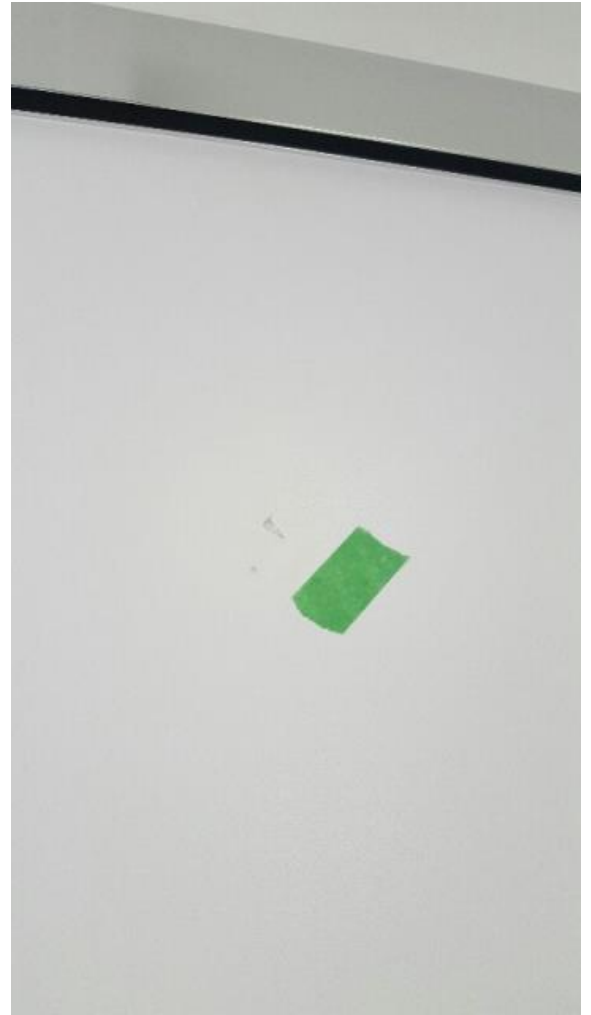
Repair gouges to First Fl
Linen Cupboard doors.
