Building Inspection Report

In accordance with AS 4349.1

Lot 24, 5 Smith St, Sampletown

7837

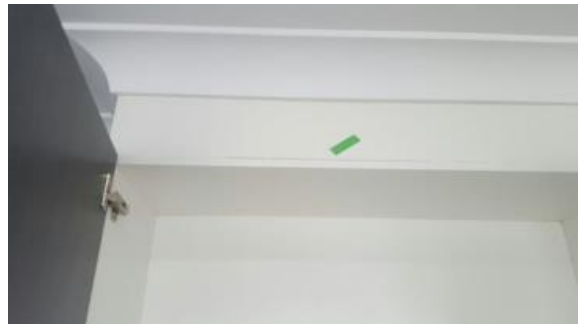
Seal gap above Refrigerator Recess cupboards and Pantry doors.

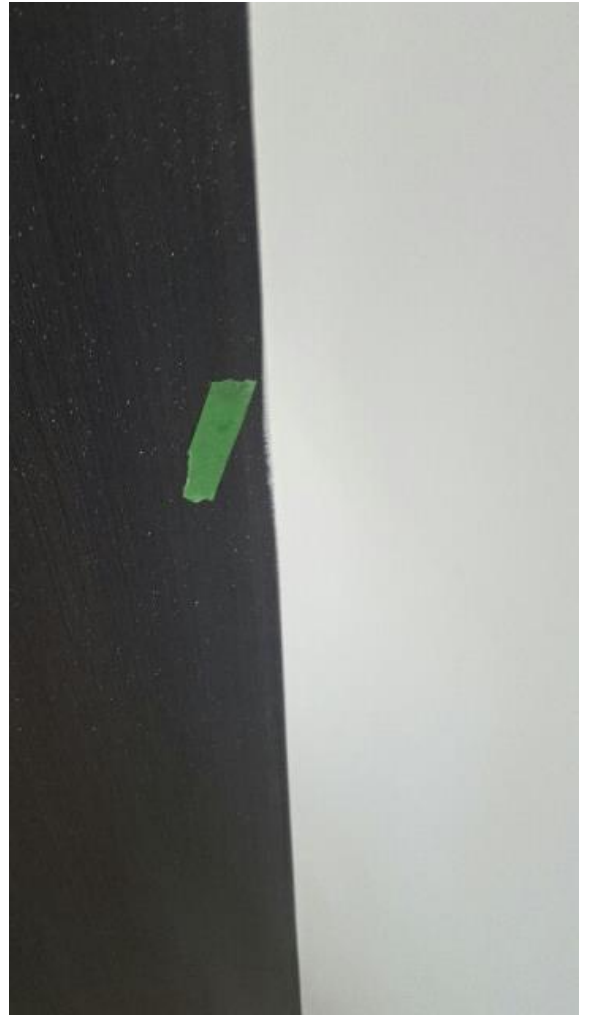
Tidy up cutting in, to
Refrigerator Recess.

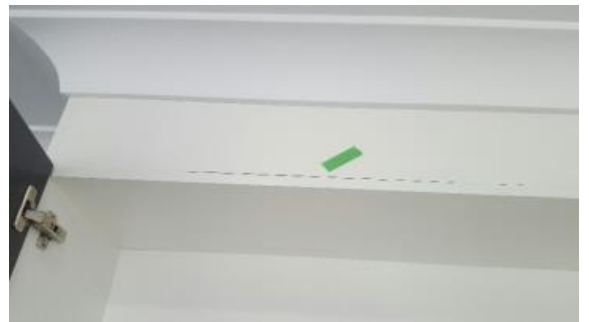
Face of Rangehood is
normally flush with face
of cupboard doors.

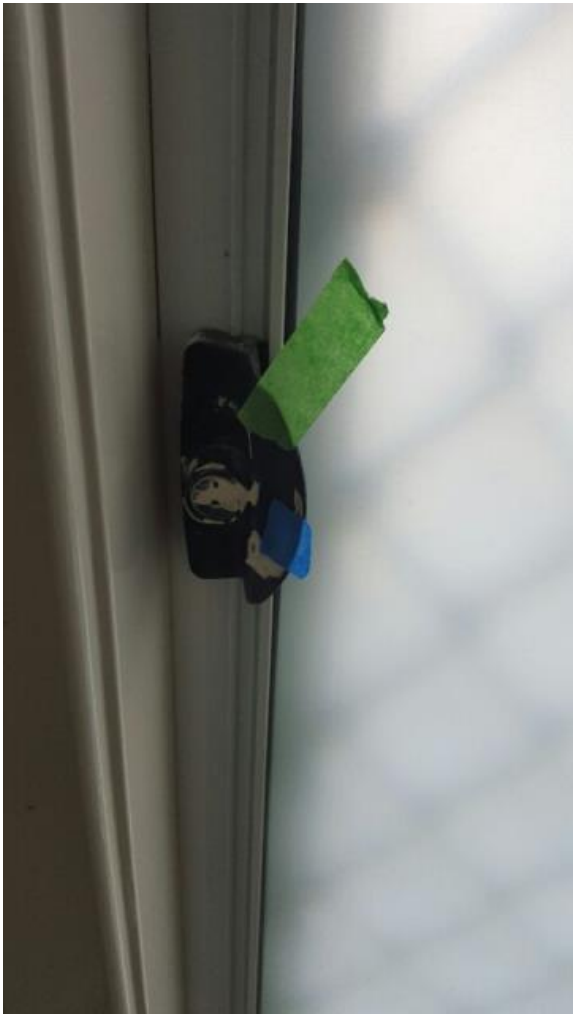
Condition Clean window handle.

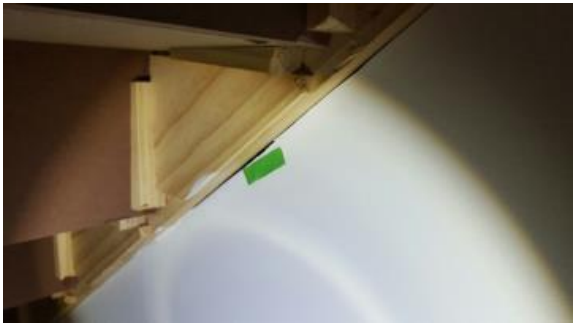
Stairs Condition Seal gaps to underside
of Stringer, both sides.

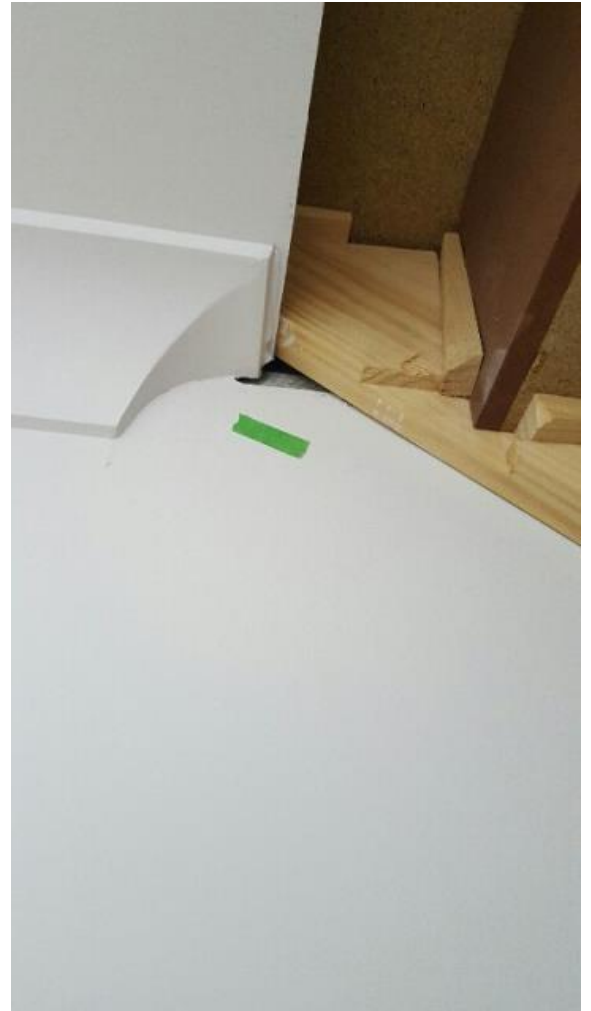
Fill gap at top of
underside of Stair.
