Building and Pest Inspection Reports

In accordance with AS 4349

Property Address:
101 Sample Street
Sampleville

Report Number:
13155

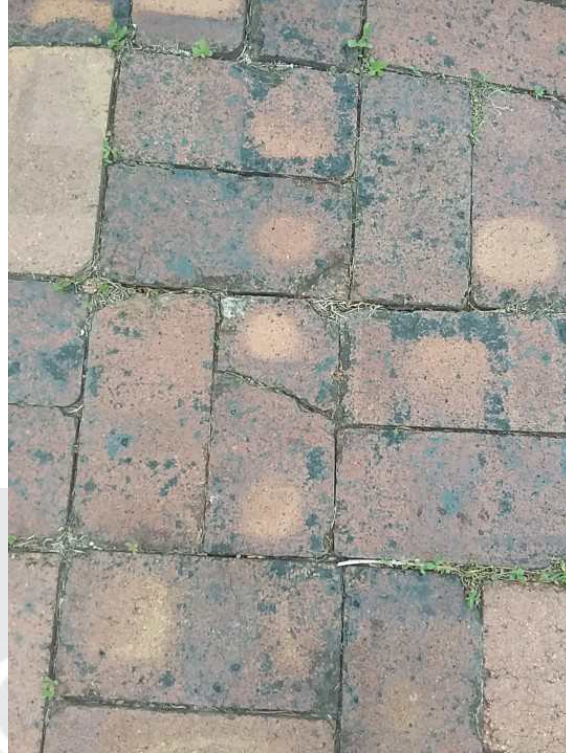
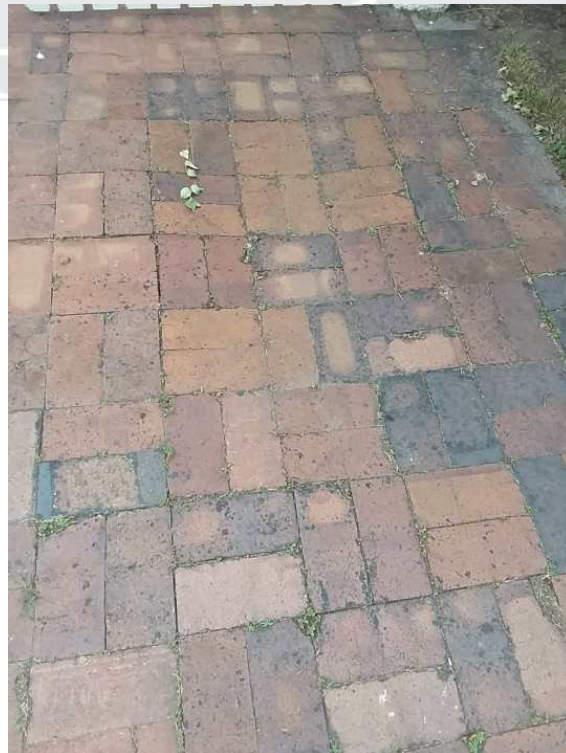
The paved driveway has cracked and subsided pavers. This could be a potential Major Safety hazard (tripping) and make the driveway unsafe. I recommend that you consult a licensed Paving Contractor about the scope of works and cost to rectify this defect and then have it rectified.

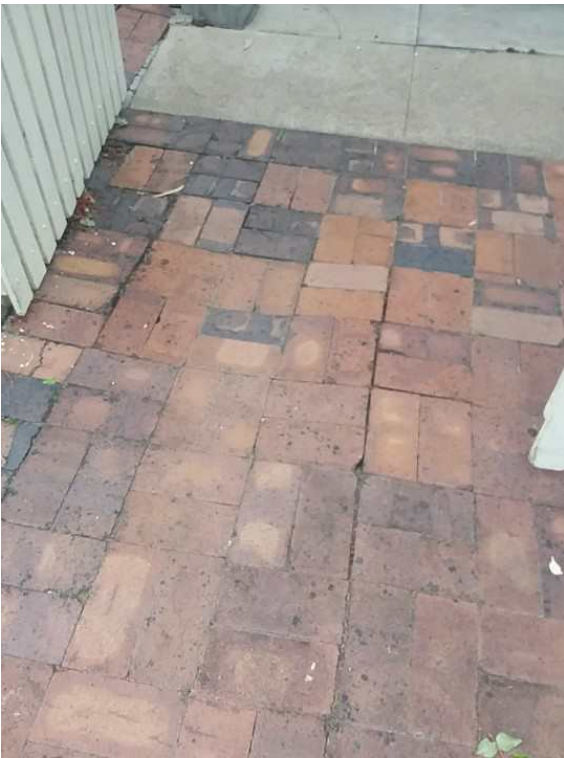
Decaying in sections. Replacement of damaged sections is recommended

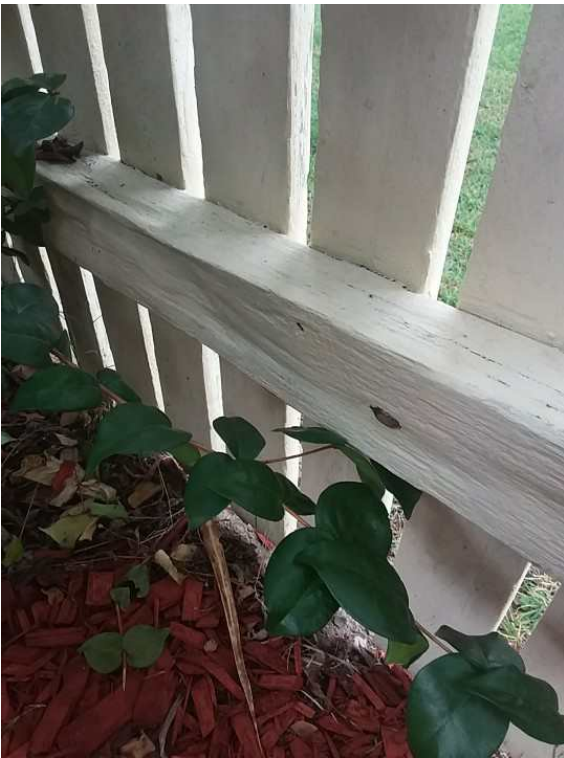
The gate/s have dropped or are damaged. This is an operational defect. I recommend that you consult a licensed tradesperson about the scope of works and cost to rectify this defect.

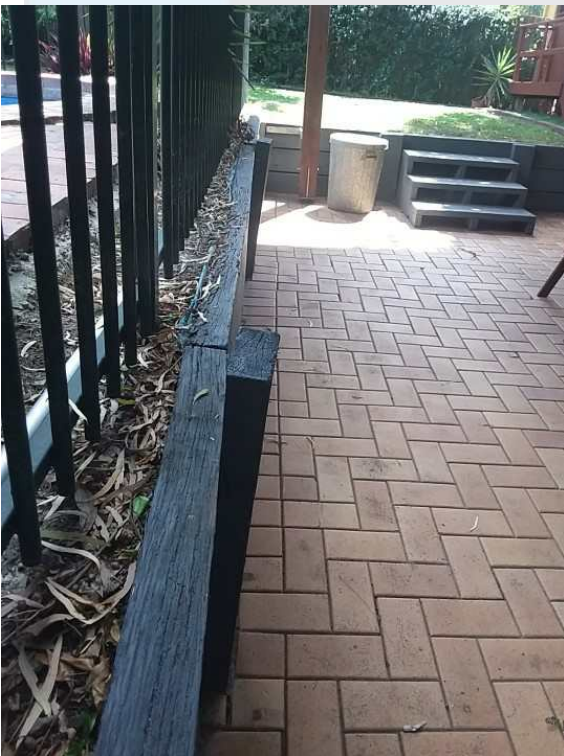
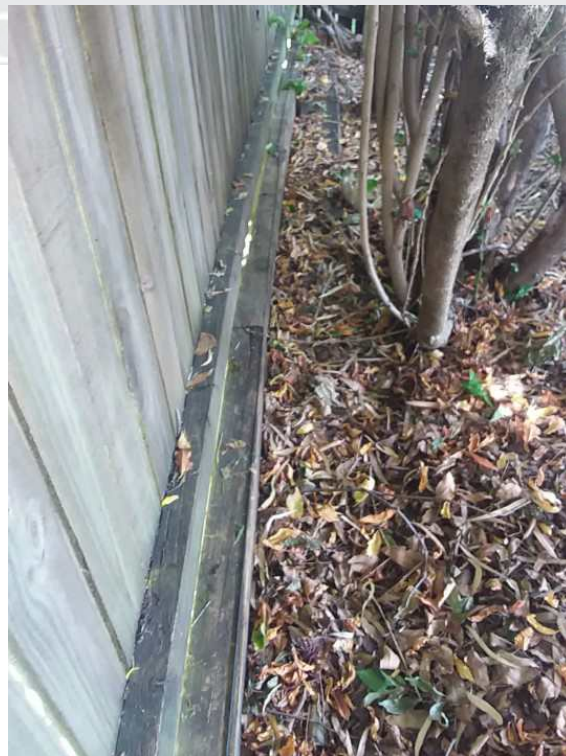
There are sections of decay (wood rot). Replacement of damaged sections is recommended. Consult a licensed Builder about the scope of work. Refer to pest report

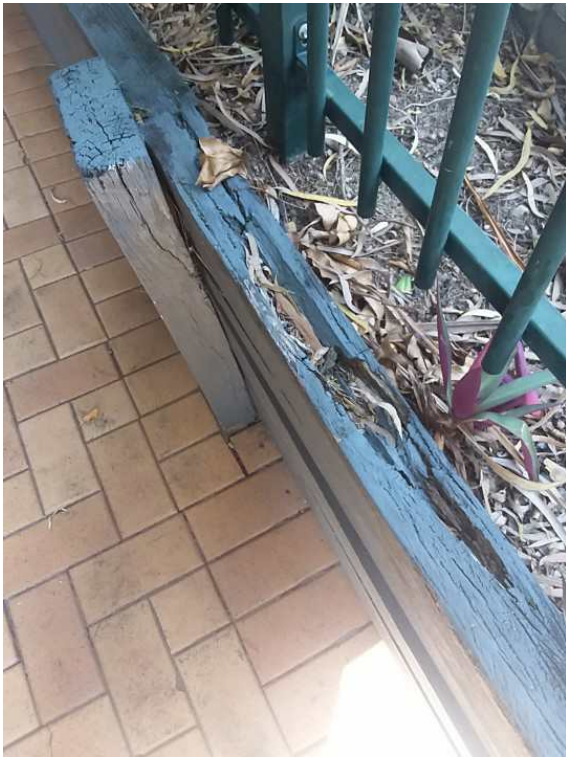
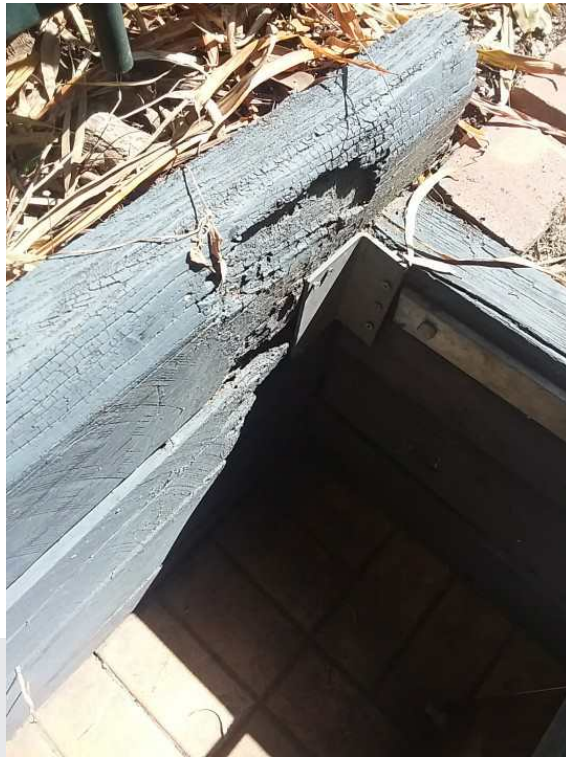
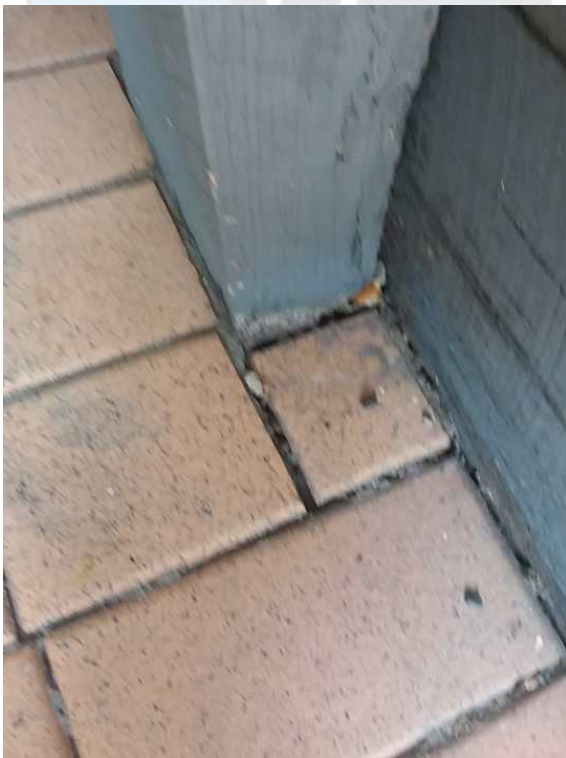
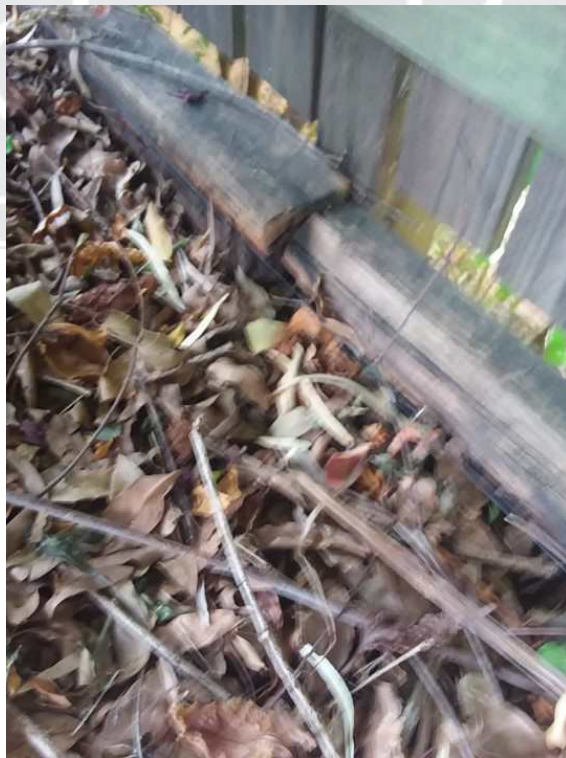
The timber retaining walls show normal wear and tear, and are leaning over these walls should be monitored. If any further movement occurs the walls will have to be replaced. Note that retaining walls over 1m in height require a Building Approval.

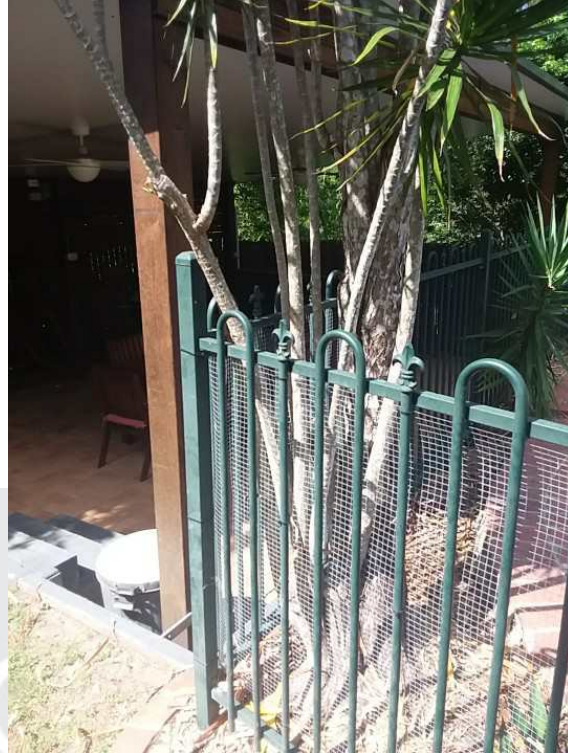
The swimming pool gate is not self closing. This is a potential Major Safety Hazard. Immediate rectification is required by a licensed tradesperson.

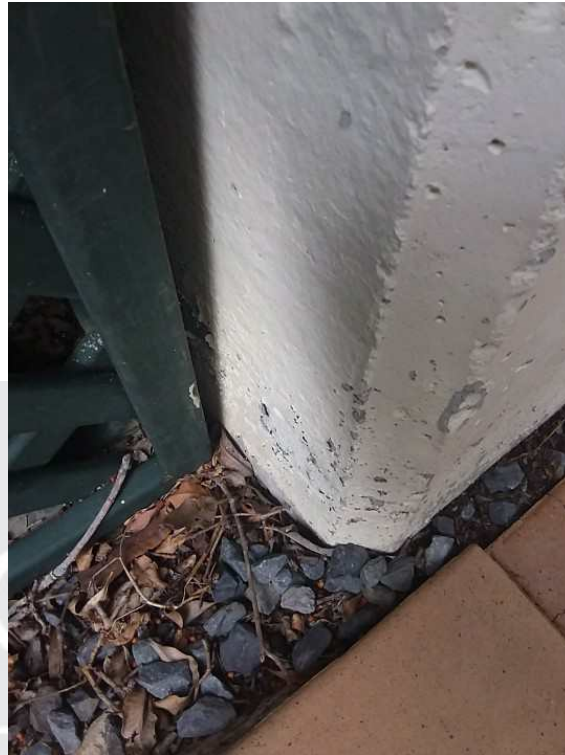
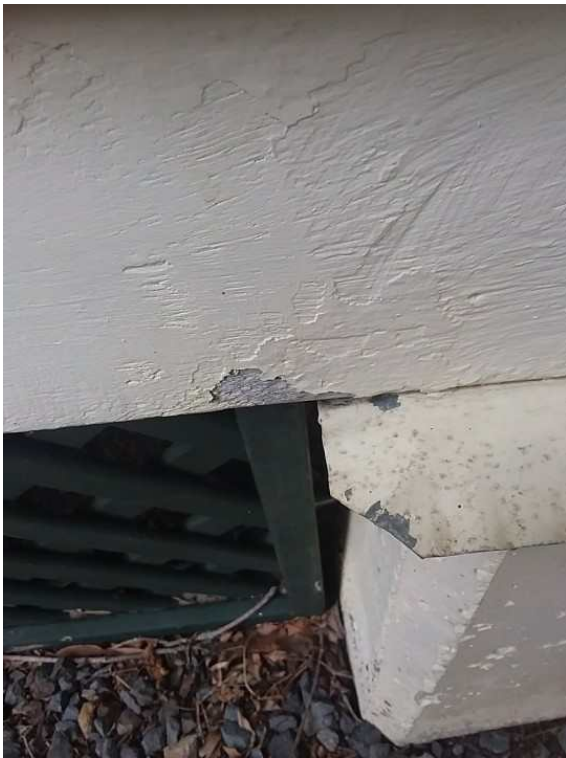
Paint is deteriorating to various sections of previously painted external surfaces. This exposes the building element to the weather and can result in accelerated deterioration and can increase the costs of repair and re-painting. I recommend you consult a licensed Painter about the necessity and cost of repainting. Note: Repainting an entire building can be very costly.

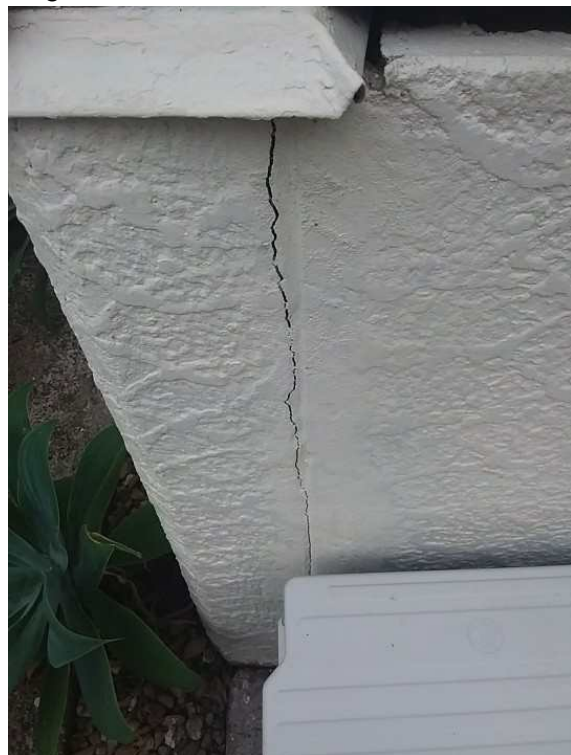
The external masonry walls appear to not have Vertical Articulation joints. These joints compensate for movement in the masonry due to variations in elements such as heat and/or moisture and are placed at prescribed locations and distances apart (often 5 to 6 metres). Lack of expansion joints may cause future problem to develop such as cracking. The expected consequence of the lack of Articulation joints is unknown. We recommend that you engage a Structural Engineer to carry out a further detailed inspection to determine the consequences of this issue. If necessary a licensed Bricklayer should then also inspect this issue and provide a scope of work and cost for repairs as may be deemed necessary by the Structural Engineer.

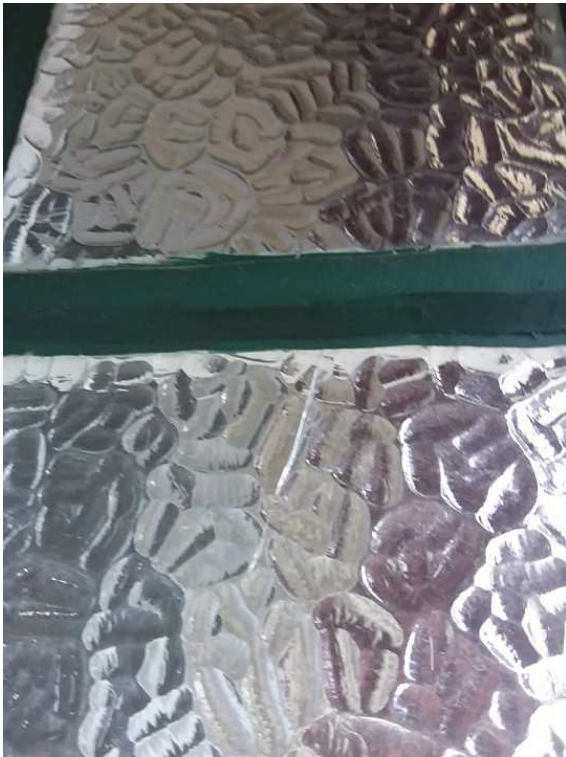
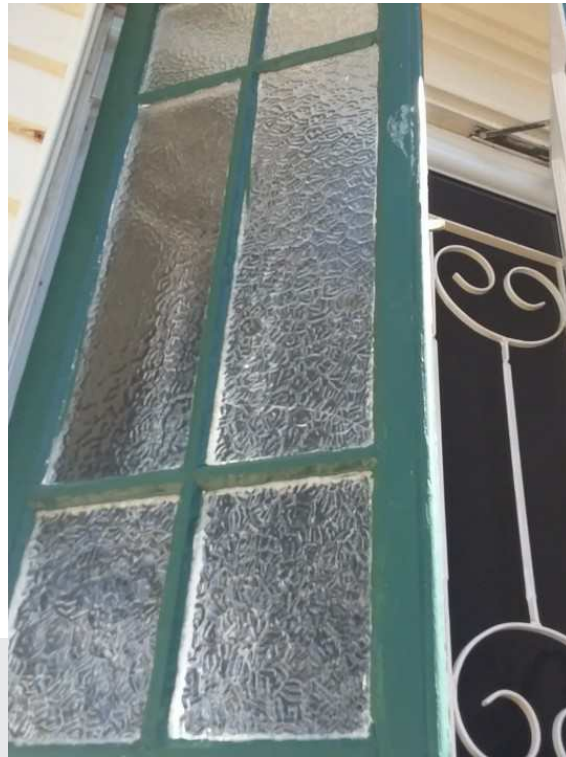
There is cracked panes of glass. This is unsafe and may cause injury. Have a licensed Glazier repair or replace cracked glass immediately.

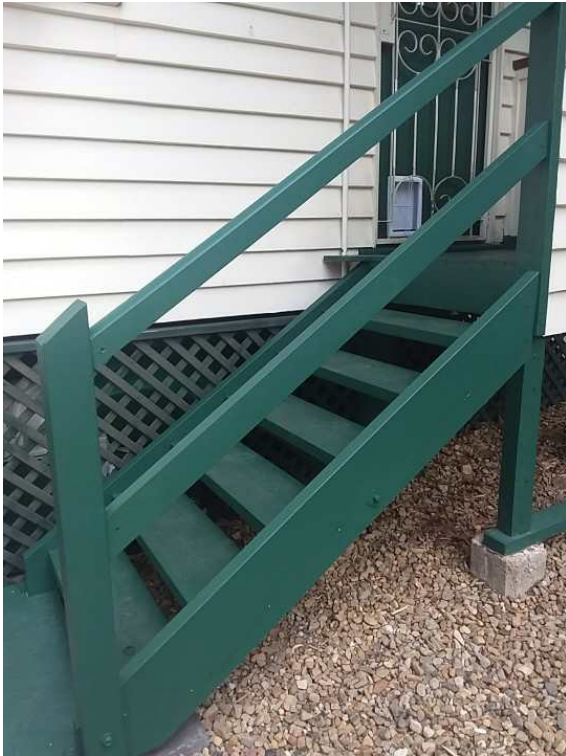
The gap between the handrail and the stairs is excessive. This may allow a small child to fall through the handrail. An intermediate rail with gaps not exceeding 125mm should be installed for safety or a young child could fall through the gap. This is Major Defect. I recommend that you contact a licensed tradesperson and have this problem rectified without delay.

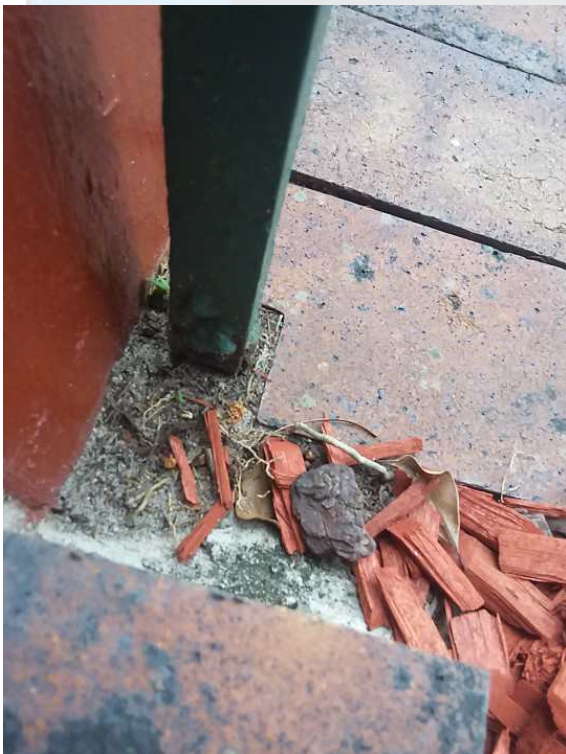
Rusting in sections. This is a minor defect that should be rectified as part of a normal maintenance program.

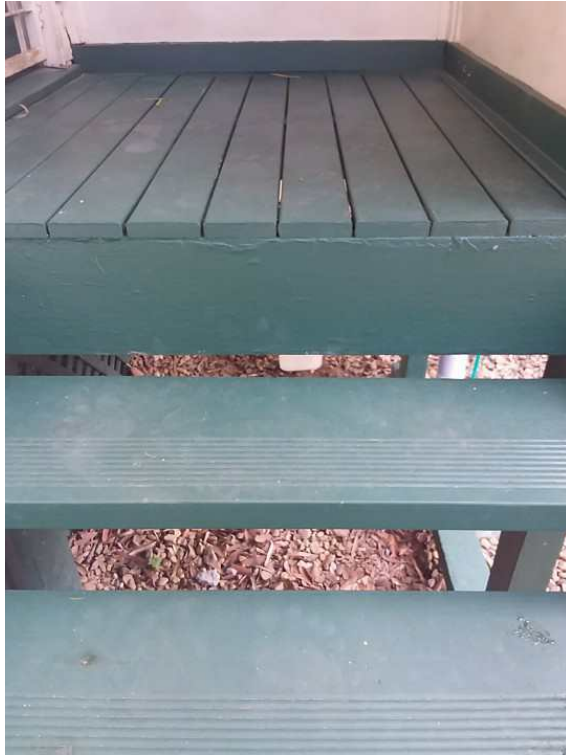
The height of the riser (or step) is too high. This is a safety hazard and may cause a person to fall and injure themselves. This is Major Defect. It is recommended that the stairs/step be altered so that the maximum height does not exceed 190mm. If an intermediate step is installed to rectify this problem, the new step must maintain the same rise (height) as all the other steps. Recommend that you contact a licensed tradesperson and have this problem rectified without delay.

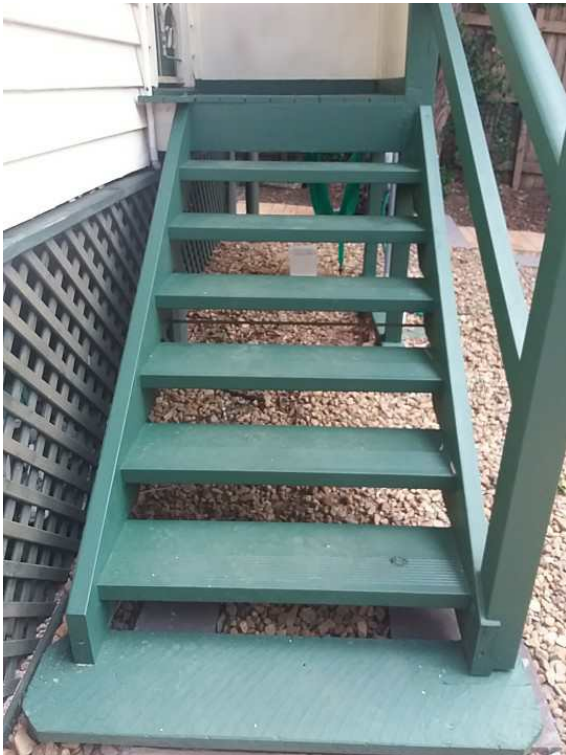
The riser heights vary. This is unsafe and may cause a person to fall and injure themselves. This is Major Defect. It is recommended that the riser heights be altered to be consistent in rise to reduce the risk of an accident. I recommend that you contact a licensed tradesperson and have this problem rectified without delay.

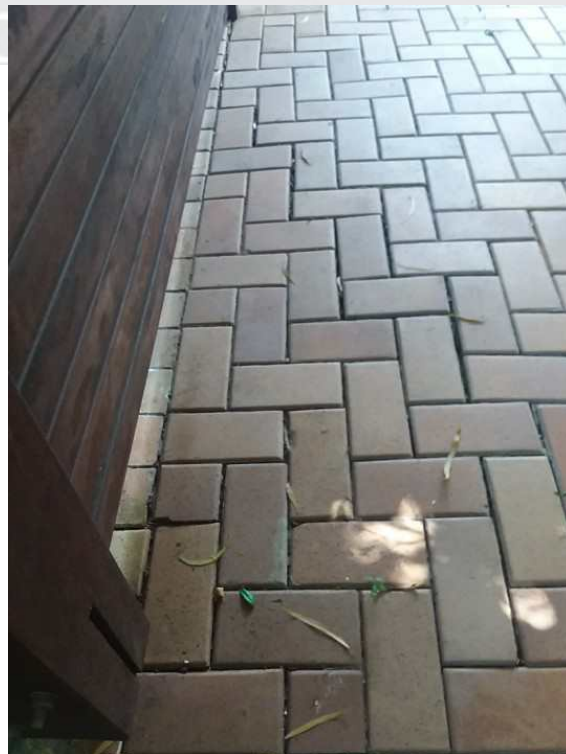
The paved floor appears to be in poor condition.

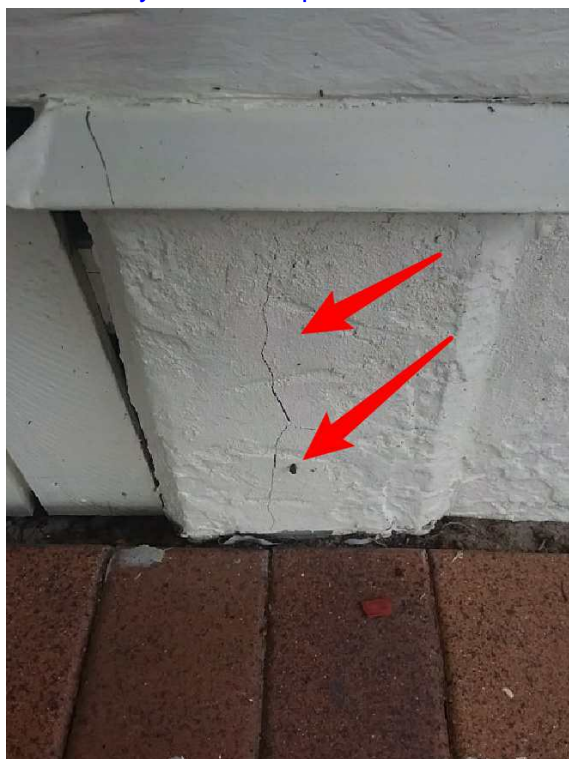
Various concrete stumps have cracks in them. This is Major Defect. This cracking is due to the corrosion of steel reinforcement inside the stump. This corrosion causes the steel to expand. The expansion exerts enough force to crack the concrete stumps. Ask a restumper to further investigate this problem and advise which stumps are that badly cracked that they may have to be replaced. Replace any badly damaged stumps immediately. In addition to replacing any badly cracked stumps, the surface drainage should be improved to reduce the volume of water that flows under the house. To improve the surface drainage you will need to install a suitable stormwater drainage system. This drainage system should be designed and installed by a licensed plumber or drainer.

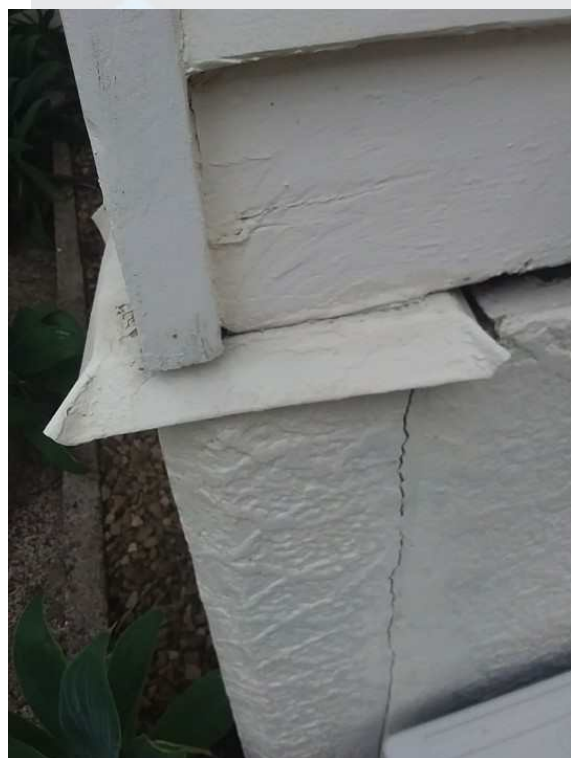
The ant capping or termite shields installed do not comply with the relevant standard and are therefore not adequate. This is Major Defect. A licensed Builder should install suitable ant capping and/or termite shields.

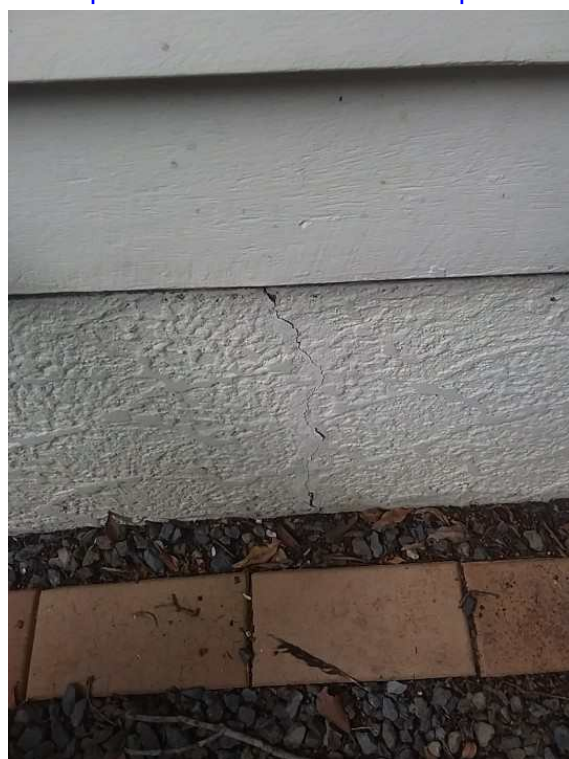
The condition of the walls is generally fair. Appearance cracks are evident to the concrete. Visible cracks are hairline to 1mm in width only. These cracks are relatively minor at this time but they could get worse over time.

There is no termite shields fitted and no mechanical connection to the timber bearer. Consult a licensed tradesperson to determine an adequate scope of works and associated costs to rectify this defect.

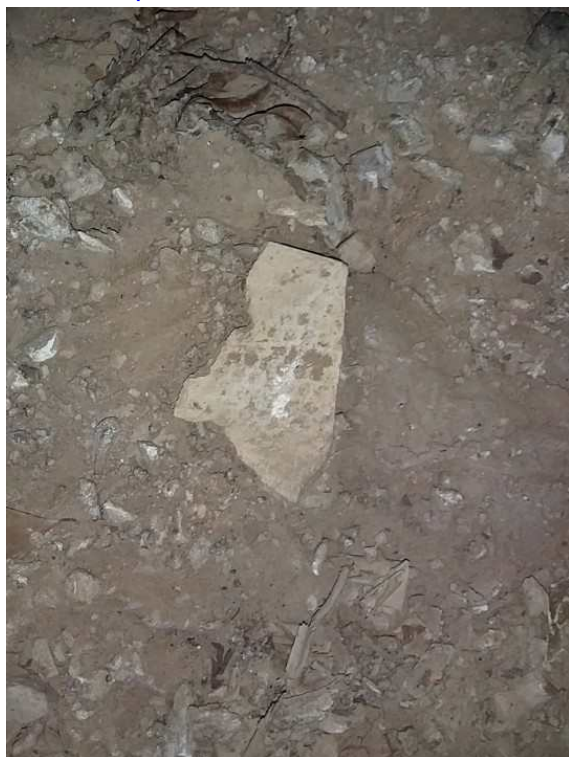
There are internal cracks to ceilings and walls that indicate that there has been some minor foundation movement. The presence of minor cracks in the building from foundation movement is not uncommon. Refer to the attached Information sheet from the CSIRO on Foundation Maintenance. This document provides a good explanation of what causes cracks in buildings and also provides tables to classify the extent of Building Movement. The information provided is based upon Australian Standards that are referenced in the Building Code. The recommendations within the CSIRO information sheet should be applied without delay to aid in reducing both the severity of Foundation movement and the extent of any subsequent damage being caused to the building from this foundation movement.

Asbestos pieces under the floor should be removed

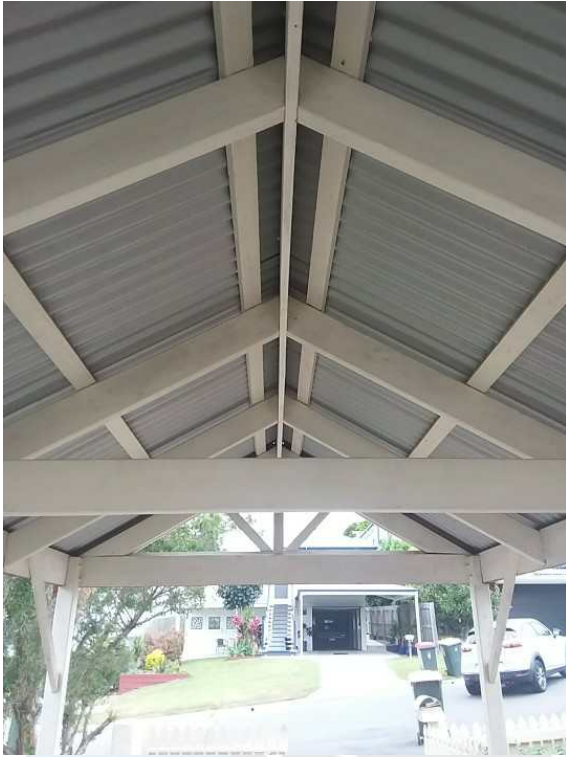
The condition of the framing is generally inadequate. There are insufficient collar ties (there should be installed on every second pair of rafters). There should also be additional bracing.

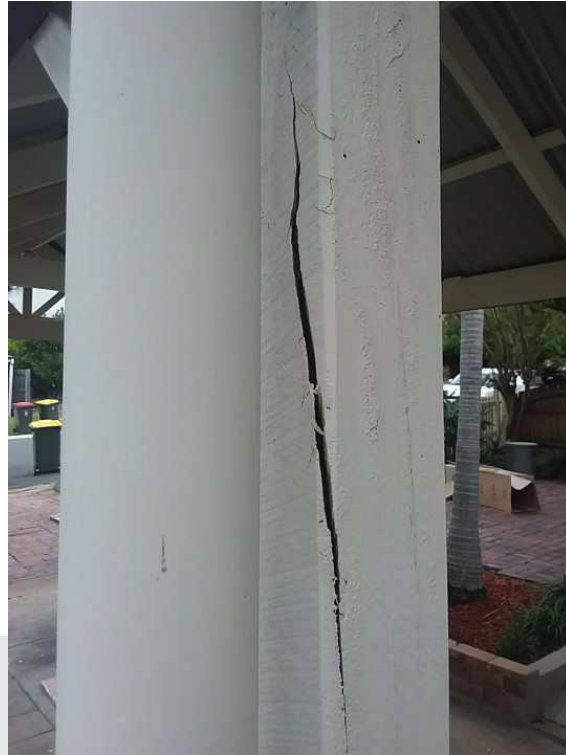
One split post. This is a minor defect that should be rectified as part of a normal maintenance program.

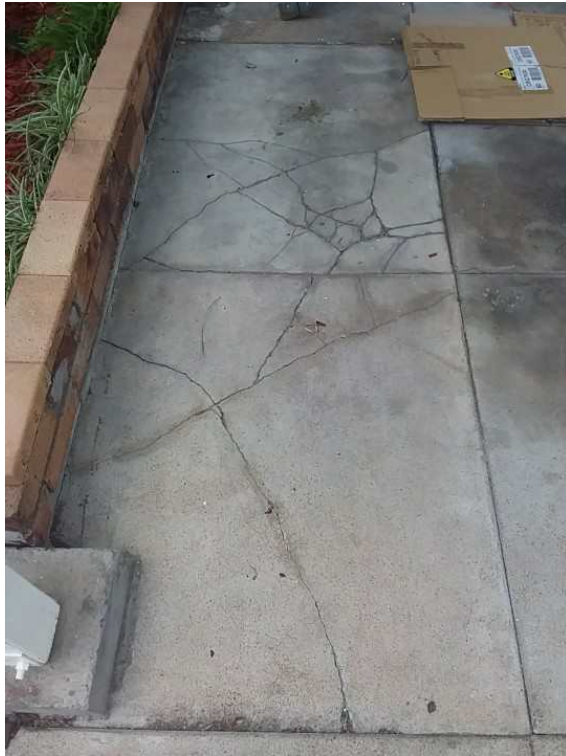
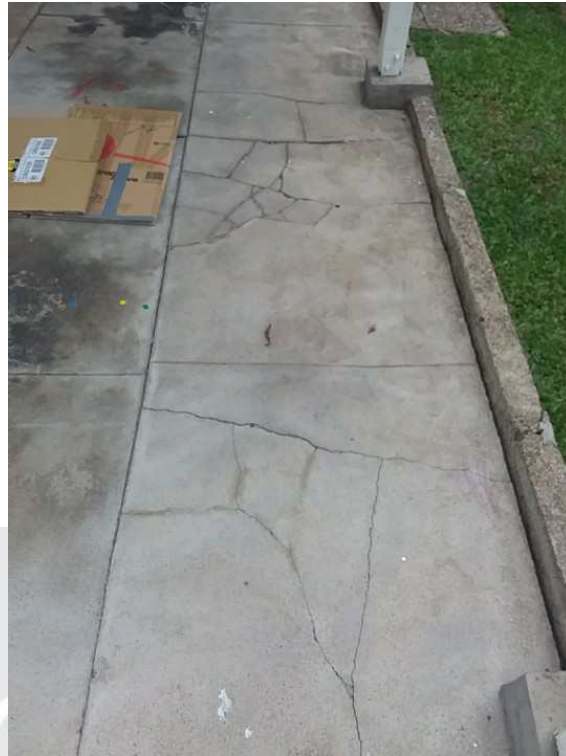
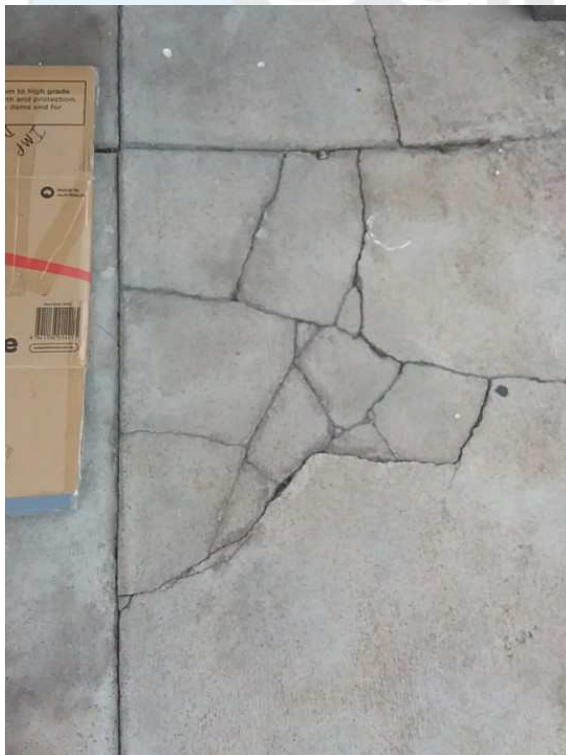
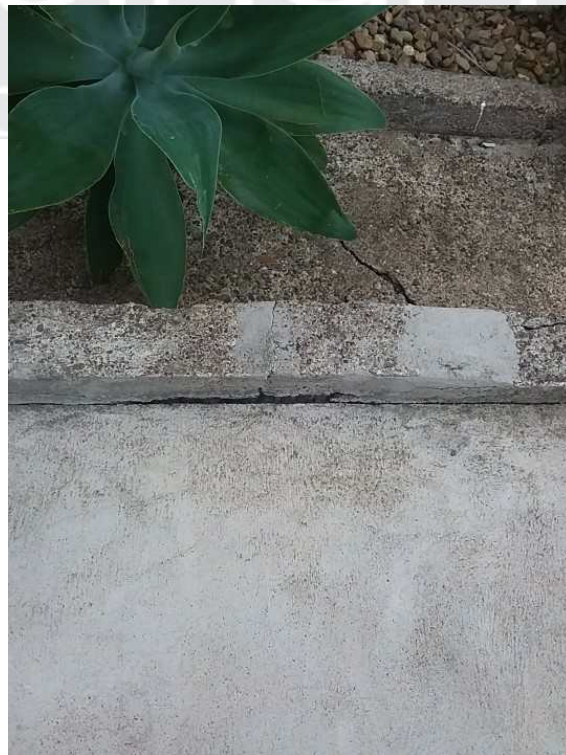
The concrete floor has Suspected Structural Cracks as there is probably no steel reinforcement present. These cracks are wider than I would normally expect for a concrete floor and could indicate Structural failure. I recommend that you consult a Structural Engineer about these cracks to confirm the likely consequence of them.

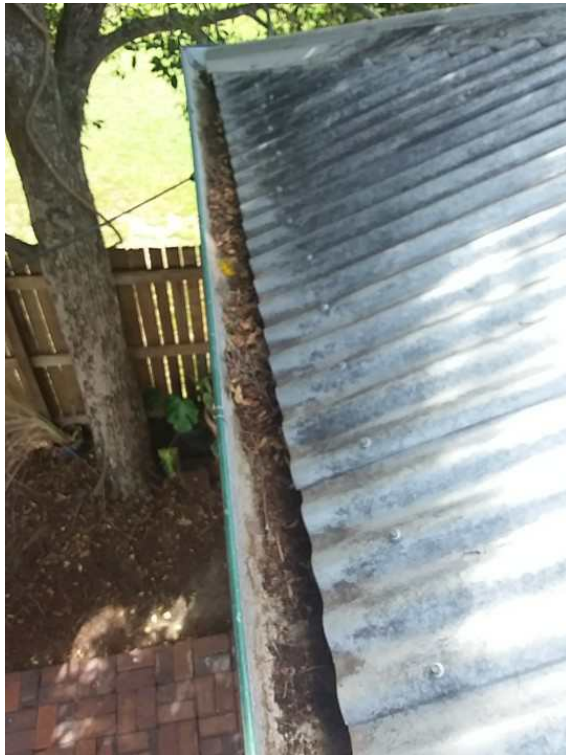
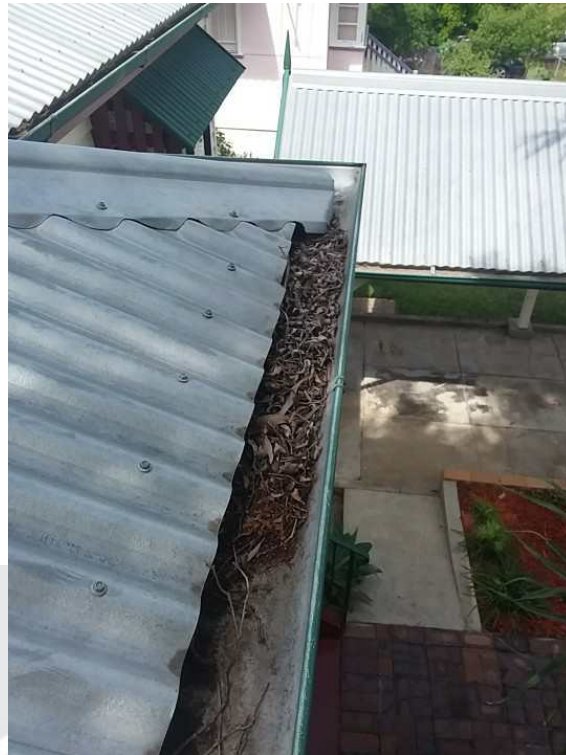
Leaves and debris are present in gutters and downpipes. These should be cleared. Minor defect. Gutters and downpipes should be kept clear of leaves and other obstructions otherwise water may cause damage to other components of the building. Recommend trimming back overhanging trees/vegetation and installing good quality 'gutter guard' to prevent build up of leaves and other obstructions.

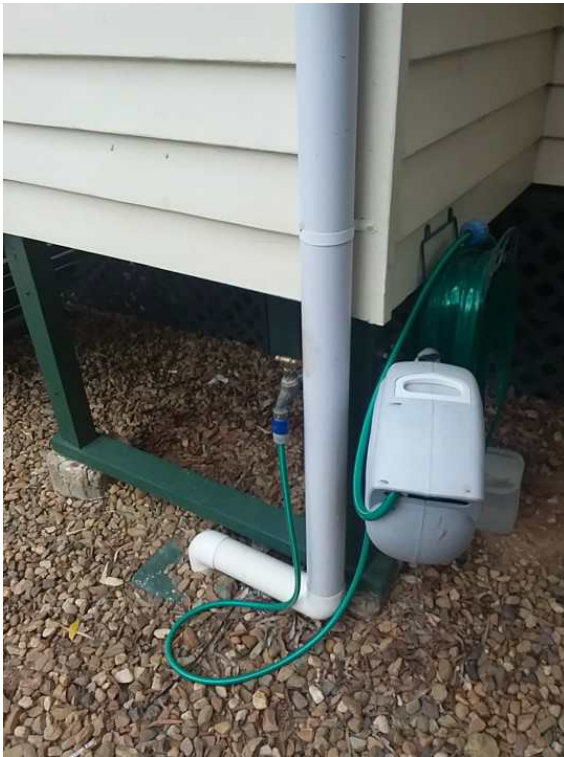
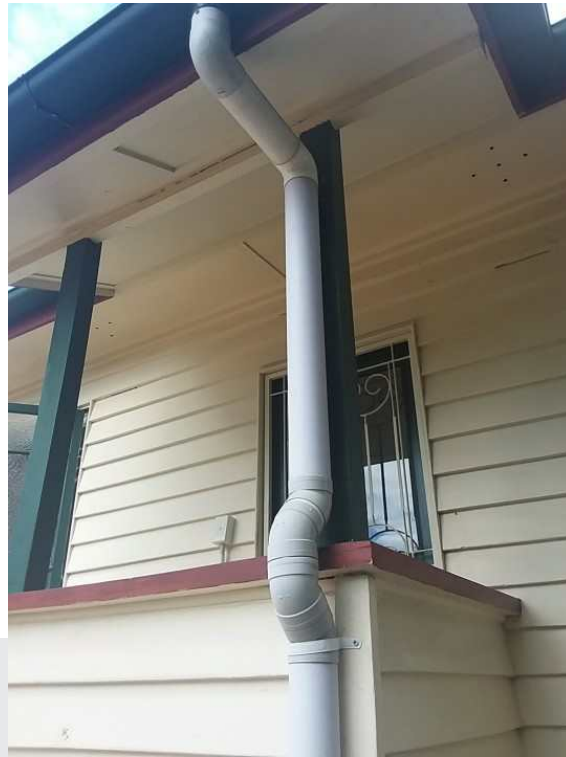
Some downpipes appear to have been replaced and are unpainted. This is a minor defect. These should be painted.

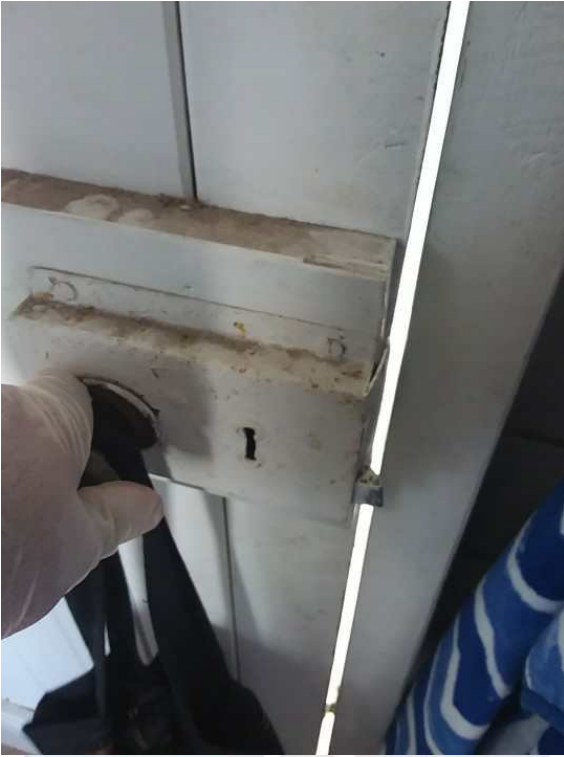
The condition of the door hardware is generally poor. There is no latch. Some repairs or maintenance will be required.

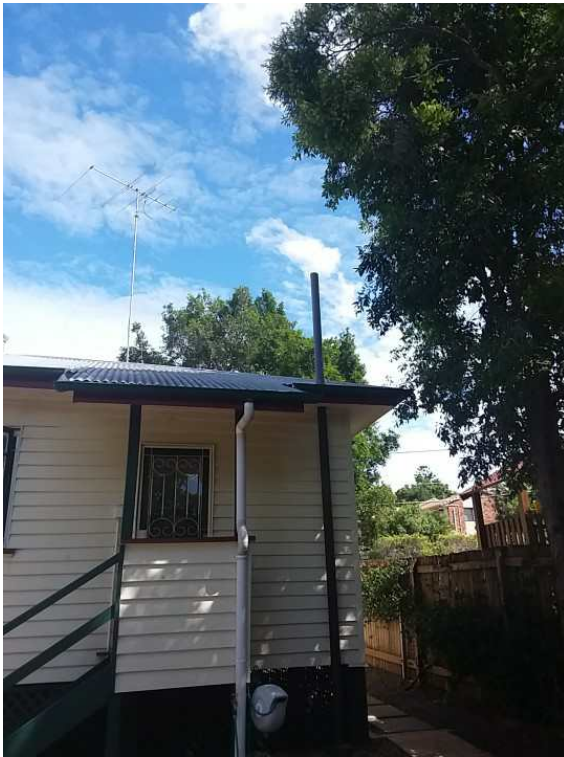
Vent caps are missing. This is a minor defect that should be rectified as part of a normal maintenance program.

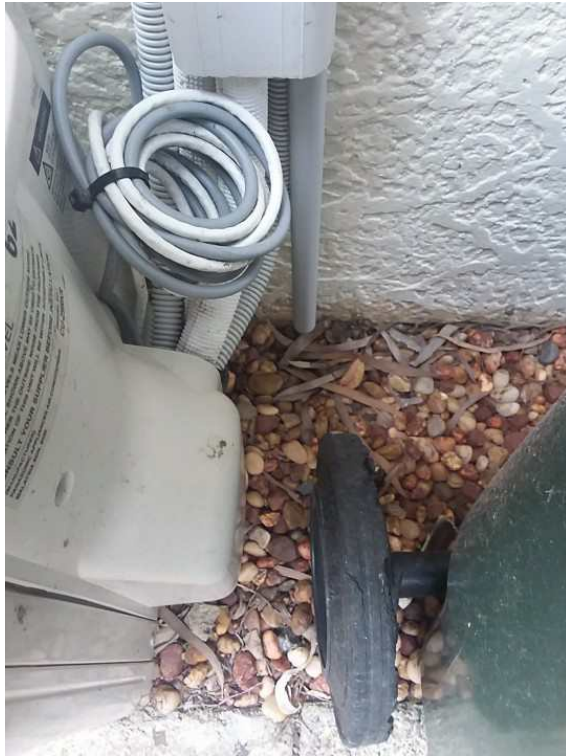
I recommend overflows be connected to the stormwater drainage system. There is a low risk of this attracting termites to the moisture.

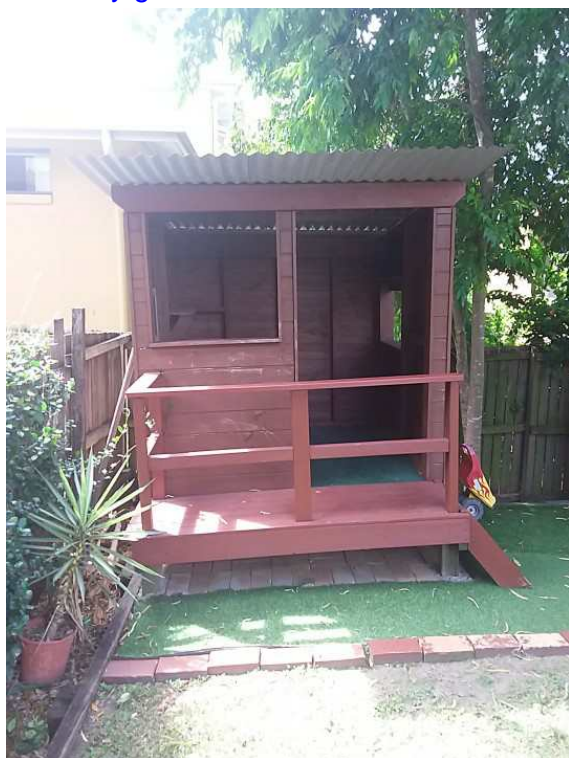
I did notice that the cubby house is not level due to subsidence of suspected inadequate footing depth. This may get worse over time.

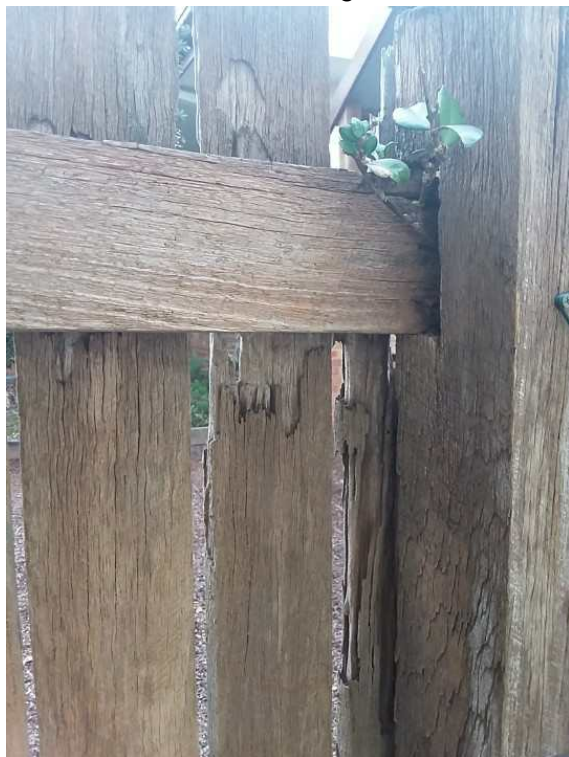
Evidence of termite damage such as mud tubes or damaged timbers were found. Please read the report.

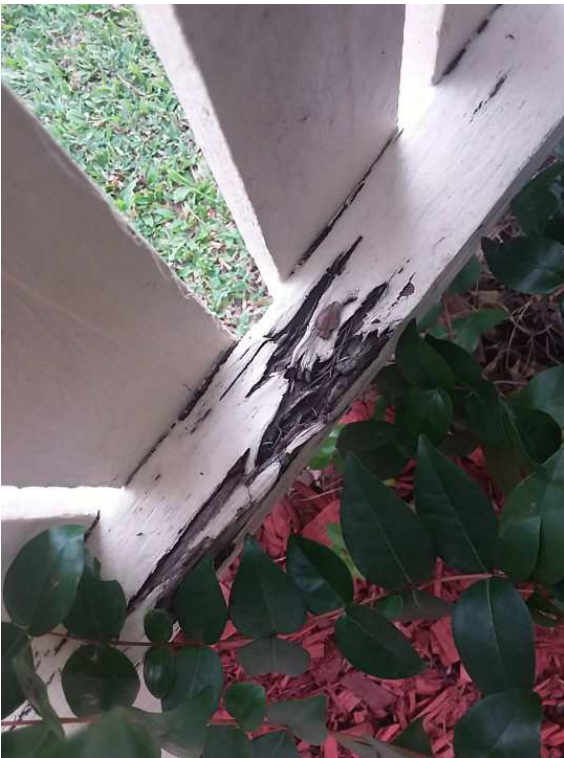
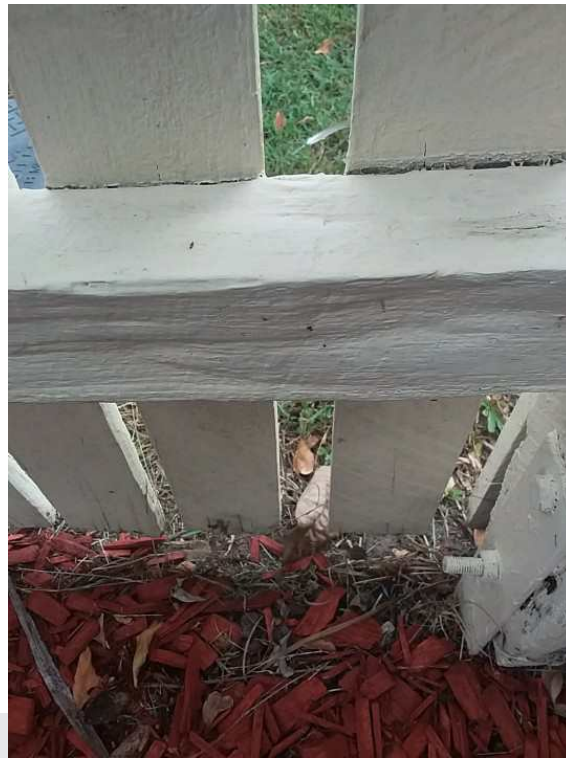
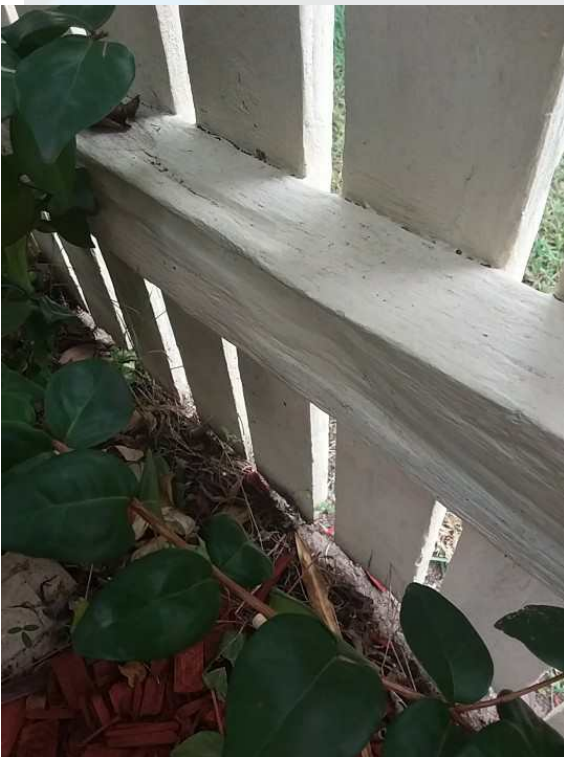
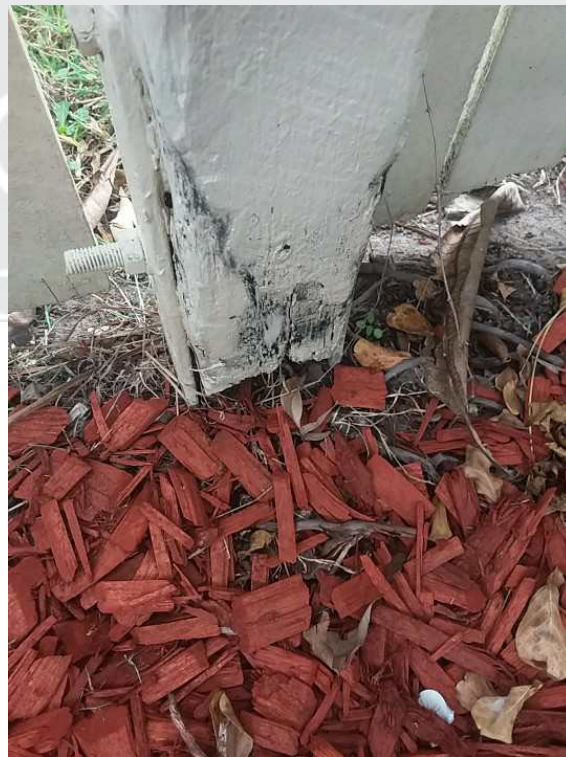
Evidence of damage resulting from active wood decay fungi (wood rot) was found. Please read the report.

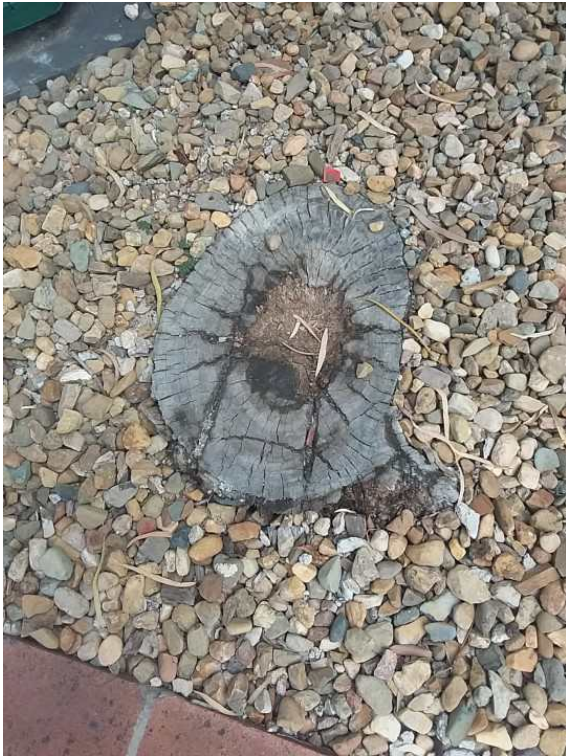
There are tree stumps in the garden. Tree stumps should be completely removed including the tree roots. Tree stumps often harbour termite colonies.

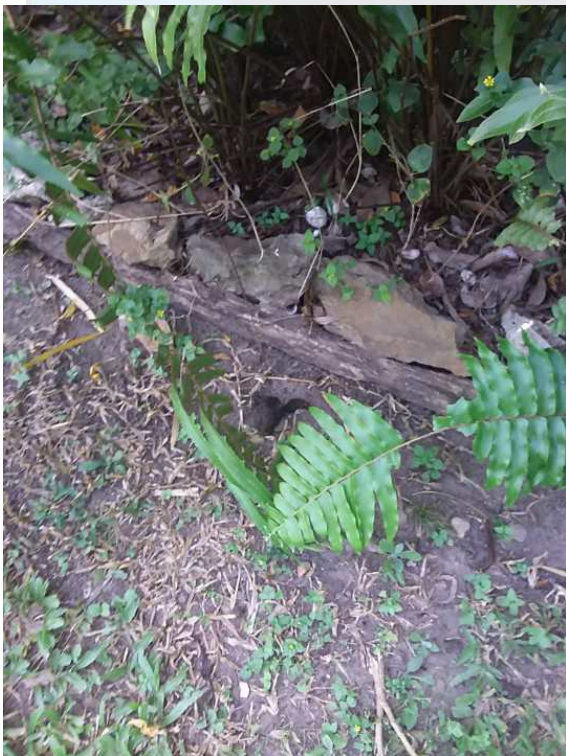
landscaping timbers can attract timber pests such as fungal decay and termites. These timbers should be removed or replaced with a treated timber or non timber alternative.
