## Building and Pest Inspection Reports

In accordance with AS 4349.0 and AS 4349.3

**7890 Main Street, Sample CBD**

The purpose of the inspection is to identify the Major Defects and Safety Hazards associated with  
SAMPLE Blg REPORT 100 year old 3 Storey Hotel

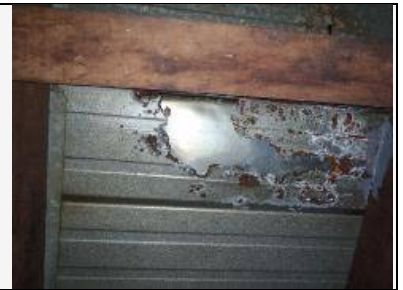
No physical access was possible to the external roof area due to the roof not being accessible from a 3.6 metre ladder. The roof should be inspected by a licensed Roofer.

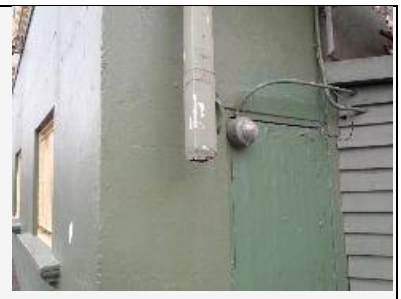
The downpipe to the rear (west) elevation is broken and loose. This condition has made this component a potential safety hazard. Suitable alterations should be carried out without delay to make this component safe. A licensed Plumber should further investigate this matter and provide a quotation for the necessary rectification.

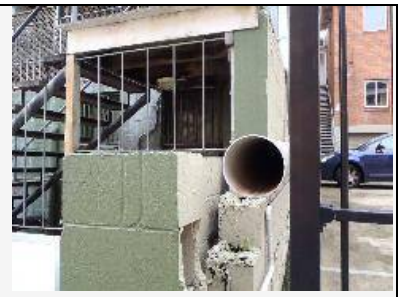
A large Storm water drain pipe from a downpipe on the Southern elevation discharges at approx. 1.7m above ground level to the rear lane. This component has not been correctly installed. A licensed Plumber should further investigate this matter and provide a quotation for the necessary rectification.

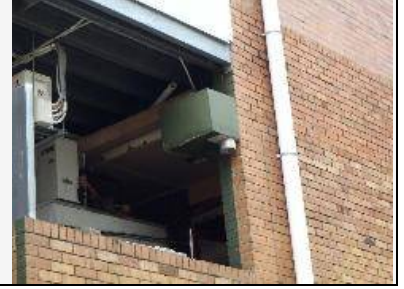
A downpipe is missing to the southern elevation. Refer to sample photo. A licensed Plumber should further investigate this matter and provide a quotation for the necessary rectification.

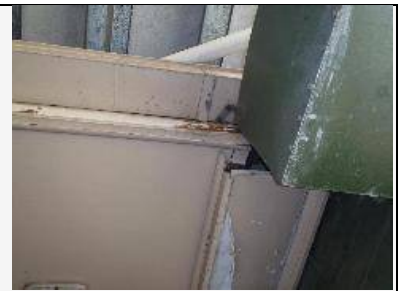
Eaves are damaged and have holes and gaps to the western elevation. Repair or replacement is required. Consult a licensed tradesperson about the scope of works and cost to rectify.

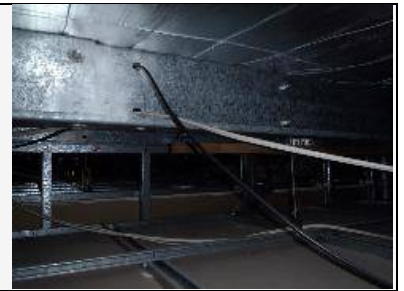
Clearance within the roof was too low to allow reasonable access (refer to report definitions section **4.7 Reasonable Access**). This allows only a very limited visual inspection from the manhole to be carried out. Defects may be present in areas that are not accessible.

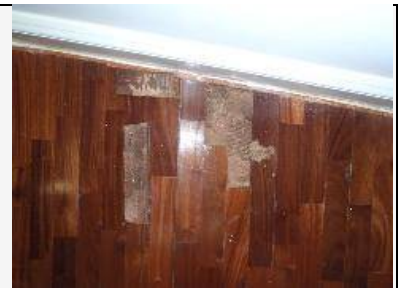
A section of parquetry flooring is buckled, loose and mishapen from suspected water damage. It is likely that there was a leak from the adjacent shower recess. Repair or replacement is required. Consult a licensed tradesperson about the scope of works and cost to rectify.

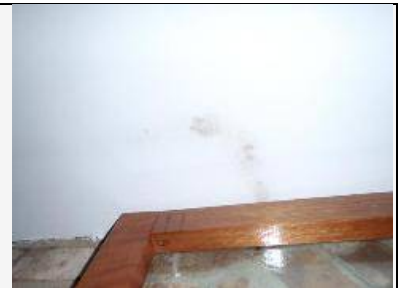
The condition of the ceiling is generally fair. Mould was noted to the ceilings. The cause of this should be investigated and rectified. Remove mould with 80% white vinegar and 20% water solution and wear PPE. There is a water leak stain on the ceiling. The moisture meter has found that the stain contains excessive moisture. This may mean that the leak is still current. We recommend that a plumber be employed to find the cause of the leak and rectify the problem immediately to prevent further damage.

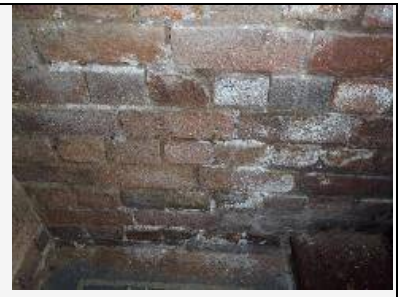
Residual mould and efflorescence noted to brick walls. This creates an unhealthy environment. Small pieces of brick and dust from bricks on the floor where fretting has caused damage. Fretting is also caused by dampness. Repair or replacement is required. Consult a licensed tradesperson about the scope of works and cost to rectify.

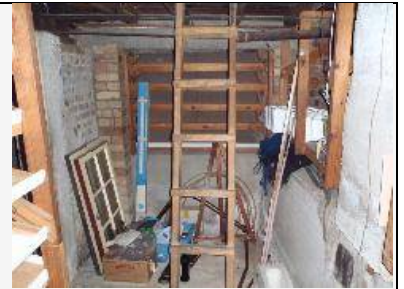
- Trap door is in poor condition and cannot be used due to there being carpet above this area. Ladder access to this storeroom from the trap door is unsafe because the ladder does not conform to Australian Standards (it is unsafe). Repair or replacement is required. Consult a licensed tradesperson about the scope of works and cost to rectify.
- Floor is water damaged. Repair or replacement is required. Consult a licensed tradesperson about the scope of works and cost to rectify.

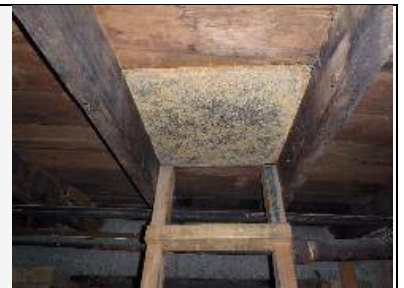
Refer to sample photo of the trap door.

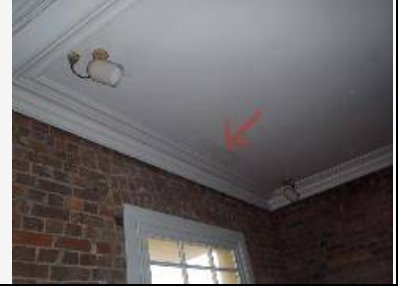
Water leak stain noted to the ceiling near the eastern elevation. Recommend having a licensed Roofer determine the cause of the leak and rectify immediately to prevent further damage.

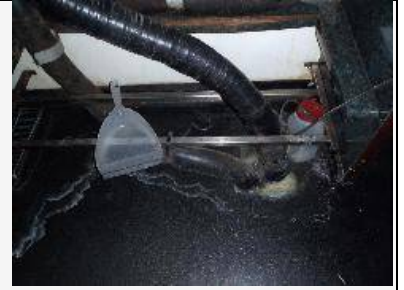
Leaking equipment in this area has caused significant water and mould damage to carpet and timber floor under the carpet (visible from the basement area). Equipment not inspected as part of this inspection report. Repair or replacement is required. Consult a licensed tradesperson about the scope of works and cost to rectify.

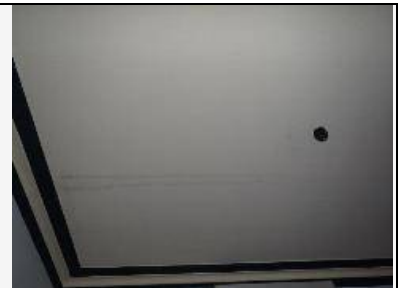
There is a large water leak stain to the ceiling located above the bar area. This area was tested with an Electronic Moisture Meter. The moisture level recorded was within a normal range. This ceiling should be monitored to ensure that the condition does not further deteriorate. If further deterioration is noted (more stains or darker stains, dripping water etc) then refer the matter to a licensed Plumber to determine the cause of the leak and rectify immediately to prevent further damage.

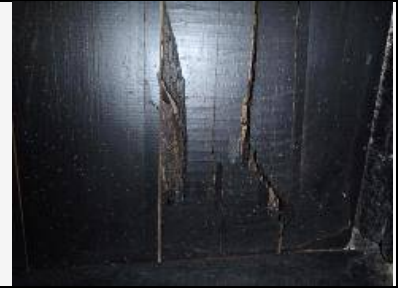
There is no ceiling lining. The underside of the floor has sections of borer damage that have weakened the floor. Repair or replacement is required. Consult a licensed tradesperson about the scope of works and cost to rectify.

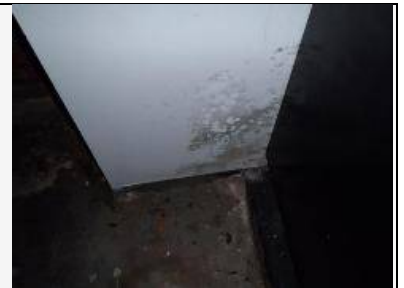
- Mould was noted to the walls. The cause should be investigated and rectified.
- Residual mould and efflorescence noted to brick walls. This creates an unhealthy environment. Small pieces of brick and dust from bricks on the floor where fretting has caused damage. Fretting is also caused by dampness. Repair or replacement is required. Consult a licensed tradesperson about the scope of works and cost to rectify.

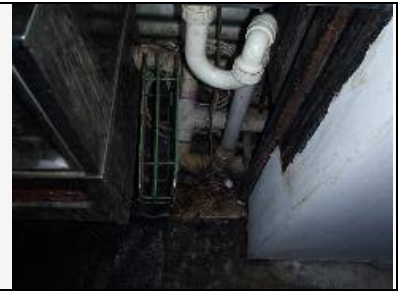
Sink is leaking water onto the floor. A licensed Plumber should further investigate this matter and provide a quotation for the necessary rectification.

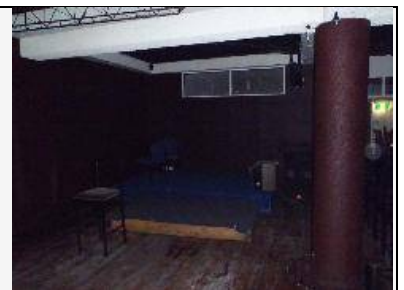
Timber dance floor area requires a sand back and recoat of clear.

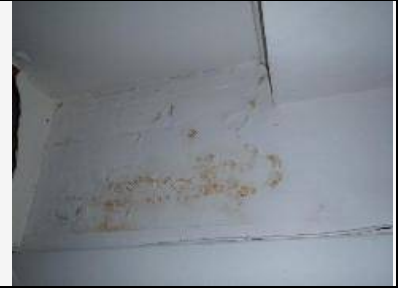
Cracked and damaged render. Water is penetrating through the walls in this area. Repair or replacement is required. Consult a licensed tradesperson about the scope of works and cost to rectify.

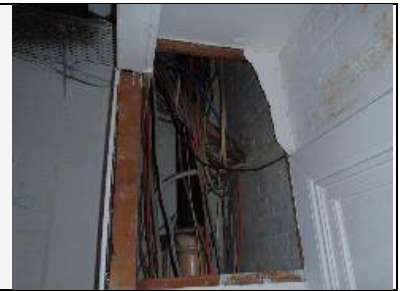
Missing sections of wall sheeting. Repair or replacement is required. Consult a licensed tradesperson about the scope of works and cost to rectify.

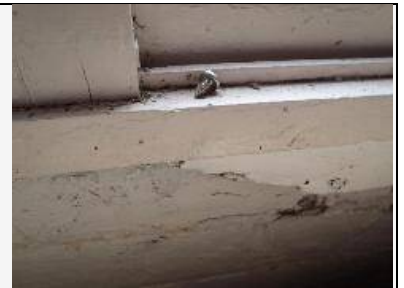
Fungal decay to timbers around the external wall windows. Repair or replacement is required. Consult a licensed tradesperson about the scope of works and cost to rectify.

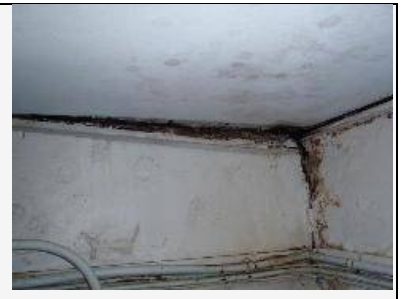
The condition of the walls is generally poor. Repair or replace as required. Water penetration damage. Sections of wall sheeting are missing. This will affect performance of cool room. Repair or replacement is required. Consult a licensed tradesperson about the scope of works and cost to rectify.

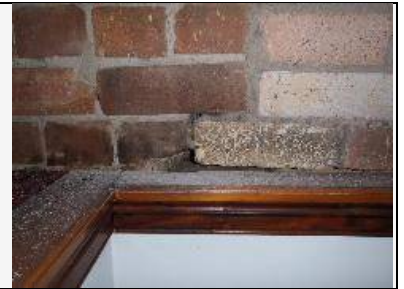
Brickwork is crumbling in large sections. Repair or replacement is required. Consult a licensed tradesperson about the scope of works and cost to rectify.

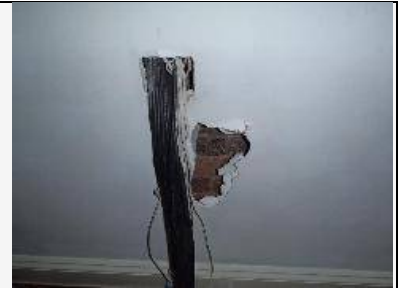
Holes in walls in areas. Repair or replacement is required. Consult a licensed tradesperson about the scope of works and cost to rectify.

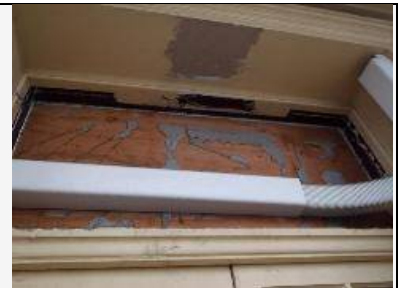
The condition of the windows is generally fair. Some windows have been filled in. This is a Minor Defect. Repair or replacement is required. Consult a licensed tradesperson about the scope of works and cost to rectify.

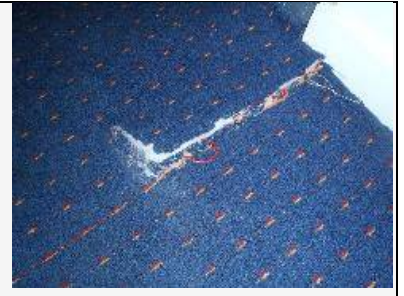
Some cracked tiles near the top of the stairs. Floor is not level in areas. Repair or replacement is required. Consult a licensed tradesperson about the scope of works and cost to rectify. Carpet is damaged in areas. Repair or replacement is required. Consult a licensed tradesperson about the scope of works and cost to rectify.

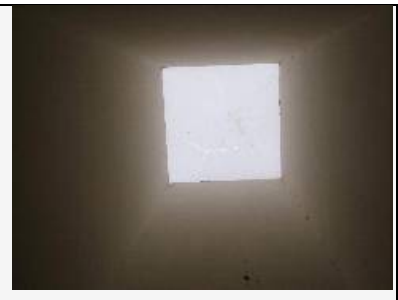
The condition of the ceiling is generally good. Skylight is broken and may allow water penetration. A licensed Roofer should further investigate this matter and provide a quotation for the necessary rectification. Hole in the ceiling. Repair or replacement is required. Consult a licensed tradesperson about the scope of works and cost to rectify.

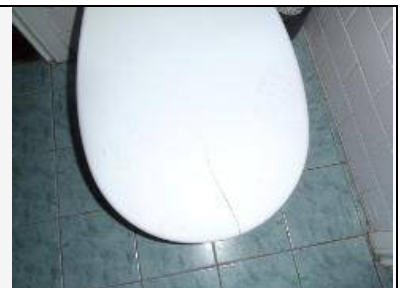
The toilet appears to be in good condition. Toilet seat is cracked. Repair or replacement is required. Consult a licensed tradesperson about the scope of works and cost to rectify.

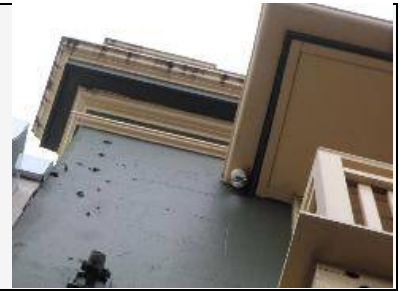
Various redundant clips, brackets, flag supports, electrical cable, conduit, holes, broken lights are preset on North, East and Western elevations. This is a Minor Defect. Repair or replacement is required. Consult a licensed tradesperson about the scope of works and cost to rectify.

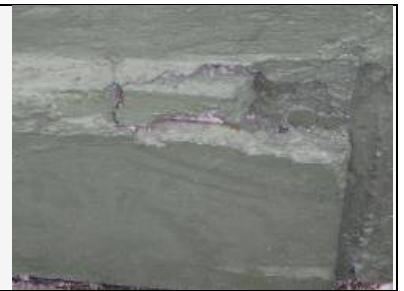
Cracked sections of render and stone mouldings to building exterior. This is a Minor Defect. Repair or replacement is required. Consult a licensed tradesperson about the scope of works and cost to rectify.

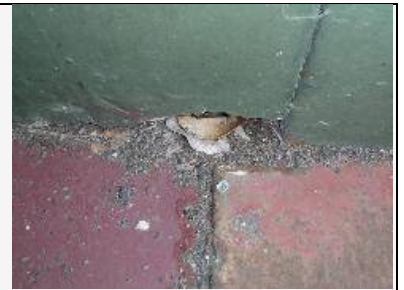
Wall sheeting to doorway on the Northern elevation is damaged at floor level. This could allow water entry. This component has not been correctly installed. Repair or replacement is required. Consult a licensed tradesperson about the scope of works and cost to rectify.

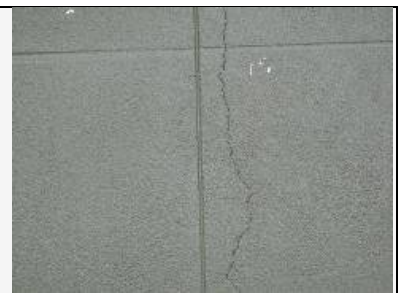
Appearance cracks of up to 1mm wide noted to the wall/s. In my opinion the appearance of this Building Element has blemished and the expected consequence of this cracking is unknown until further information is obtained. For peace of mind I recommend that you obtain an assessment of this crack/s from a Structural Engineer. Refer to sample photo of North elevation.

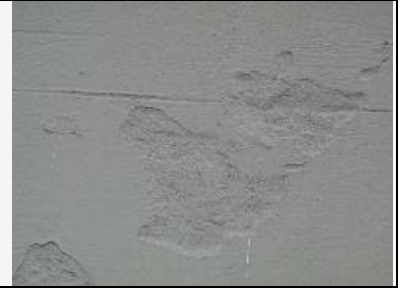
Some pitting to render finish on external wall sections. Refer to sample photo. This is a Minor Defect. Repair or replacement is required. Consult a licensed tradesperson about the scope of works and cost to rectify.

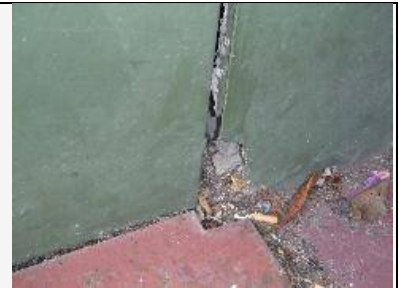
Some joints around openings for doors have pulled apart. This may allow entry of water and vermin. This is a Minor Defect. Repair or replacement is required. Consult a licensed tradesperson about the scope of works and cost to rectify.

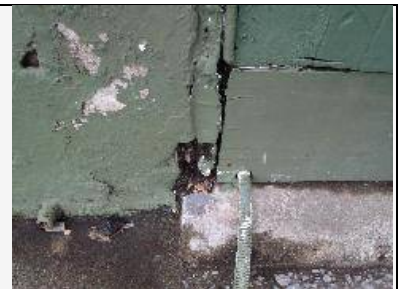
Some joints between external wall material types have pulled apart. This may allow entry of water and vermin. This is a Minor Defect. Repair or replacement is required. Consult a licensed tradesperson about the scope of works and cost to rectify. Refer to sample photo of the rear (west) elevation.

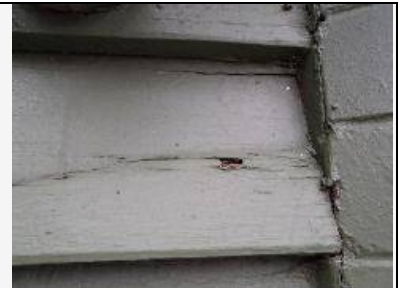
Sections of decaying boards to the switchboard. This is a Minor Defect. Repair or replacement is required. Consult a licensed tradesperson about the scope of works and cost to rectify.

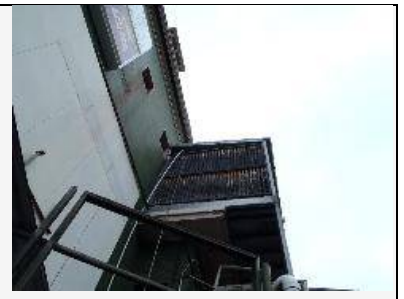
The lattice to the rear elevation is damaged. This condition has made this component a potential safety hazard. Suitable alterations should be carried out without delay to make this component safe. Item is damaged. Repair or replacement is required. Consult a licensed tradesperson about the scope of works and cost to rectify.

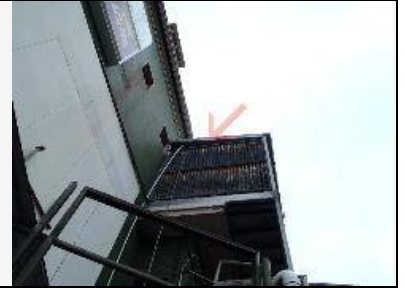
The storeroom to the first floor rear elevation is not properly weatherproofed. This component has not been correctly installed. Repair or replacement is required. Consult a licensed tradesperson about the scope of works and cost to rectify.

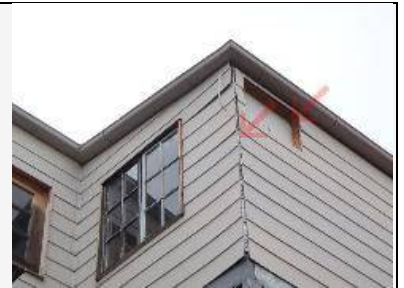
Rear elevation has openings and corners that are not properly weatherproofed. This component has not been correctly installed. Repair or replacement is required. Consult a licensed tradesperson about the scope of works and cost to rectify.

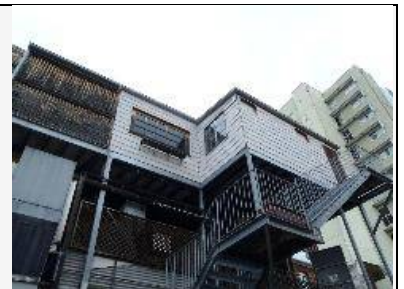
Loose hardiplank boards to the rear elevation. This is a Minor Defect. Repair or replacement is required. Consult a licensed tradesperson about the scope of works and cost to rectify.

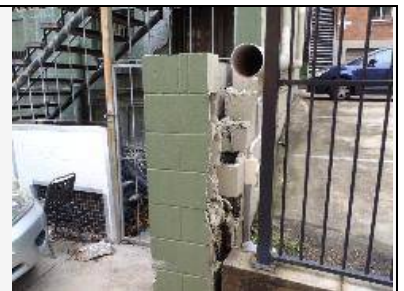
Section of wall to the SW corner of the property is damaged. Repair or replacement is required. Consult a licensed tradesperson about the scope of works and cost to rectify.

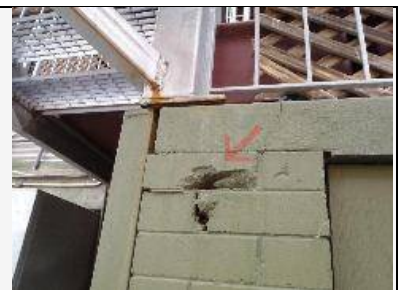
Two damaged bricks to the rear elevation. This is a Minor Defect. Repair or replacement is required. Consult a licensed tradesperson about the scope of works and cost to rectify.

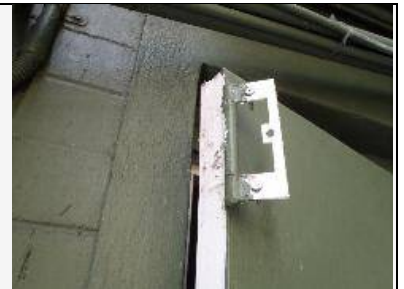
Pair of doors to the Rear elevation at basement level have broken hinges. This is a Minor Defect. Repair or replacement is required. Consult a licensed tradesperson about the scope of works and cost to rectify. NB This is a security risk. Ask seller to rectify asap.

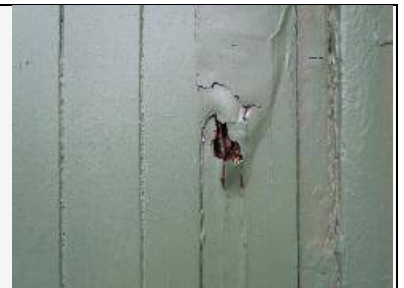
Door and jamb to rear elevation has severe decay from a lack of external flashing. Replacement is required. Consult a licensed tradesperson about the scope of works and cost to rectify.

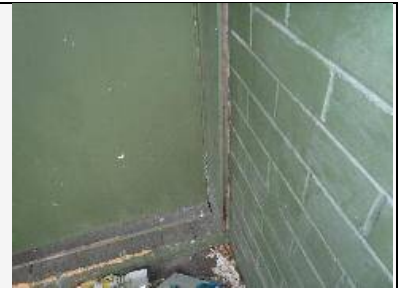
Pair of doors serving the Switchboard room are water damaged and warped. Refer to sample photo. Repair or replacement is required. Consult a licensed tradesperson about the scope of works and cost to rectify.

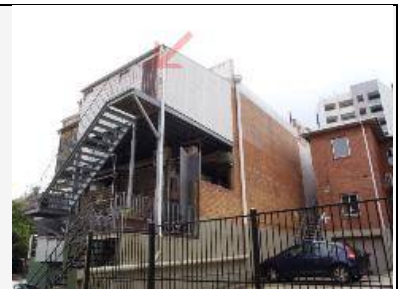
External door opening is close to the boundary and not suitably fire rated. Consult a licensed tradesperson about the scope of works and cost to rectify.

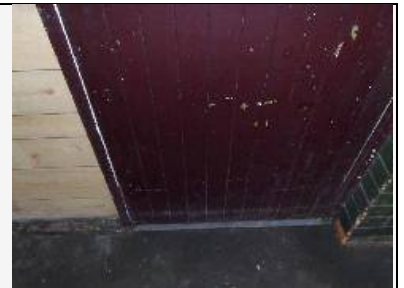
Doors to the rear elevation have water damage to the first floor level. Repair or replacement is required. Consult a licensed tradesperson about the scope of works and cost to rectify.

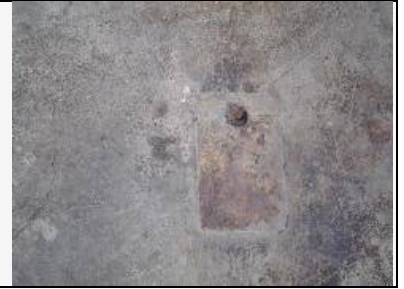
Rusty bolts project from the floor. This condition has made this component a potential safety hazard. Suitable alterations should be carried out without delay to make this component safe.
