Building and Pest Inspection Reports

In accordance with AS 4349.0 and AS 4349.3

4567 Sample Hwy, Sampleville

The purpose of the inspection is to identify the Major Defects and Safety Hazards associated with
SAMPLE Blg REPORT 50 year old Factory and Offices

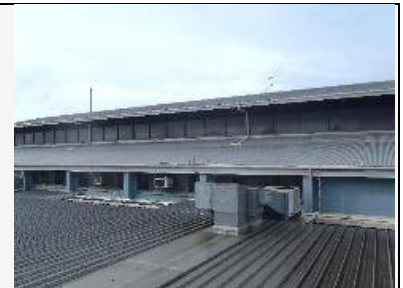
The overall condition of the reasonably accessible roof coverings to the front Office area and Western plane of the factory roof appears to be good. The balance of the roof (and this is most of the roof area) there is extensive surface rust to the roof sheets. Rust can result in roof leaks that can cause damage to the building and stored items within it. Rust will shorten the life of the roof. I suspect that the rusted sections of roof sheets are the original roof and therefore could be approximately 50 years old. This roof may be nearing the end of its serviceable life. A licensed Roofer should further investigate this matter and provide a quotation for the necessary rectification i.e. repair rust or replace rusting roof sections if necessary.

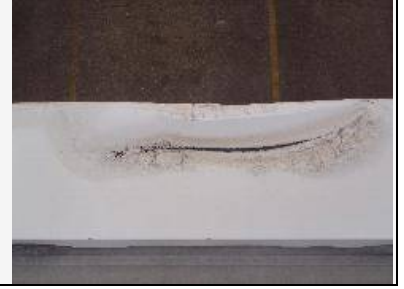
A small section of roof capping to the Northern end of the Office area roof is dented. Refer to sample photo. This is a Minor Defect. A licensed Roofer should further investigate this matter and provide a quotation for the necessary rectification.

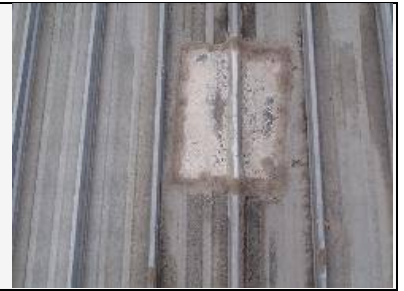
A small section of Office area roof has been patched. Maintain silicone to prevent leaks. No action is required at this time. Refer to sample photo.

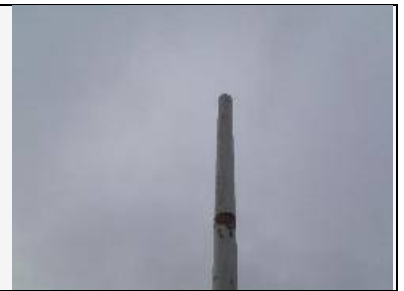
Sewer vent pipes that penetrate the roof are not capped and paint is peeling off. This is a Minor Defect. Repair or replacement is required. Consult a licensed tradesperson about the scope of works and cost to rectify.

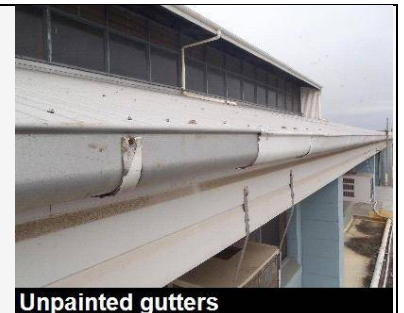
- Many sections of original Gutters are damaged or rusting in sections. This will cause water leaks that can cause damage to other parts of the building. These should be repaired or replaced by a licensed Roofer or Plumber as necessary.
- Some sections of gutter appear to have been replaced and are unpainted. These should be painted.

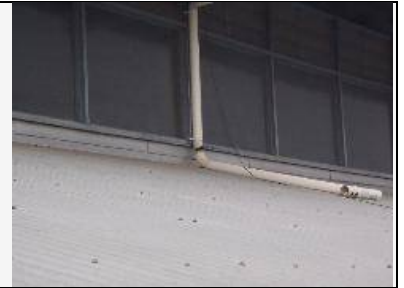
Section of downpipe spreader has pulled apart. This is a Minor Defect. A licensed Roofer should further investigate this matter and provide a quotation for the necessary rectification.

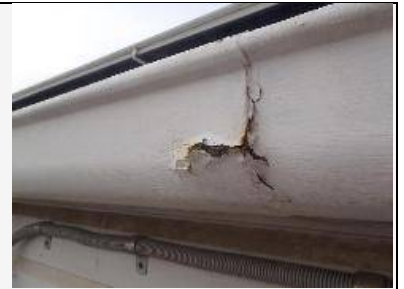
Gutters are damaged or rusting in sections. This will cause water leaks that can cause damage to other parts of the building. These should be repaired or replaced by a licensed Roofer or Plumber as necessary.

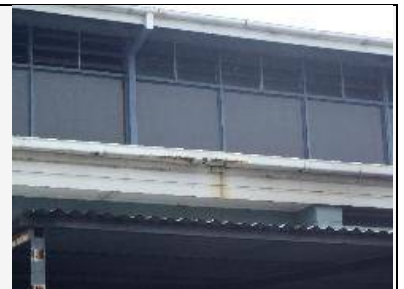
Gutters are damaged or rusting in sections. This will cause water leaks that can cause damage to other parts of the building. These should be repaired or replaced by a licensed Roofer or Plumber as necessary. Refer to sample photo.

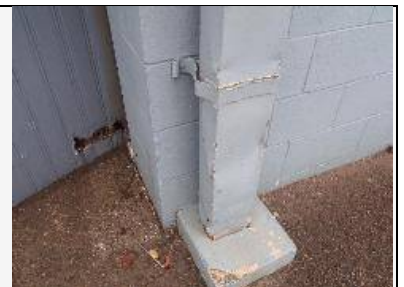
The downpipe/s have been dented in sections. This is a Minor Defect.

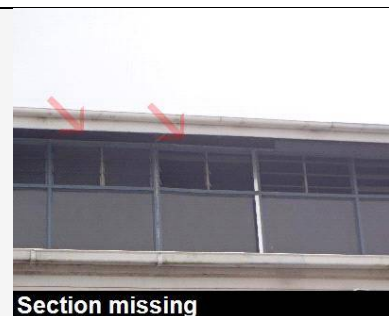
The eaves are lined with fibre cement sheeting and are generally in a good condition. Sections are unlined. A section of cladding below the fascia to the rear elevation of the factory is missing. Repair or replacement is required. Consult a licensed tradesperson about the scope of works and cost to rectify.

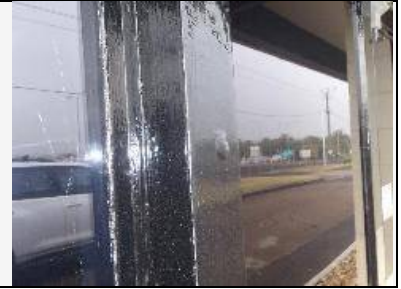
The condition of the door is generally good. Some blistering paint to the door. This is a Minor Defect. The door rubs slightly on the frame and minor adjustments are required to ensure smooth operation.

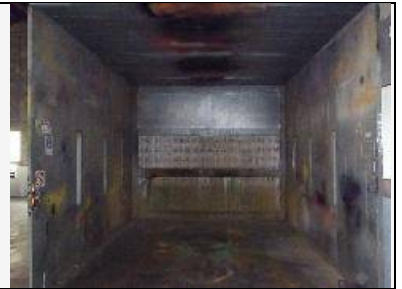
Spray booth is damaged in sections. Repair or replacement is required. Consult a licensed tradesperson about the scope of works and cost to rectify. Spray booth is built close to the rear wall of the factory and restricts inspection of the rear wall from the inside.

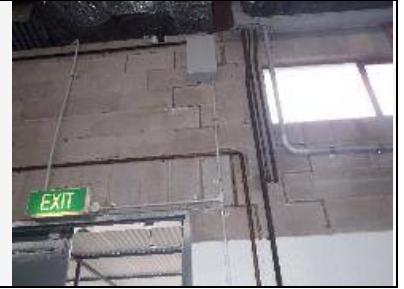
There are cracks in the blockwork. Refer to External Wall notes. Refer to sample photo.

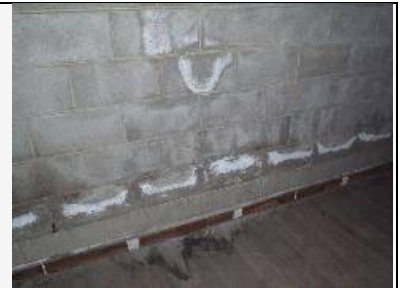
There is efflorescence (salt crystals) to the surface of the block wall. These crystals are the residue of excess moisture. This is a non-structural defect but dampness could be a problem. Further investigation by a Damp Control expert is recommended if dampness is a problem.

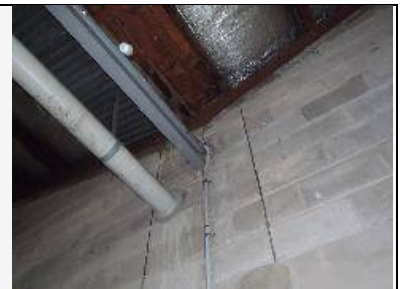
A steel roof beam has pulled away from the concrete block wall causing minor damage to the blockwall. Refer to sample photo. You should have this matter further investigated by an appropriately qualified Structural Engineer prior to the contract becoming unconditional.

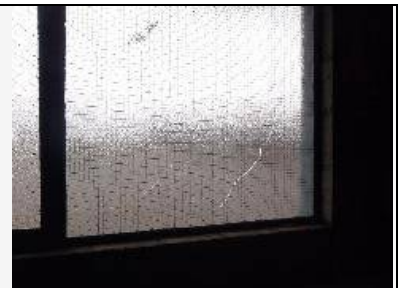
- Windows are stiff to operate and some do not open at all. Repairs are required to windows to ensure smooth operation.
- There are many cracked and broken wired glass and ordinary glass windows. The cost to replace broken glass with suitable safety glass will be significant.

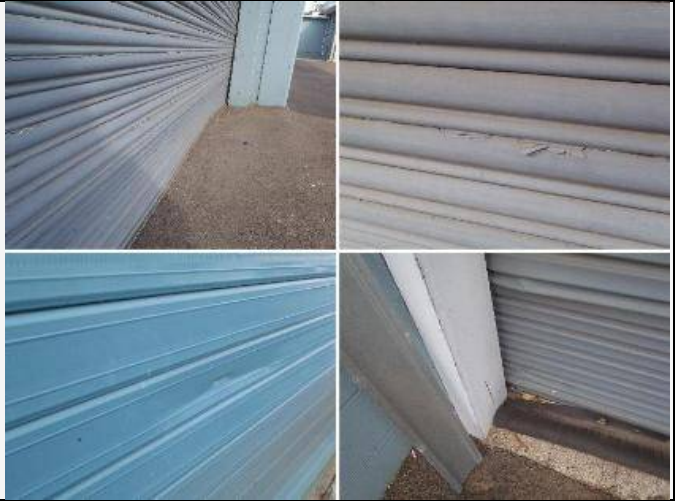
The condition of the door is generally fair. Hinged doors require repainting. Roller doors have impact damage (dents and holes). Repair or replacement is required. Consult a licensed tradesperson about the scope of works and cost to rectify.

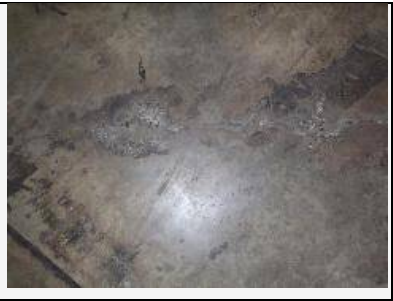
The concrete floor has cracks exceeding 1.5mm in width. This does not conform to current standards but slab appears to be stable. Some cracks have become pitted in areas. Refer to sample photo. You should have this matter further investigated by an appropriately qualified Structural Engineer prior to the contract becoming unconditional.

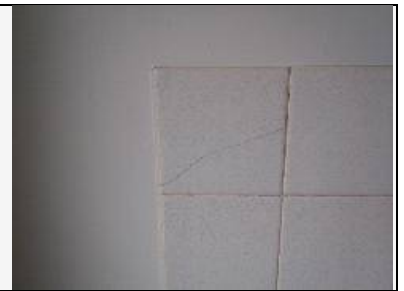
Some cracked wall tiles. This is a Minor Defect.

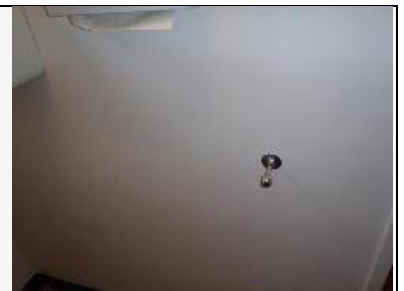
- One towel rail is damaged. This is a Minor Defect. Male WC.
- Mirror is damaged and other mirror is located too high. Replacement is required. Consult a licensed tradesperson about the scope of works and cost to rectify. Male WC.

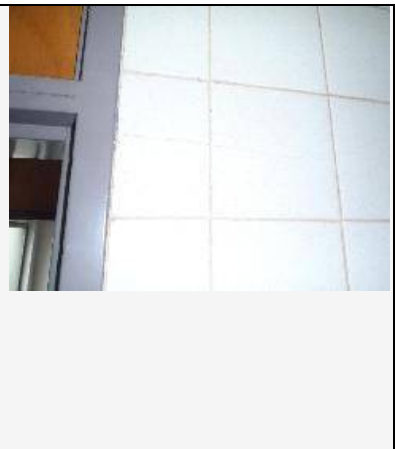
There are a small number of cracked wall tiles. The cracks are hairline cracks that are unlikely to cause leaks. No action is required at this time. Monitor this area and consult a licensed tiler if any leak damage is noticed in future. Sections of grout and cracked and or missing to the wall tiles. This is likely to allow the passage of moisture that can damage other components behind the tiles. Excessive moisture can also create conditions conducive to termites. A licensed floor tiler should Re-grout tiles.

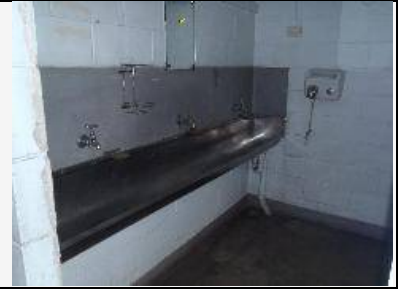
The basin and taps appear serviceable. Taps are stiff, rewasher the taps. This is a Minor Defect.

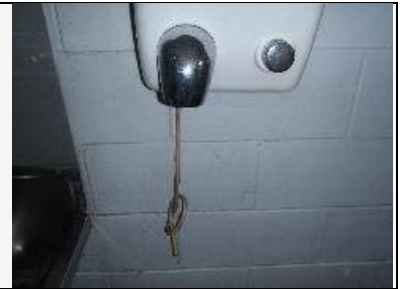
Hand dryer has a missing plug. This defect affects the operation of this component. Repair or replacement is required. Consult a licensed tradesperson about the scope of works and cost to rectify.

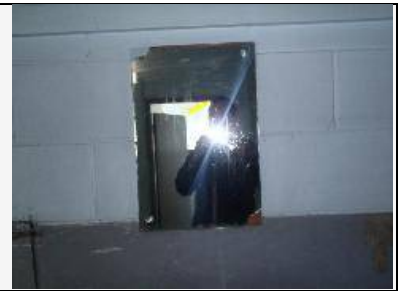
The mirror is broken. A new mirror is required. Refer to sample photo. This is a Minor Defect.

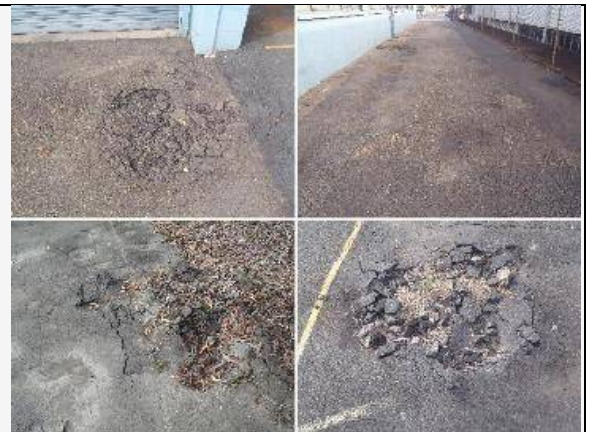
The Asphalt hardstand/parking area is generally in poor condition. There are many large potholes. This condition has made this component a potential safety hazard. Suitable repairs should be carried out without delay to make this component safe. With each pothole costing approx. \$350 to \$450 each to repair the cost to resurface this large area could be significant. You should have a quote prepared by an Asphalt company prior to the contract becoming unconditional.

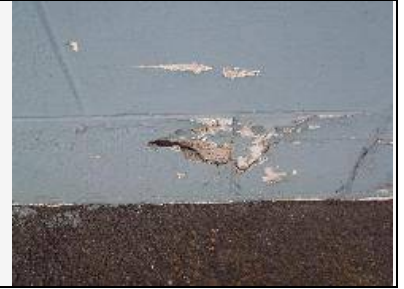
One damaged block to the Southern elevation. Appears to have been caused by impact damage. Repair or replacement is required. Consult a licensed tradesperson about the scope of works and cost to rectify.

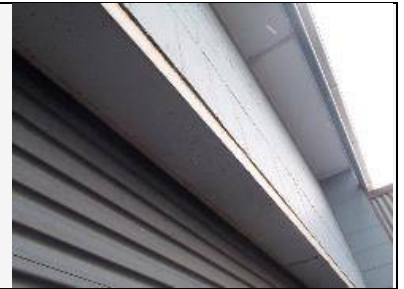
Minor rust is evident to some lintels. This should be treated to prevent further deterioration. This is a Minor Defect.

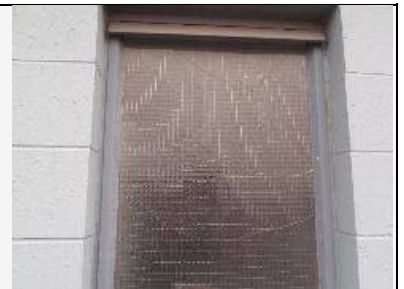
There are many cracked and broken wired glass and ordinary glass windows. The cost to replace broken glass with suitable safety glass will be significant. Given the age of the building/s we recommend that you have a glazier check that the glazing (glass) in the building/s is both suitable and safe. Many older buildings have ordinary annealed glass when safety glass would now be required to comply with Australian Standards. Any glass found not to meet current standards should be replaced as required in the interests of safety.

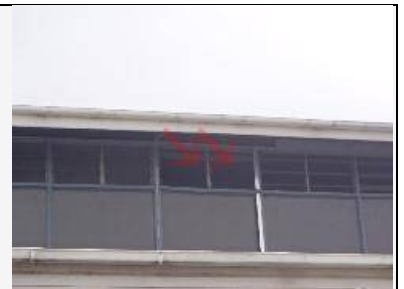
A section of louvres is missing to the rear elevation of the factory. Refer to sample photo. This is a Minor Defect. Repair or replacement is required. Consult a licensed tradesperson about the scope of works and cost to rectify.

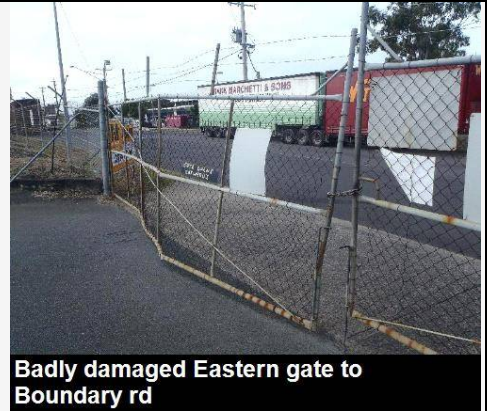
The fences posts are leaning over in sections and some sections of wire are rusted and damaged. Many of the gates are badly damaged and need to be replaced as they have bent and broken sections of steel frame.

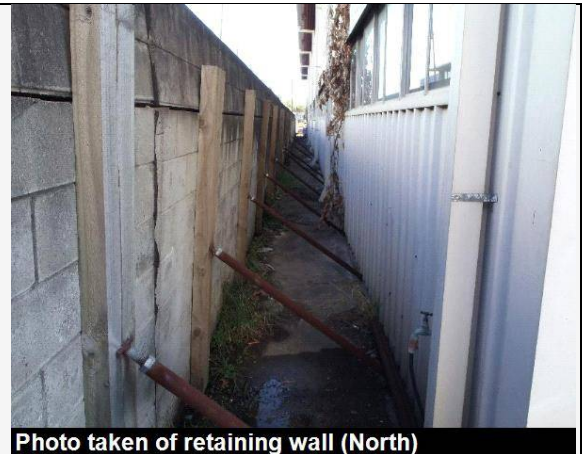
The retaining wall to the Northern boundary, located approximately 2m into the neighbouring property (Purple Pig Business) has cracked and displaced (failed). Refer to sample photo. This wall has been temporarily propped and appears to be stable. You should have this matter further investigated by an appropriately qualified Structural Engineer prior to the contract becoming unconditional.

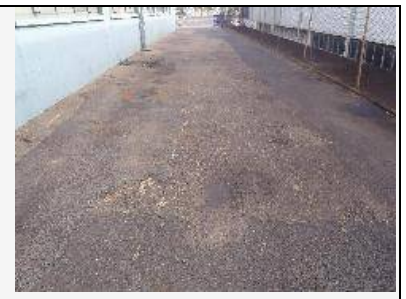
This wall does not appear to provide structural support to your building but does appear to support a section of driveway access to that Northern side of the building. For peace of mind I recommend that you have this matter further investigated by an appropriately qualified Structural Engineer prior to the contract becoming unconditional.

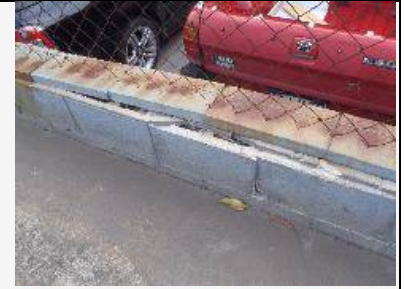
Capping sections and top course of blockwork to the Northern boundary adjoining the buildings facing Boundary street are loose or missing in long sections. This is a Minor Defect. Repair or replacement is required. Consult a licensed tradesperson about the scope of works and cost to rectify. Access will be required to the Neighbouring property to assess damage.

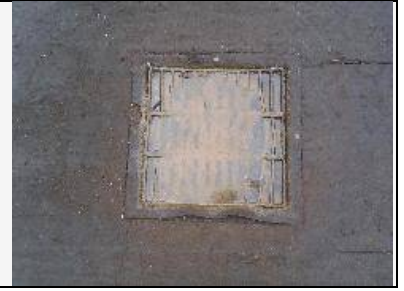
The Pit to the Wash bay area at the Eastern elevation (rear) of the Factory Area is blocked. A licensed Plumber should further investigate this matter and provide a quotation for the necessary rectification.

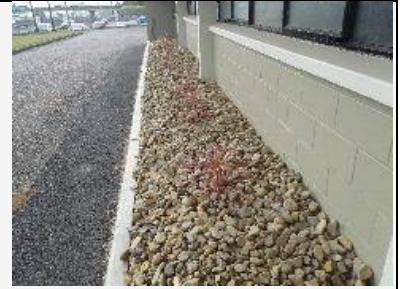
Front of office area has gravel piled high against the external walls. If these garden beds are watered or receive a lot of rain this could allow dampness to penetrate the wall and cause damage to the building. I recommend lowering the gravel/garden beds at least 150mm lower than the internal floor level. This advice also applies to the Garden Courtyard area. I could not find a drain to the garden courtyard area. This area should have a suitable system of surface drainage installed to prevent a build up of water causing damage to the surrounding building.

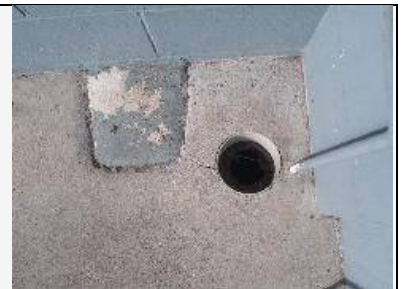
Drain cover missing to the Western elevation. This is a Minor Defect. Refer to sample photo. A licensed Plumber should further investigate this matter and provide a quotation for the necessary rectification.

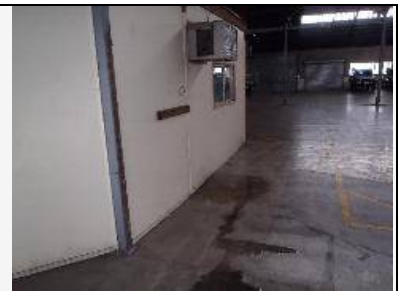
- Air con to ground floor office area under the Mezzanine is leaking water onto the floor. Refer to sample photo. Repair or replacement is required. Consult a licensed tradesperson about the scope of works and cost to rectify.
- Air con to Office area and Box type wall air con units were switched on and operational at the time of inspection. A licensed Air con expert should inspect and report on the Air con system for you to ensure the system works on all settings and is balanced, adequate etc.

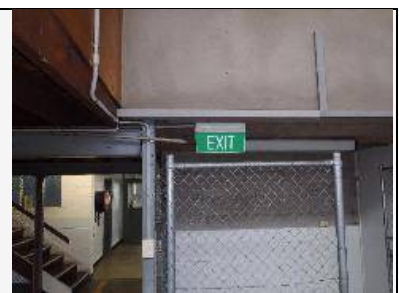
One of the Emergency exit signs in the Factory area is positioned in such a location that it could cause a person to become trapped in a wire cage area if the room was filled with smoke. This could cause panic and death in a fire. I recommend that the Exit sign be suitably re-positioned by an Electrician. Refer to sample photo.

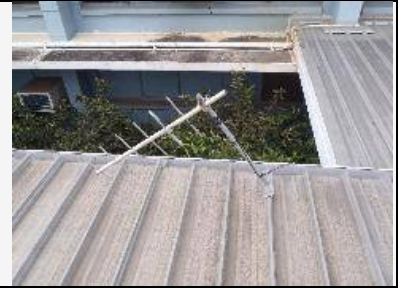
One the TV antennas has fallen over. This is a Minor Defect. Repair or replacement is required. Consult a licensed tradesperson about the scope of works and cost to rectify.

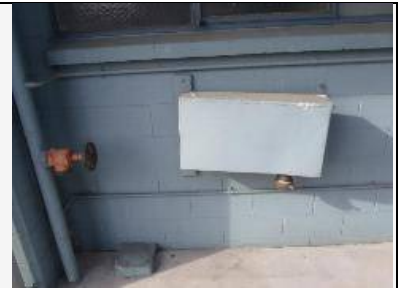
Fire Hydrants are missing signage. This condition has made this component a potential safety hazard. Suitable alterations should be carried out without delay to make this component safe.

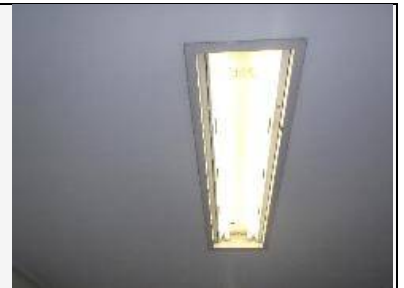
Most of the light fittings to the office and ancillary areas are missing diffusers (transparent covers). This condition has made this component a potential safety hazard. Suitable alterations should be carried out without delay to make this component safe. Refer to sample photo.

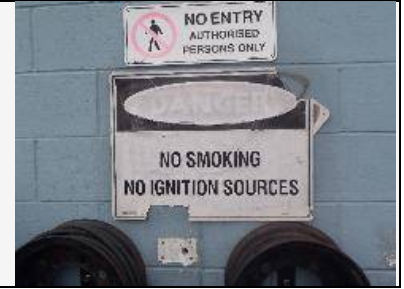
Signage is damaged and missing in areas. Refer to sample photo. Repair or replacement is required. Consult a licensed tradesperson about the scope of works and cost to rectify.
