Building and Pest Inspection Reports

In accordance with AS 4349.0 and AS 4349.3

1234 Sample Street, Sample Town

CLIENT 3333

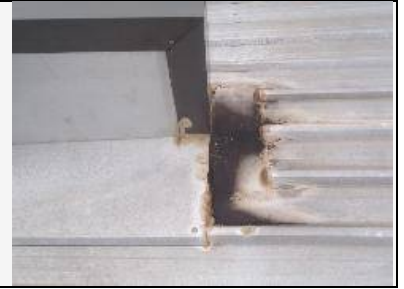
Small section of flashing to the Eastern side of the roof is holding water. This is not leaking at this time but will probably leak if silicone deteriorates. Silicone should be maintained to this area and to the entire roof for that matter.

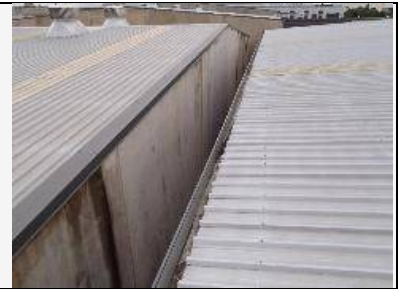
Gutters and downpipes appear to be in serviceable condition. I suspect that there may be a leak from around the downpipe located above the Disabled toilet on the Western side of the Warehouse.

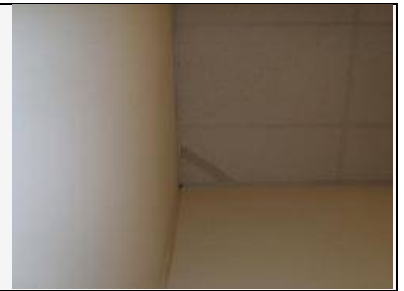
Ceilings are generally in a good condition. There are a few leak stains to the suspended ceiling tiles above the offices on the top floor. These leaks may be caused by condensation from the office Air conditioning system.

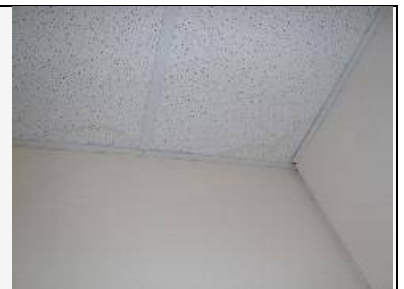
In the North West corner of the large office located on the top floor to the Western side of the building there is a damp leak stain on the ceiling. The stain is faint. Refer to sample photo. I could hear water running down the roof drainage system in the roof above. I suspect that there may be a roof leak here. A licensed Plumber should further investigate this matter and provide a quotation for the necessary rectification.

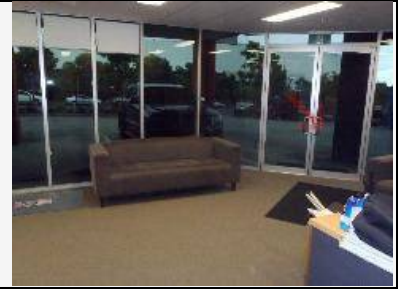
Doors are generally in a good condition. Various doors rub slightly (including the front entry door). This defect affects the operation of this component. This is a Minor Defect. Ease as required.

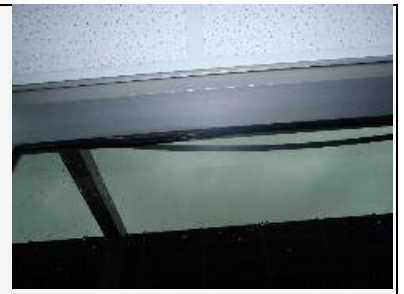
Section of window rubber seal is loose to the interior and exterior of one window located to the large office on the top floor front (North) elevation of the office area. This may allow water penetration. Not leaking at the time of inspection. Repair or replacement is required. Consult a licensed tradesperson about the scope of works and cost to rectify.

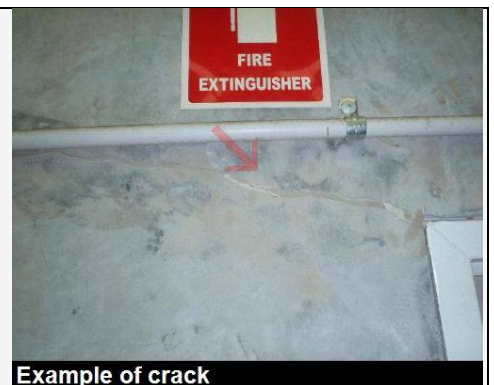
Example of crack

The condition of the walls is generally good. Appearance cracks are evident to walls especially at the top of door openings and near corners of some panels. Visible cracks are hairline to 1mm in width only. These cracks appear to be only minor shrinkage cracks at this time but they could get worse over time and be very costly to rectify. These cracks should be monitored to ensure that the condition does not further deteriorate. If cracks get worse then refer the matter to a Structural Engineer for further investigation.

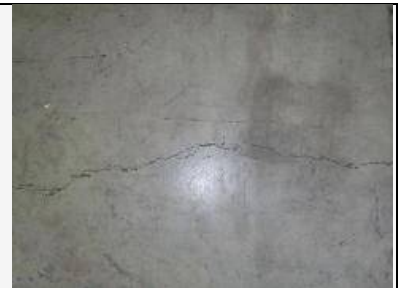
The condition of the floor is generally good. Appearance cracks of up to 1.5mm wide noted to the floor. In my opinion the these are typical shrinkage cracks where only the appearance of this concrete floor slab has blemished. NB The expected consequence of this cracking is unknown until further information is obtained and cracks can get worse over time. These cracks should be monitored to ensure that the condition does not further deteriorate. If cracks get worse then refer the matter to a Structural Engineer for further investigation.

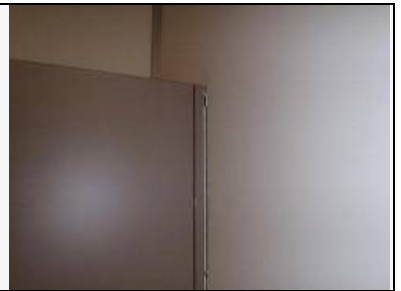
The condition of the fixtures is generally good. Small gap between joinery and side wall due to some minor settlement. No action is required at this time. If further movement occurs the overhead cupboard may need to be re-fixed to the wall.

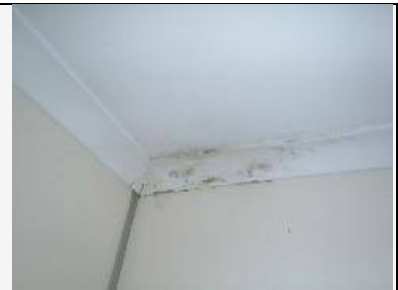
Water damage and dampness to the ceiling in the South West corner of the disabled toilet room. Repair or replacement is required. Consult a licensed tradesperson about the scope of works and cost to rectify. I suspect that there is a downpipe leaking above this area. A licensed Plumber should further investigate this matter and provide a quotation for the necessary rectification.

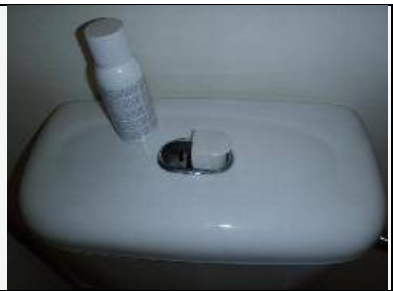
The toilets appear to be in good condition. One part of the flush button is missing to the disabled WC cistern. This is a Minor Defect. A licensed Plumber should further investigate this matter and provide a quotation for the necessary rectification.

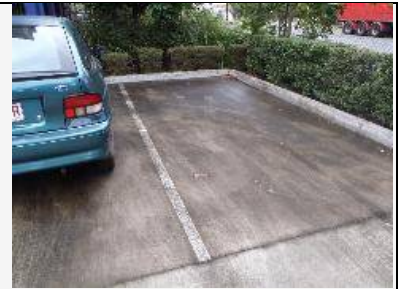
The concrete driveway and carpark stands in good condition. The concrete slab has various Appearance shrinkage cracks of less than 1mm in width. These cracks occur when the concrete dries out too quickly after being poured. This is generally considered to be a minor defect. No action required at this time. Some areas are slippery from dirt, moss and water. This could be a slipping hazard. I recommend that affected areas be cleaned with high pressure water cleaning. Refer to sample photo.

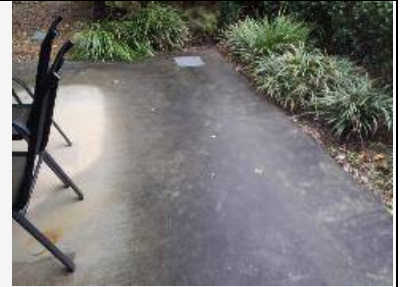
The concrete paths and other concrete areas are in good condition. The concrete slab has various Appearance shrinkage cracks of less than 1mm in width. These cracks occur when the concrete dries out too quickly after being poured. This is generally considered to be a minor defect. No action required at this time. Some areas are slippery from dirt, moss and water. This could be a slipping hazard. I recommend that affected areas be cleaned with high pressure water cleaning. Refer to sample photo.
