## Building and Pest Inspection Reports

In accordance with AS 4349.1 and AS 4349.3

**1 Sample street, Sampletown**

**CLIENT 1111**

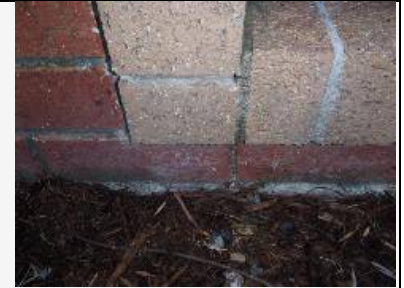
Articulation joints are filled with mortar instead of mastic to the section above the footing. This will not allow expansion joints to function properly and could make the house more prone to damage (such as cracks to the external brick walls) from building movement. We recommend that you engage a licensed Bricklayer to inspect this area and provide a scope of work and cost for repairs as may be necessary.

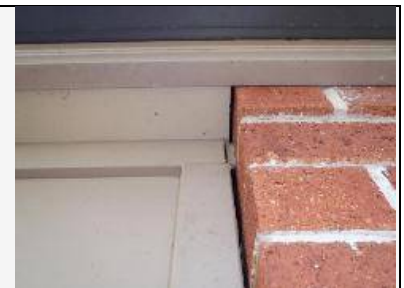
There are gaps between window and door frames and the adjacent external brickwork. These gaps are likely to be the result of building movement. i.e. the concrete floor slab flexes causing gaps to form. This movement may continue causing gaps to get wider and other damage could be caused, and may then cost more to rectify, if not given prompt attention. For some further information on this topic, read the attached information sheet from the CSIRO on Foundation Maintenance and Footing Performance: A Homeowner's Guide. For more advice on the cause, likelihood of it getting worse and recommended actions to take, I recommend that you engage a suitably experienced Consulting Structural Engineer to provide this advice in a report after they visit the property. Once the

Refer to sample photo taken between garage door opening and adjacent brickwork located to the SE corner.

Engineers report has been received a licensed Builder can then provide a quotation for any necessary works following the Engineers recommended method.

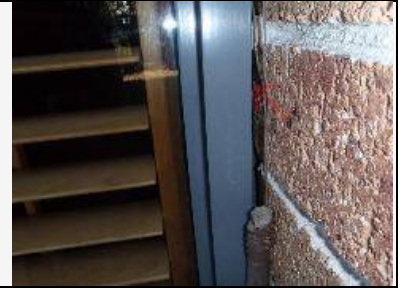
Refer to sample photo taken between window on front elevation (south) and the adjoining brickwork.

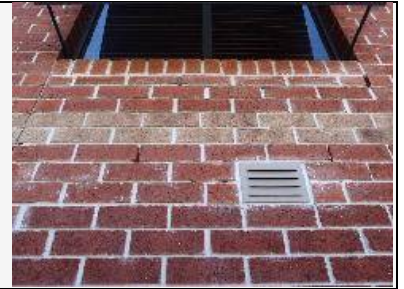
Mortar joint widths should have a nominal thickness of 10mm. The mortar joints vary from the acceptable standards in areas. We recommend that you engage a licensed Bricklayer to inspect this area and provide a scope of work and cost for repairs as may be necessary.

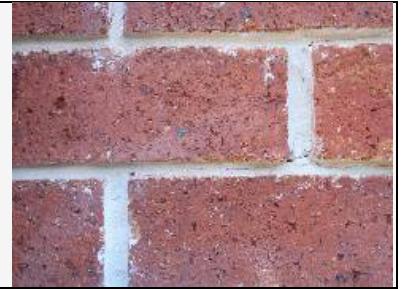
Excess mortar has not been cleaned off the brickwork.

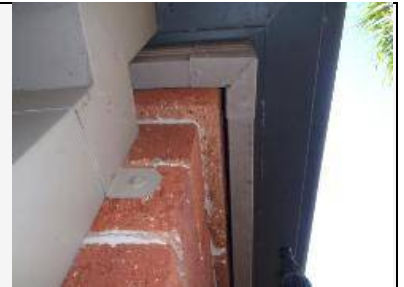
Refer to sample photo showing gaps of approx. 5mm between fascia boards and brickwork. Repair or replacement is required. Consult a licensed tradesperson about the scope of works and cost to rectify.

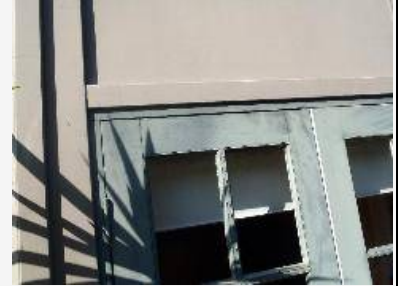
The condition of the exterior of the windows is generally fair. Various windows are stiff and require servicing by a window specialist to ensure smooth operation. Storm moulds or flashings are either not present or require attention to ensure water does not penetrate through this area and cause damage to the building. There is damage to woodwork around the bay window that may be a result of this defect. Have a licensed Carpenter repair or install new flashings or storm moulds as required.

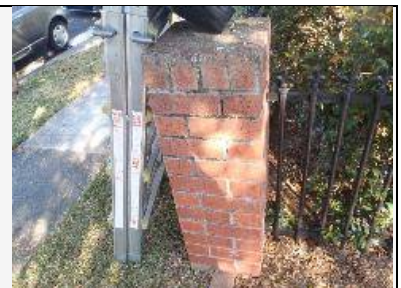
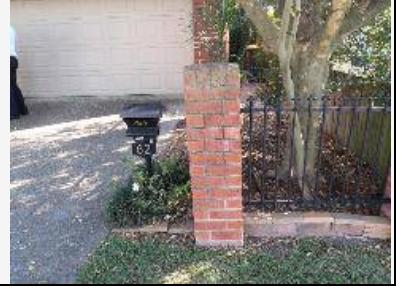
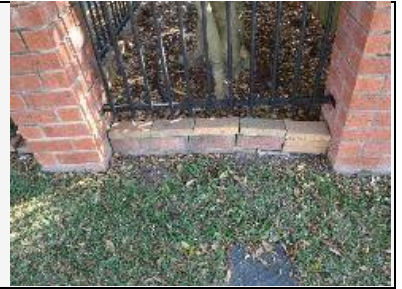
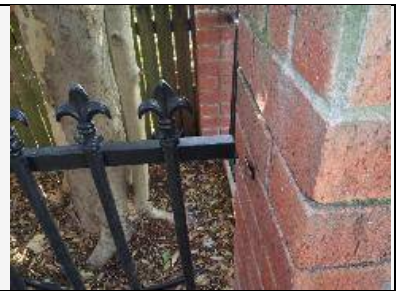
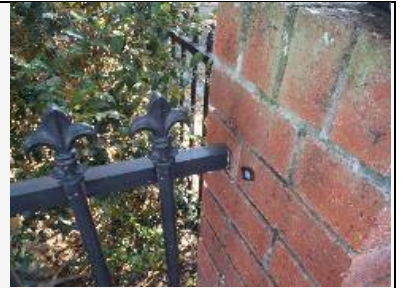
Some brick columns are leaning over. Plinth is damaged. Fence panels have pulled away from columns. They may be damaged by tree roots. Repair or replacement is required. Consult a licensed tradesperson about the scope of works and cost to rectify.

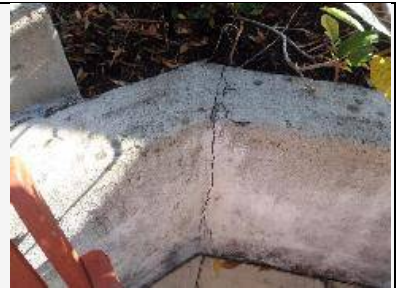
The concrete block retaining walls show normal wear and tear and Appearance cracks. Repair or replacement is required. Consult a licensed tradesperson about the scope of works and cost to rectify.

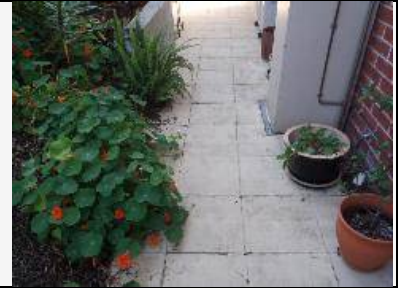
The paved area has subsided in sections. This could be a tripping hazard. This paving will require relaying by a licensed Paver. The paved areas have minor subsidence, this is likely to get worse over time as the pavers do not appear to have been laid onto a reinforced concrete base.

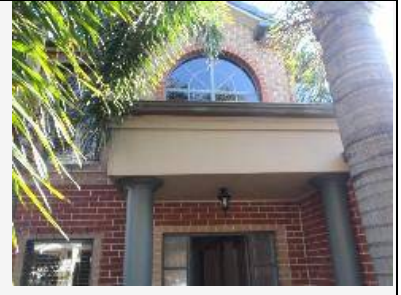
The entire porch is out of level. I suspect that the pad footings have subsided. You should have this matter further investigated by an appropriately qualified Structural Engineer prior to the contract becoming unconditional. A licensed Builder should provide a scope of works and quote to rectify this defect. Refer to sample photo.

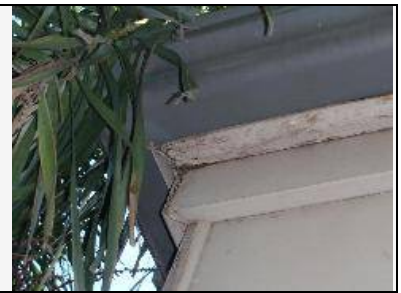
Sections of timber trim are decaying. This is a Minor Defect. Repair or replacement is required. Consult a licensed tradesperson about the scope of works and cost to rectify.

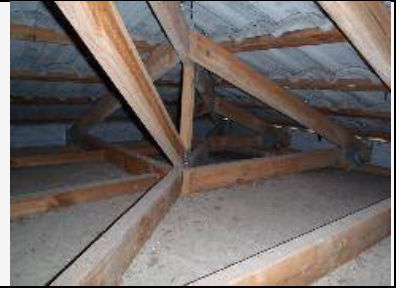
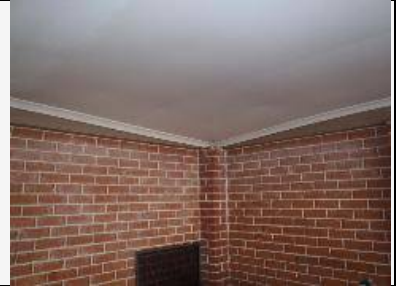
Refer to internal notes. Ceiling is damaged. Repair or replacement is required. Consult a licensed tradesperson about the scope of works and cost to rectify.

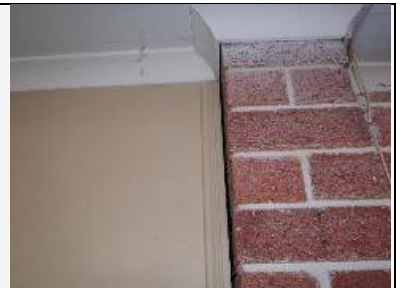
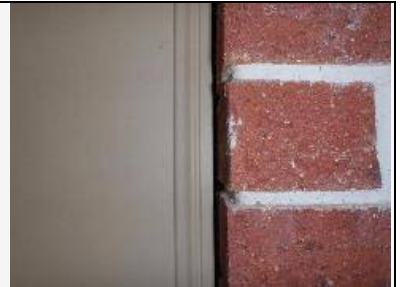
There is a gap between the brick wall and the plasterboard wall. This defect may continue to deteriorate and cost more to rectify. You should have this matter further investigated by an appropriately qualified Structural Engineer prior to the contract becoming unconditional.

Refer to sample photo showing a gap of approx. 8mm.

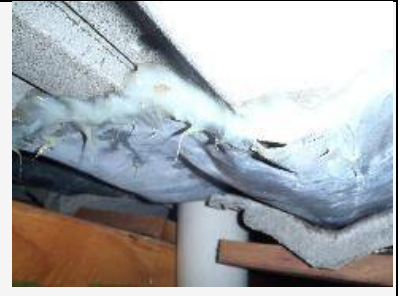
There is a hole in the flashing sealant. Refer to sample photo. This condition may allow the penetration of dampness. Dampness can cause damage to the Building, attract Timber Pests and create an unhealthy environment. A licensed tradesperson should determine a scope of works to rectify this item and repair as necessary.

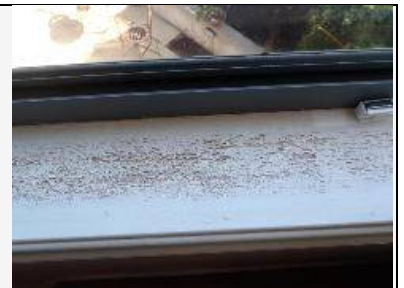
Paintwork has deteriorated in sections. Repaint as required. Consult a licensed Painter about the scope of works required a quote to repaint.

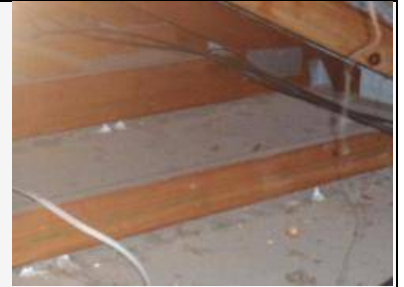
The ceilings have sagged in larger rooms. This may be due to moisture from condensation in the roof. There are also some popped nail heads. Some sections have had poor quality patching. A section of ceiling to the SW corner of the top floor living room and NE corner of the garage has dropped away from the roof trusses. This defect may continue to deteriorate and ceiling could eventually collapse. Have this matter further investigated by a licensed Builder. Repair or replacement may be required.

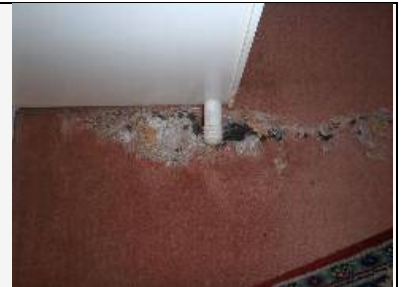
Carpets are very worn and have holes and some stains. Replacement of floorcoverings is required. Tiled floors are generally in a good condition.

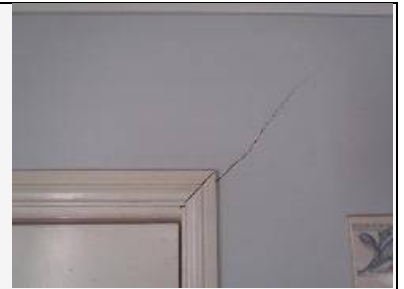
Walls are generally in a fair condition. The condition of the walls is generally fair. Appearance cracks are evident to walls. Visible cracks are hairline to 1mm in width only. Read the attached information sheet from the CSIRO on Foundation Maintenance and Footing Performance: A Homeowner's Guide and apply the recommendations therein. These cracks are relatively minor at this time but they could get worse and be very costly to rectify.

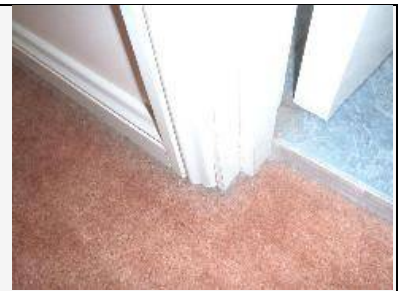
There is water damage to woodwork in the bay window area at the rear of the house. This defect may continue to deteriorate and cost more to rectify. Repair or replacement is required. Consult a licensed tradesperson about the scope of works and cost to rectify. Refer to sample photo of water damage to the skirting near the ensuite. Repair or replacement is required. Consult a licensed tradesperson about the scope of works and cost to rectify.

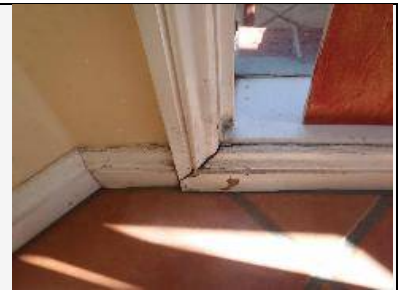
Refer to sample photo of bay window woodwork that is water damaged. Repair or replacement is required. Consult a licensed tradesperson about the scope of works and cost to rectify.

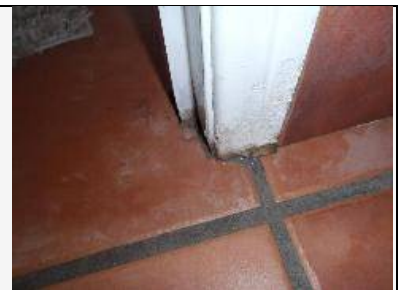
Refer to sample photo of laundry woodwork that is damaged. Repair or replacement is required. Consult a licensed tradesperson about the scope of works and cost to rectify.

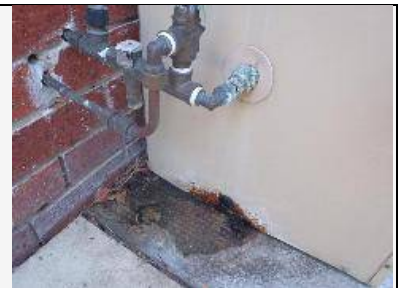
I did notice some rust at the base. A licensed Plumber should further investigate this matter and provide a quotation for the necessary rectification.

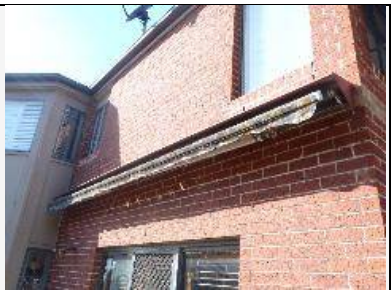
Awning not operated. Canvas appears to be damaged. Repair or replacement is required. Consult a licensed tradesperson about the scope of works and cost to rectify.

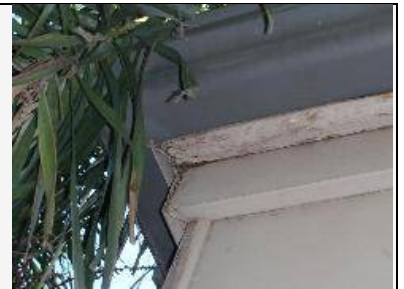
Visible timber damage appears minor to moderate. Refer to the definitions section of this report - Section 1.6 - Timber Damage.

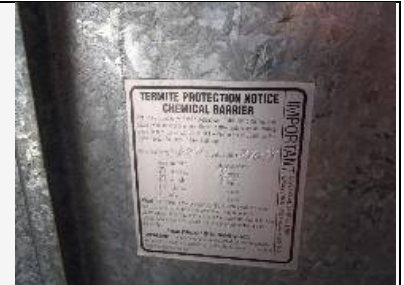
The date on the treatment notice located in the meter box indicates that the chemical barrier has expired (no longer deemed to be providing adequate protection against termite attack). Therefore a new chemical barrier in accordance with AS3660.1 (or other Termite Management System that complies with AS3660.1) is required immediately.
