Building and Pest Inspection Reports

In accordance with AS 4349.0 and AS 4349.3

56 Postwar Street, Sample Town

26th July 2012 at 12:30pm

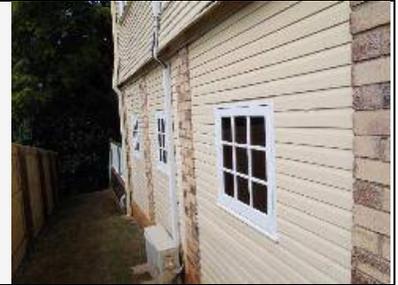
The condition of the exterior of the windows is generally good. Storm moulds are not present but there is no evidence of significant water penetration to the interior of the building. No action is required at this time.

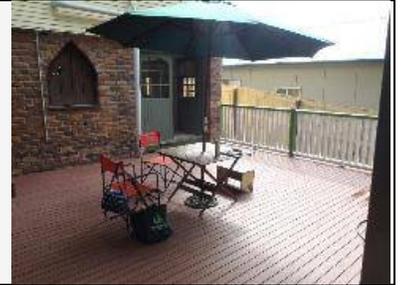
Rear elevation.

Balustrades are generally in a good condition.

Decking is generally in a good condition.

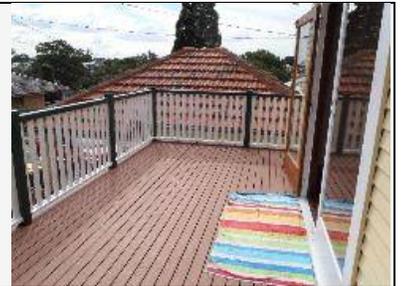
Front elevation.

Balustrades are generally in a good condition.

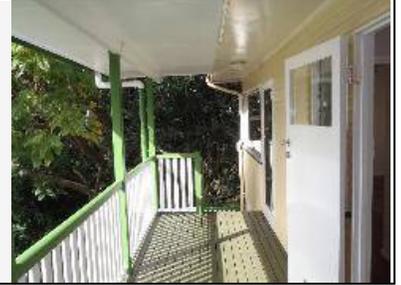
Left hand side elevation.

Balustrades are generally in a good condition.

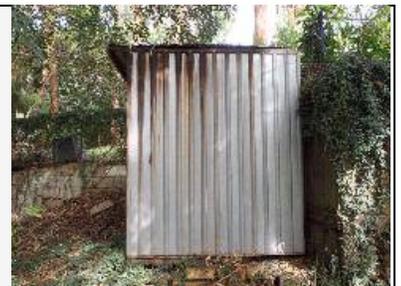
Metal garden shed:

The structure is generally in a poor condition. Section of slab floor missing.

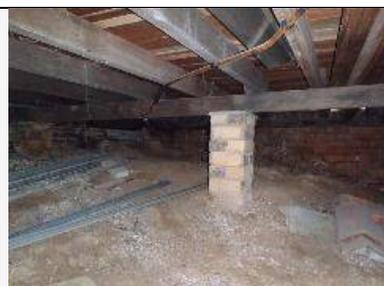
The subfloor framing appears to be adequate.

The brick piers are generally in a acceptable condition.

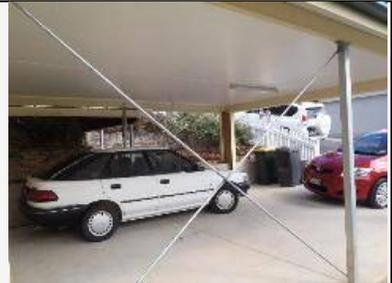
Freestanding to the front of the main house.

Not accessible as there is no manhole.

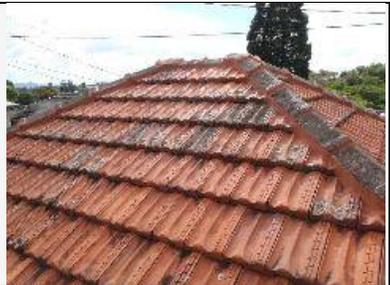
The roof is of pitched style construction.

The overall condition of the reasonably accessible roof coverings appears to be good.

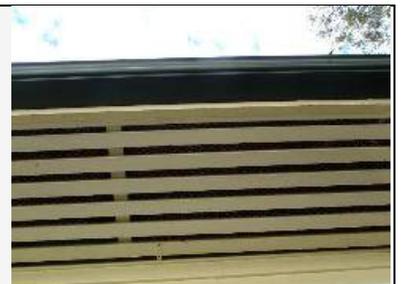
The eaves are lined with fibre cement sheeting and are generally in a good condition. The eaves are lined with timber lining boards in sections. The overall condition of the eaves lining is good.

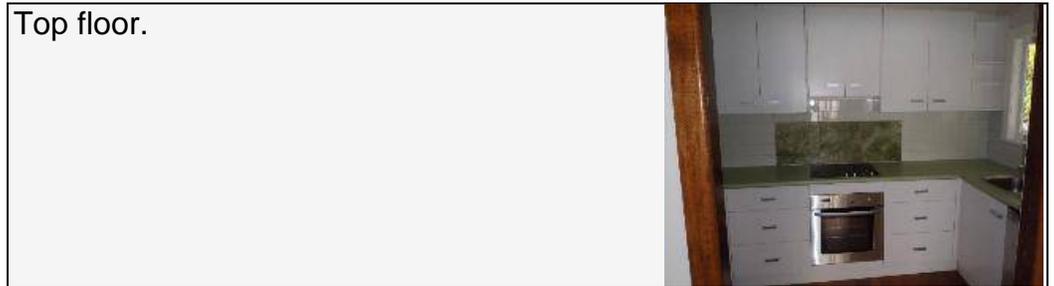
Top floor.

The condition of the fixtures is generally good.

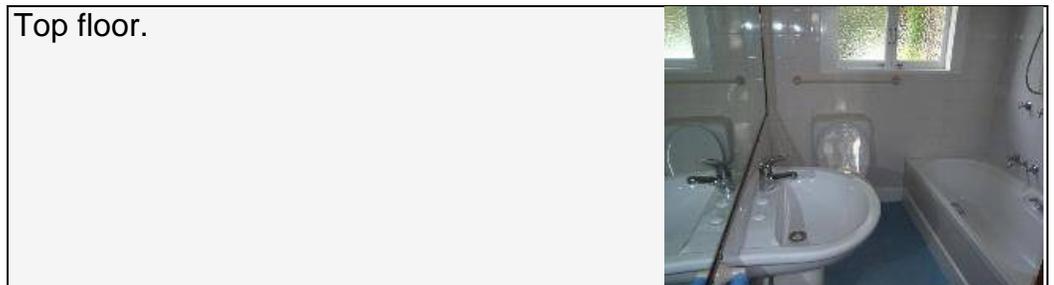
Top floor.

The shower is located over the bathtub. The shower and bath appear to be in a good condition. The area will need to be kept well sealed to prevent water penetration to surrounding areas. The shower/bath was inspected and where access permitted a moisture meter was used, and there was no visible water penetration to surrounding areas.
IMPORTANT NOTE: This test may not reveal water leaks until the shower/bath is put into constant use and surrounding areas monitored over a period of time.

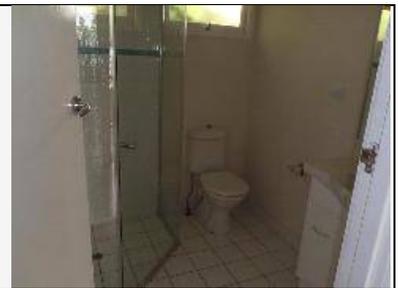
Top floor, The rear right hand side of the building.

The shower appears to be generally in a good condition. The shower recess was inspected and where access permitted a moisture meter was used, and there was no visible water penetration to surrounding areas.
IMPORTANT NOTE: This test may not reveal water leaks until the shower is put into constant use and surrounding areas monitored over a period of time.

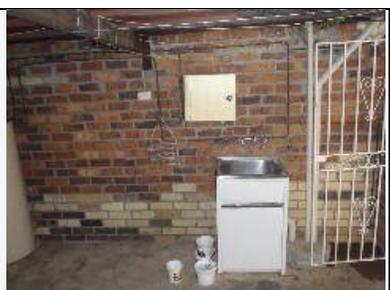
There is no laundry room as such, only a laundry tub and washing machine taps located under the house.

The laundry tub and taps are generally in a good condition.

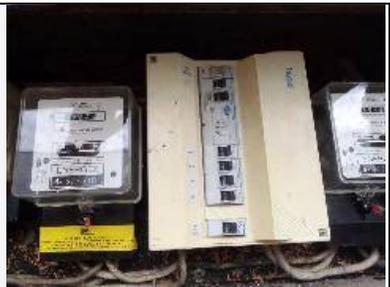
- There is a Earth Leakage Circuit Breaker (Safety Switch) installed however, the operation or adequacy was not tested and is not commented on.

Smoke detector is fitted to the hall however the operation or adequacy was not tested and is not commented on. I recommend installing a smoke detector in each of the ground floor areas including the subfloor/laundry area.
