Building and Pest Inspection Reports

In accordance with AS 4349

Property Address:
101 Sample Street
Sampleville

Report Number:
13155

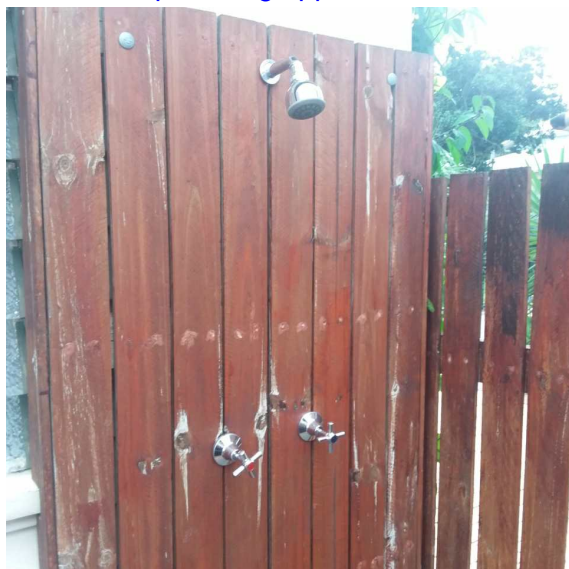
New plumbing fixtures appear to have been installed (outdoor shower), these require plumbing approval. Check that plumbing approval has been issued.

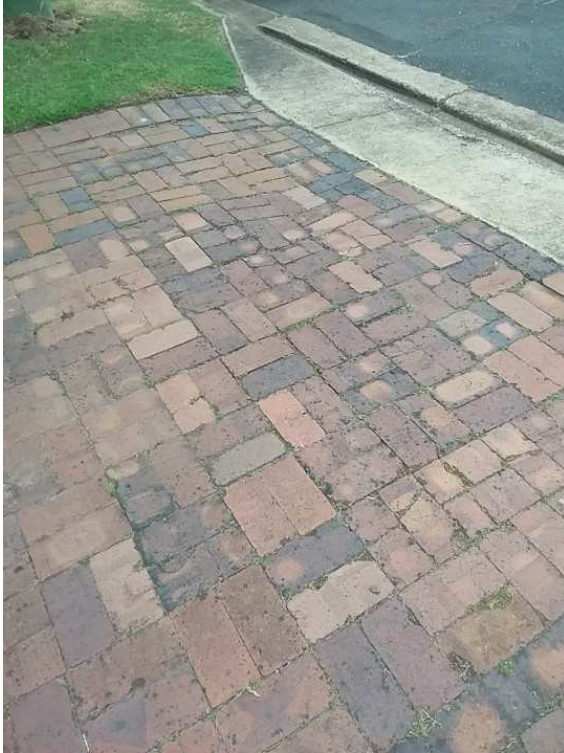
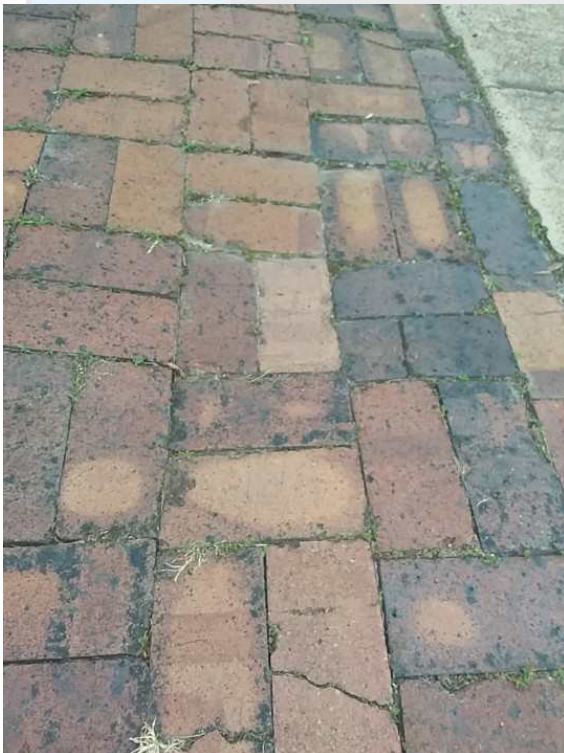
The paved driveway has cracked and subsided pavers. This could be a potential Major Safety hazard (tripping) and make the driveway unsafe. I recommend that you consult a licensed Paving Contractor about the scope of works and cost to rectify this defect and then have it rectified.

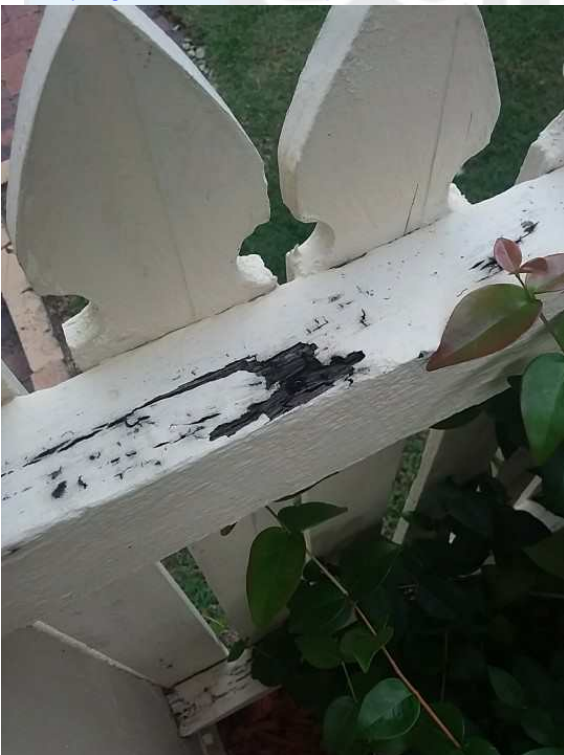
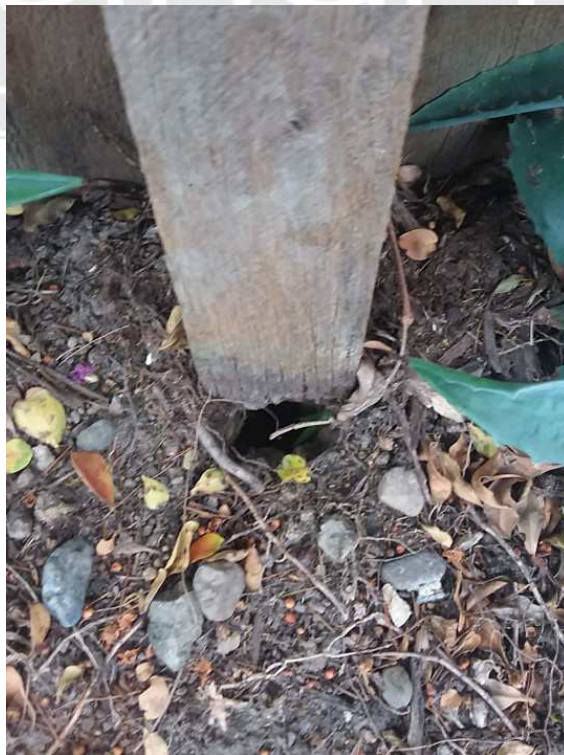
Decaying in sections. Replacement of damaged sections is recommended

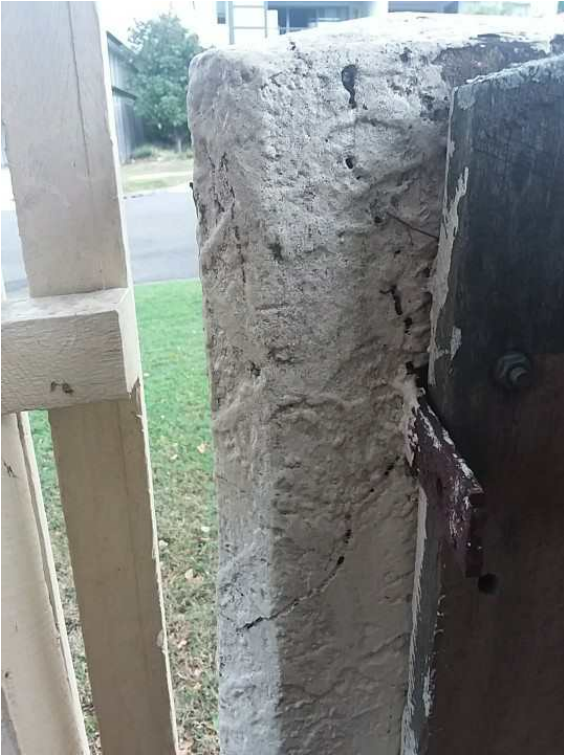
Cracked concrete stump to the front left hand corner. This is a minor defect that should be rectified as part of a normal maintenance program.

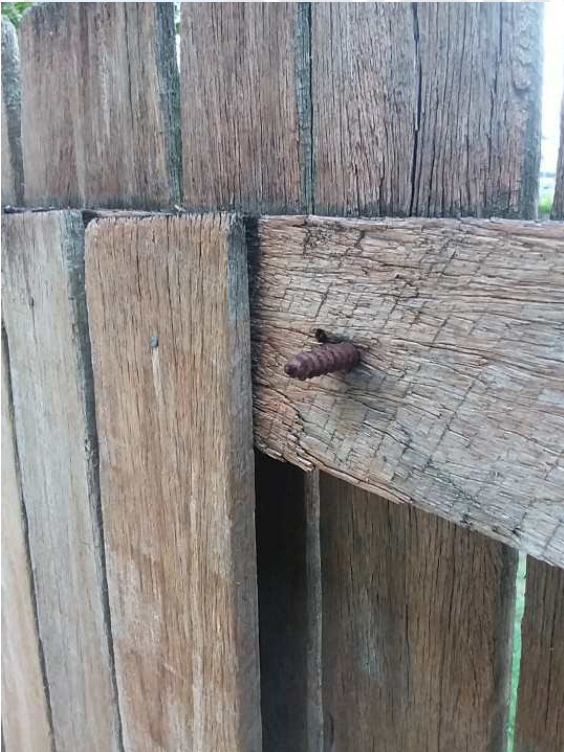
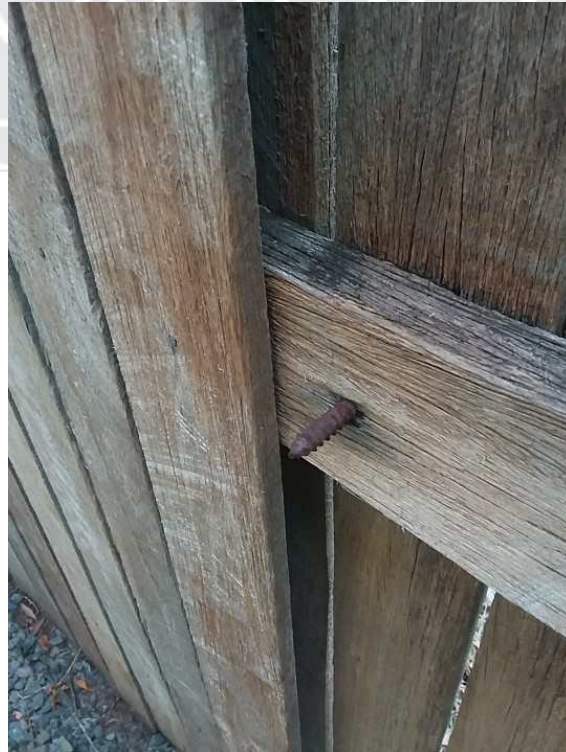
Screws protruding. This item is a potential major safety hazard. Consult a licensed tradesperson about the scope of work and cost of works and have this item promptly rectified.

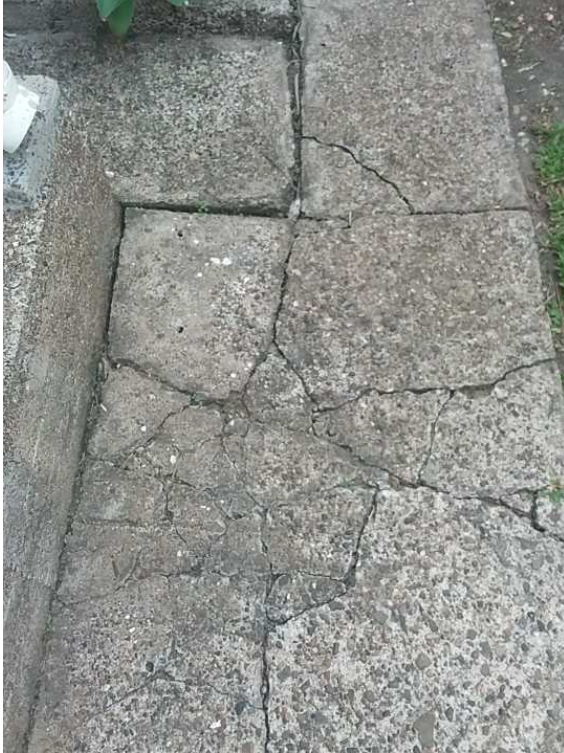
The concrete paths and other concrete areas are in poor condition as they have severe cracks and subsidence making them a potential Major Safety Hazard (tripping hazard). Replacement is recommended. Consult a licensed Concretor about the scope of works and cost to rectify this defect.

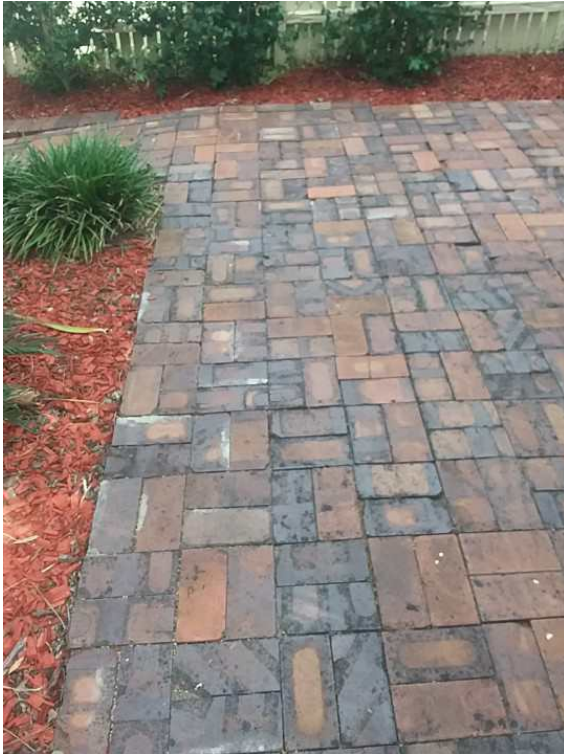
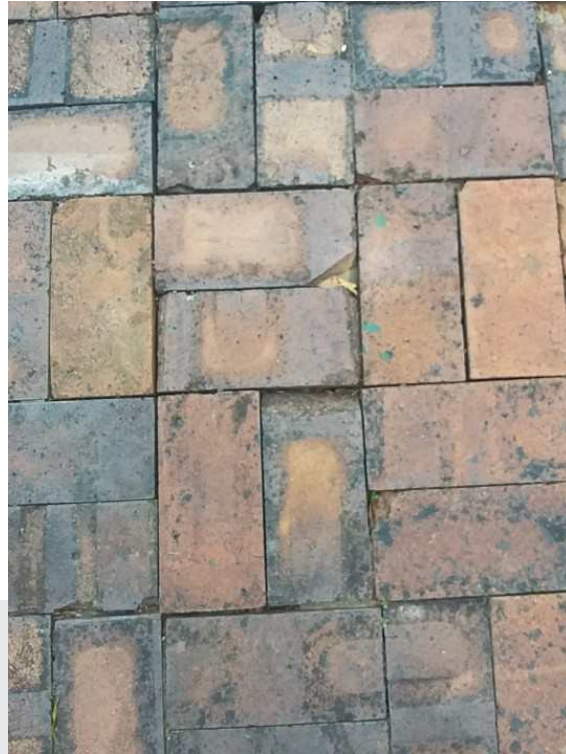
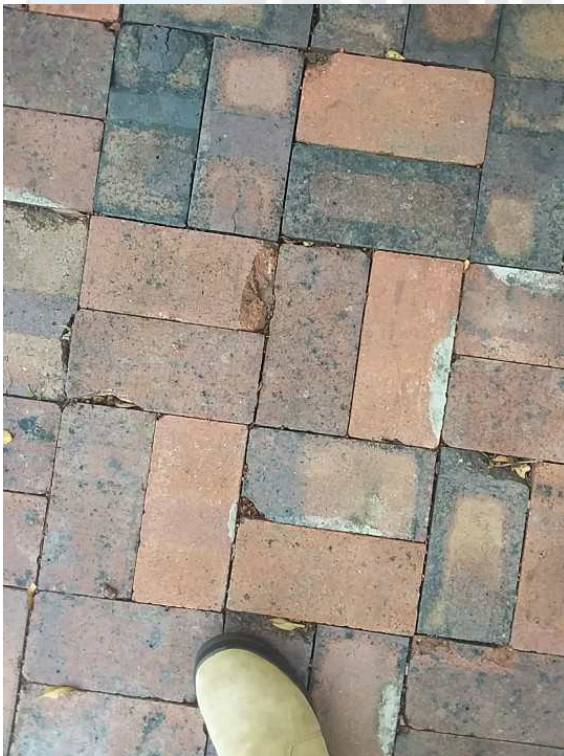
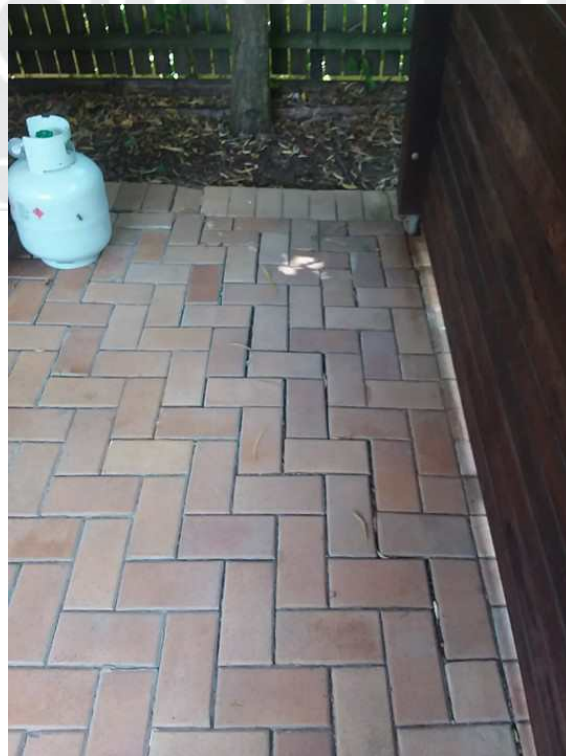
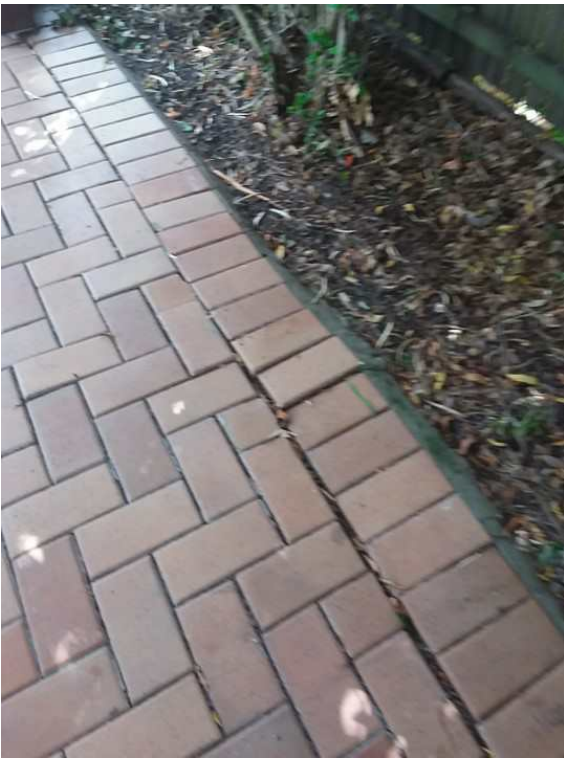
The paved areas have minor subsidence, this is likely to get worse over time as the pavers do not appear to have been laid onto a reinforced concrete base. This defect should be referred to a licensed Paving contractor.

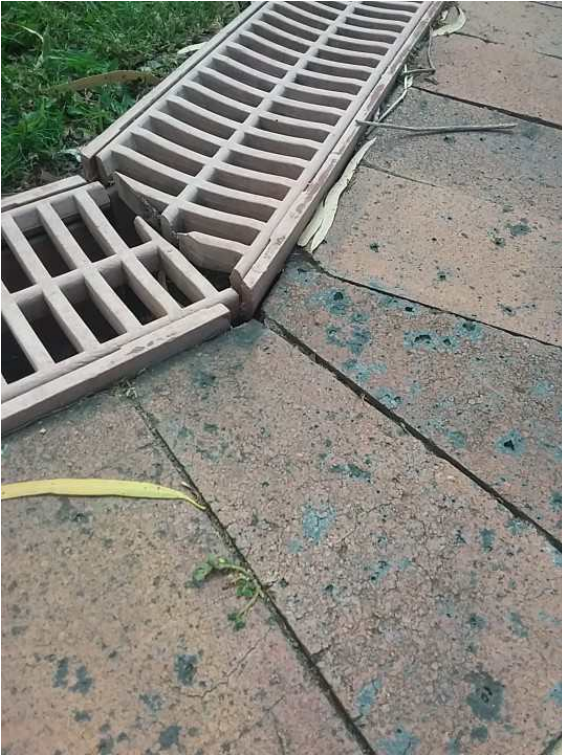
Channel drain damaged in sections. This item is a potential major safety hazard. Consult a licensed tradesperson about the scope of work and cost of works and have this item promptly rectified.

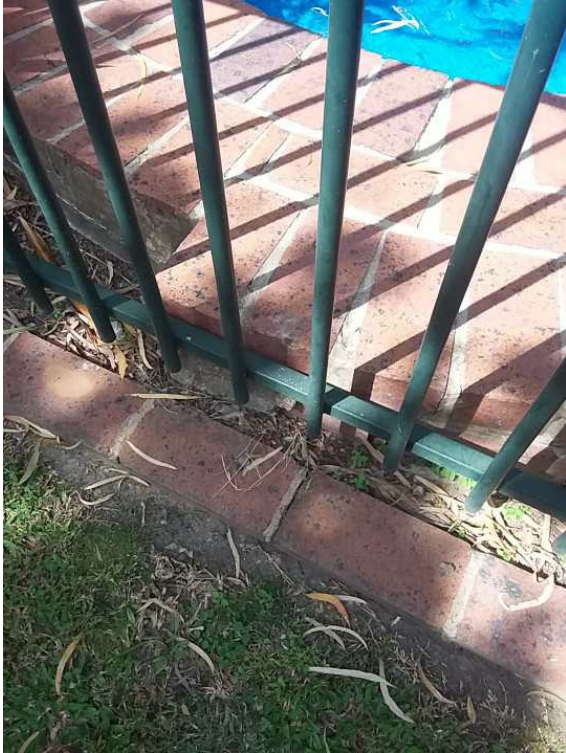
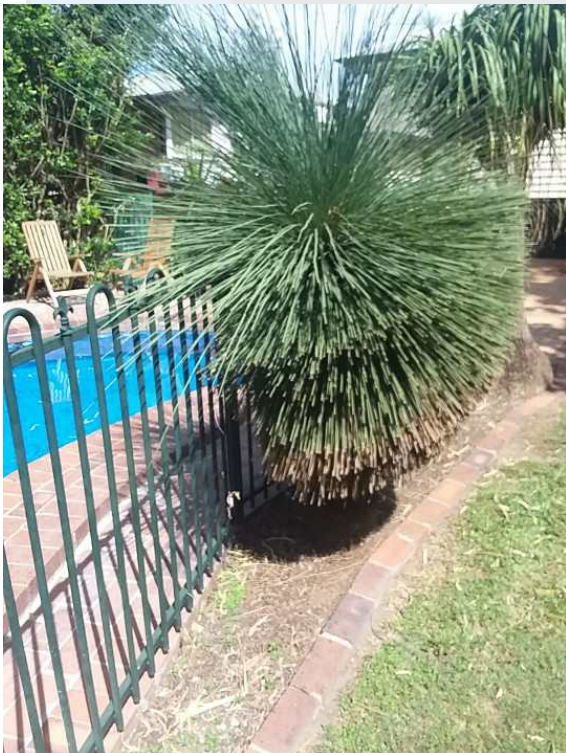
Pool fencing is installed. The Pool should be registered on the Pool Safety Register held by the QBCC and a Pool Safety Certificate should be issued by a licensed inspector to ensure the Pool fencing is safe and compliant. If you are in the process of purchasing the property then you need to ensure that the Pool Safety Certificate is provided by the Seller or otherwise you will be legally required to provide this. Consult a Pool Safety Inspector for further information.

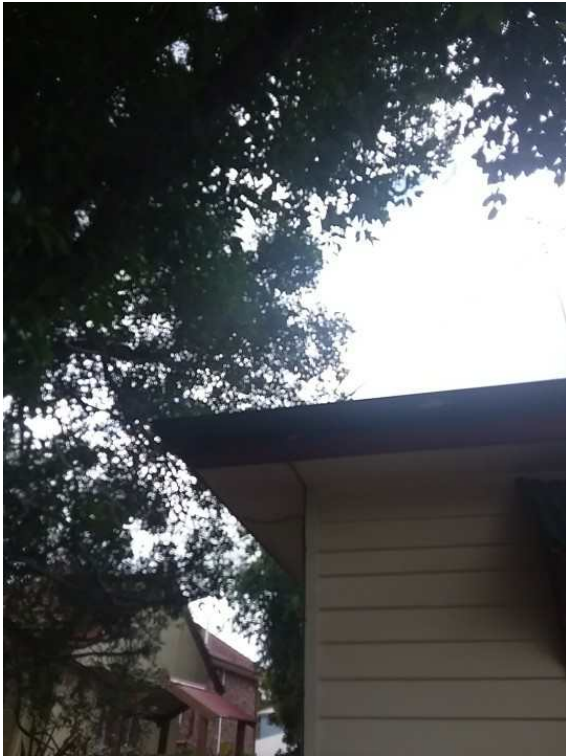
We recommend the trees overhanging the roof be trimmed to prevent damage of the roofing surface, and allow free flow of roof runoff.

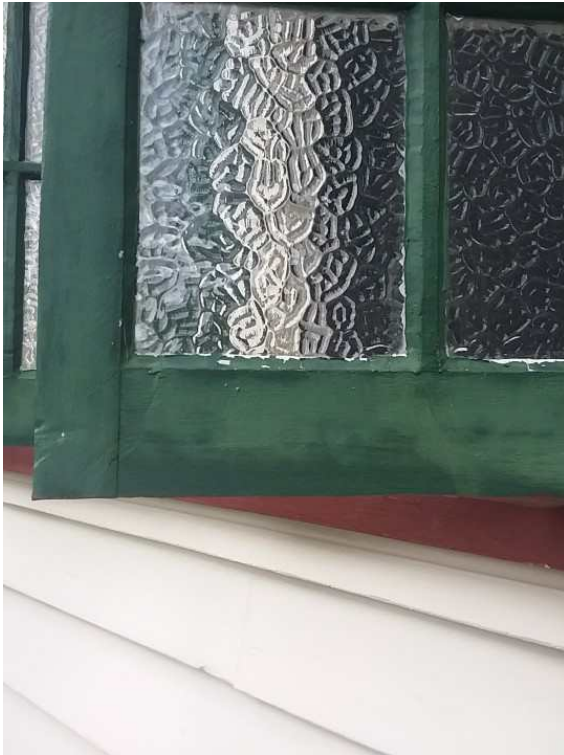
Paint is deteriorating to various sections of previously painted external surfaces. This exposes the building element to the weather and can result in accelerated deterioration and can increase the costs of repair and re-painting. I recommend you consult a licensed Painter about the necessity and cost of repainting. Note: Repainting an entire building can be very costly.

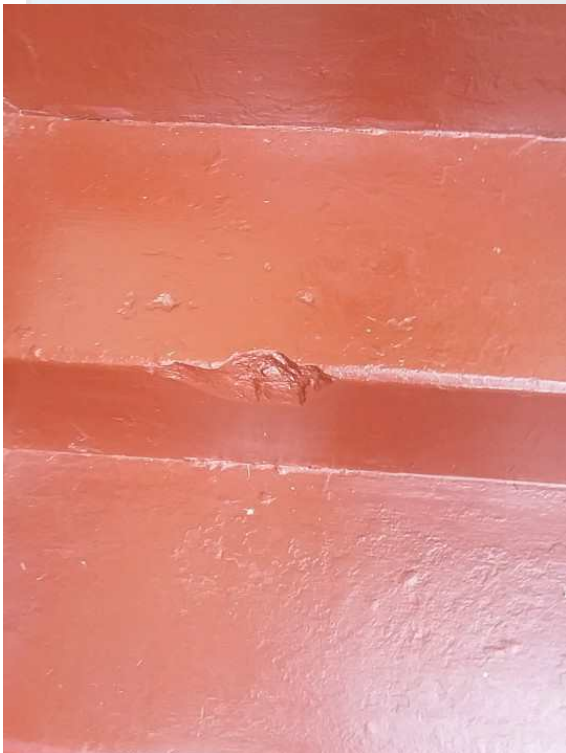
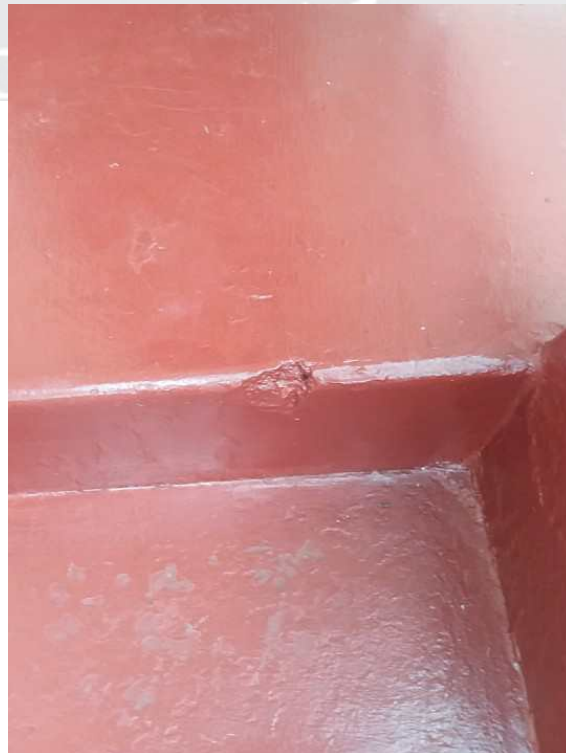
Chipped tread to front steps. This item is a potential major safety hazard. Consult a licensed tradesperson about the scope of work and cost of works and have this item promptly rectified.

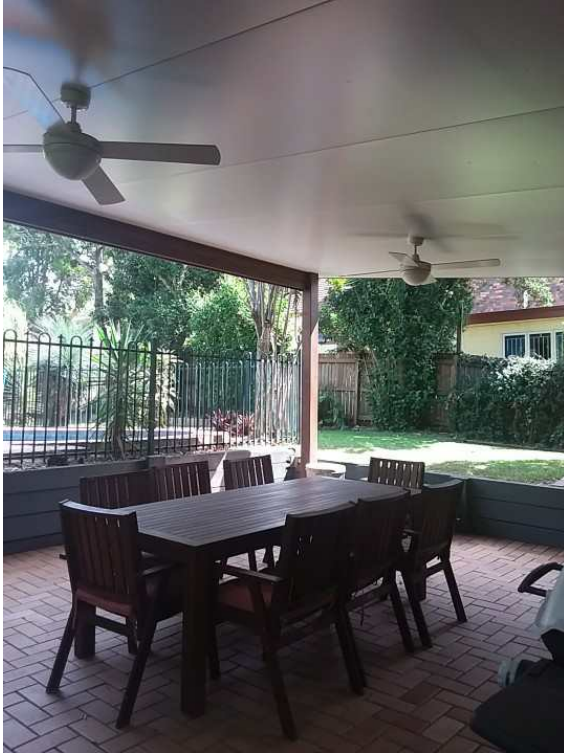
Covered area

I suspect that this structure may not have council approval. This structure should have a Building approval, Form 21 and QBCC home warranty insurance. Ask Seller to provide these.

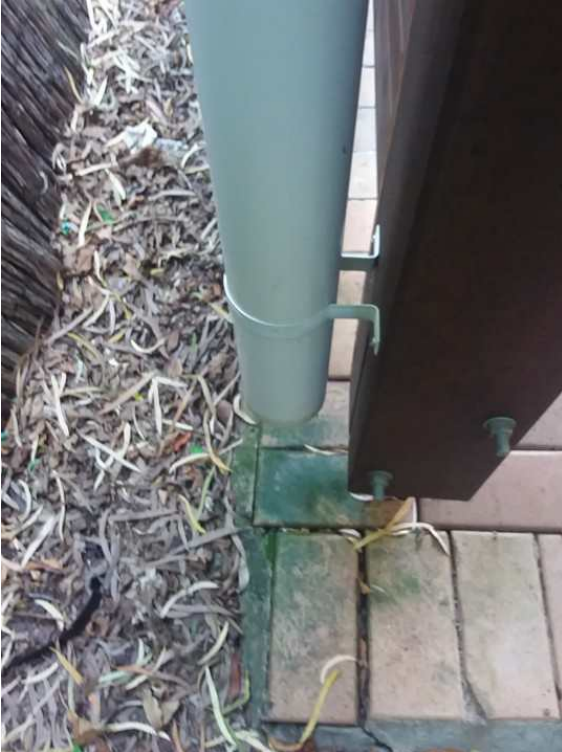
Some downpipes do not appear to be connected to an approved point of discharge such as council stormwater drains, rubble pits, or street kerb and channel. This can cause damage to buildings or be a nuisance. This should be rectified by a licensed plumber.

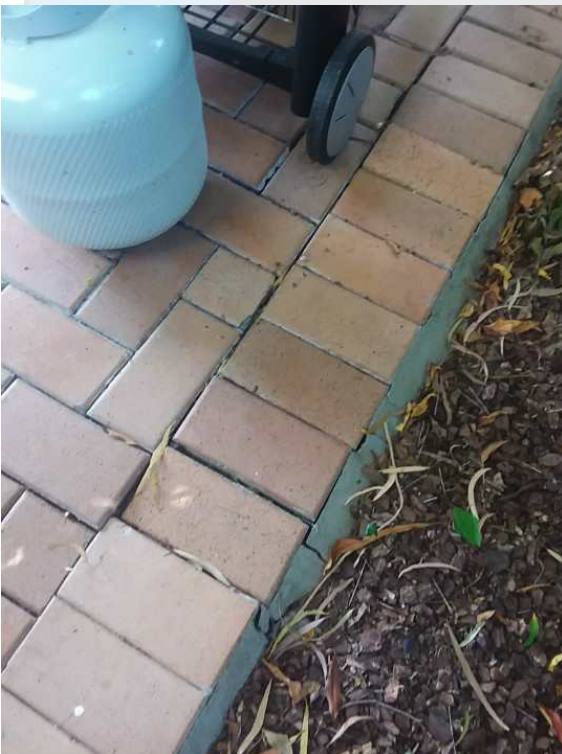
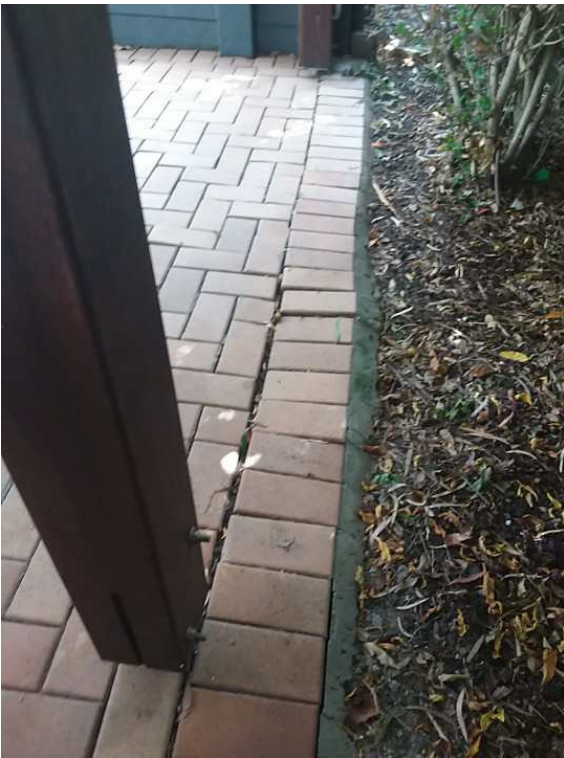
The paved floor appears to be in poor condition.

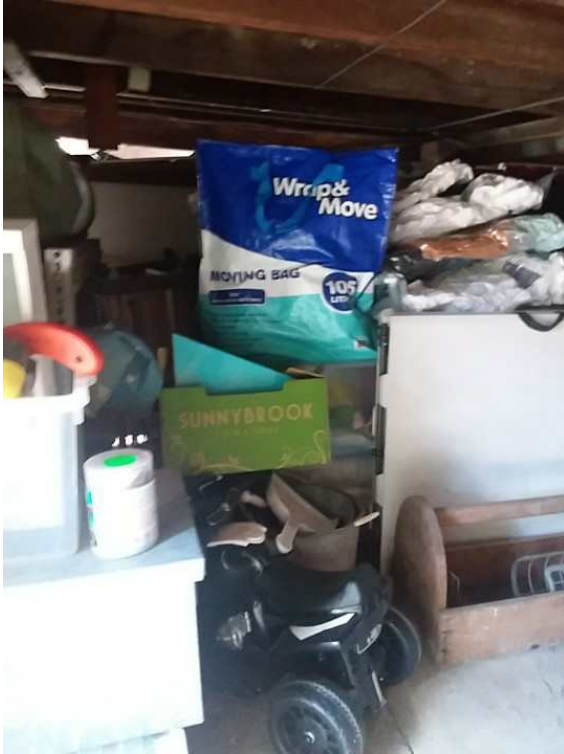
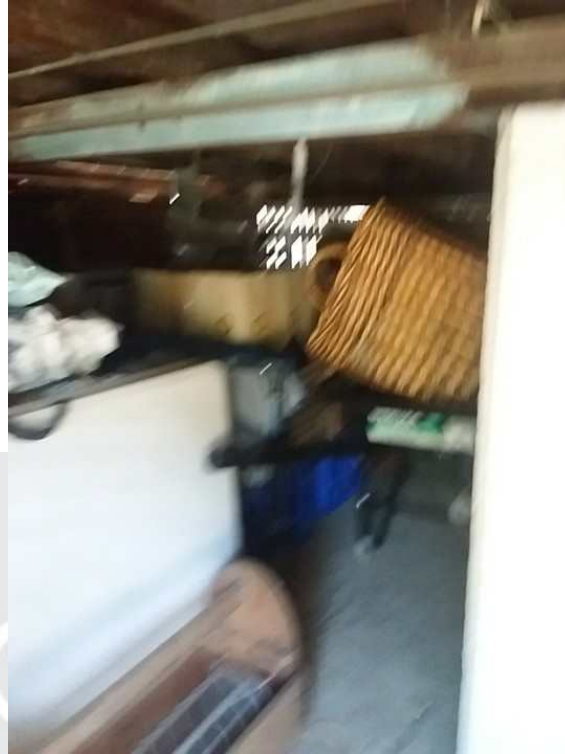
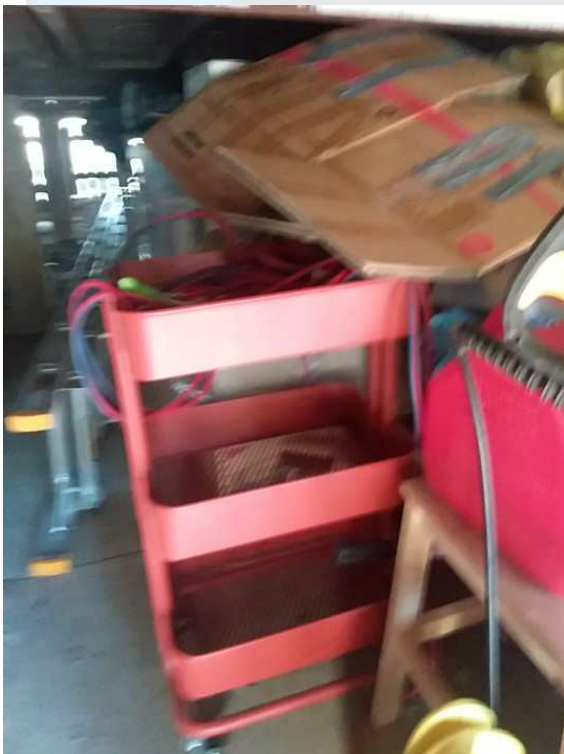
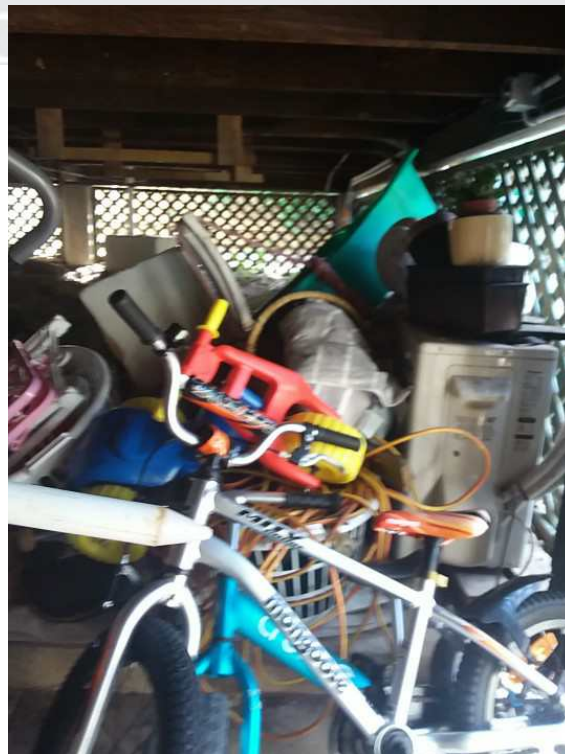
Stored goods are present in this area and restricted inspection. Access should be gained and this area re-inspected in case there are defects concealed by these stored items.

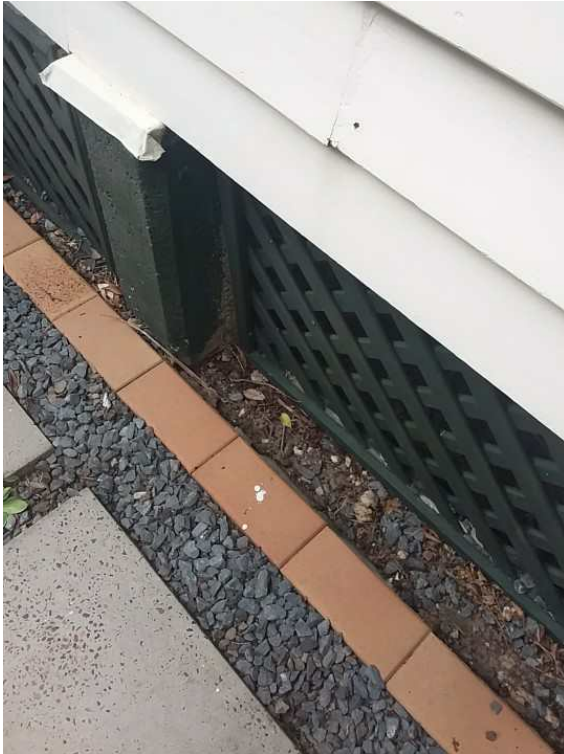
Sections of timber battens are damaged or missing. This could be a safety hazard or security problem. Have a licensed Carpenter or handyman replace the damaged/missing sections.

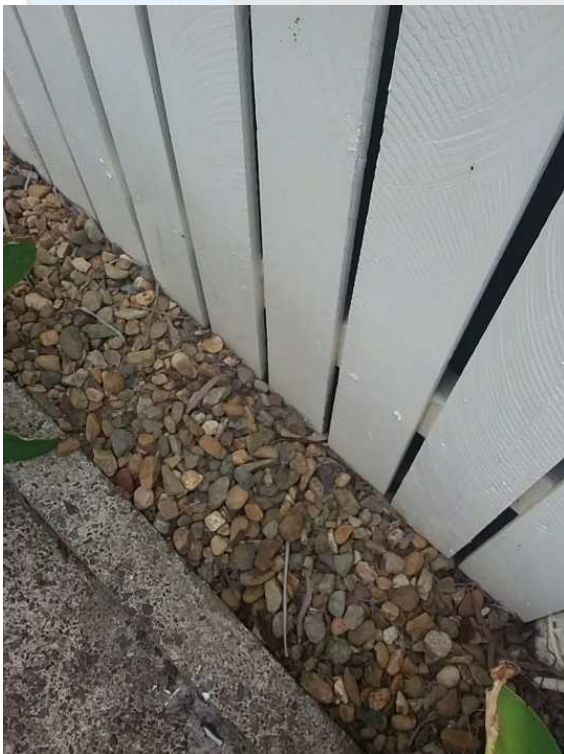
The timber battens between stumps are in contact with the ground in sections. This ground contact can result in decay or termite attack. This is a minor defect. Recommend trimming battens so that there is at least 100mm clearance between battens and soil. Have a licensed Carpenter or handyman rectify as required.

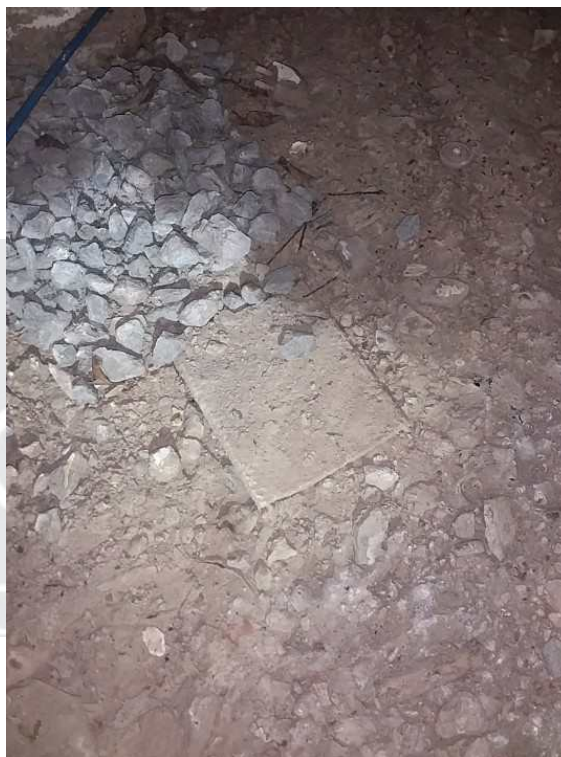
Asbestos pieces under the floor should be removed

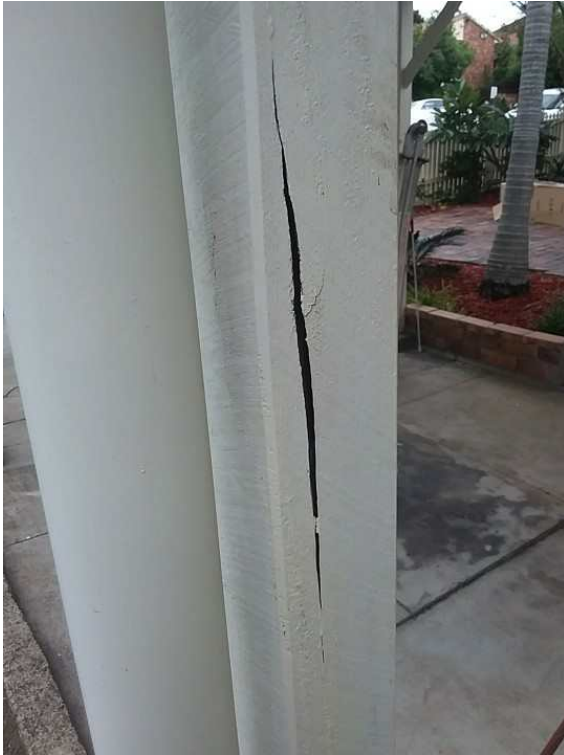
One split post. This is a minor defect that should be rectified as part of a normal maintenance program.

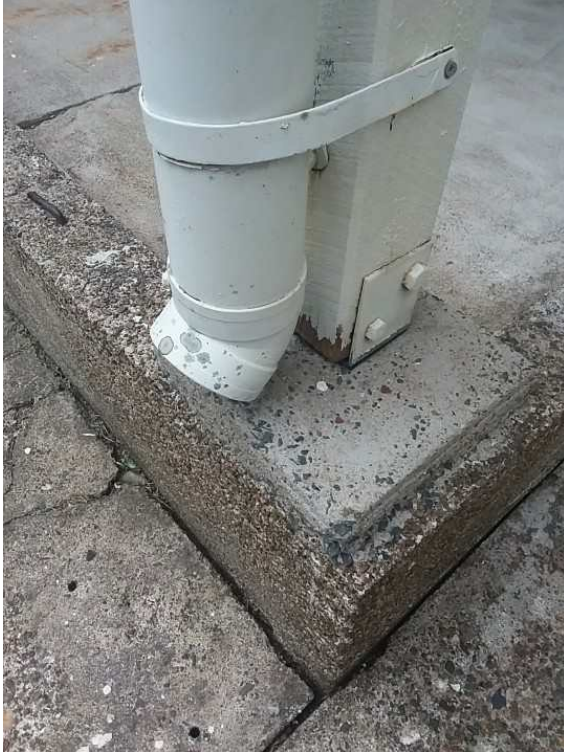
Some downpipes do not appear to be connected to a stormwater dispersal system. This should be rectified.

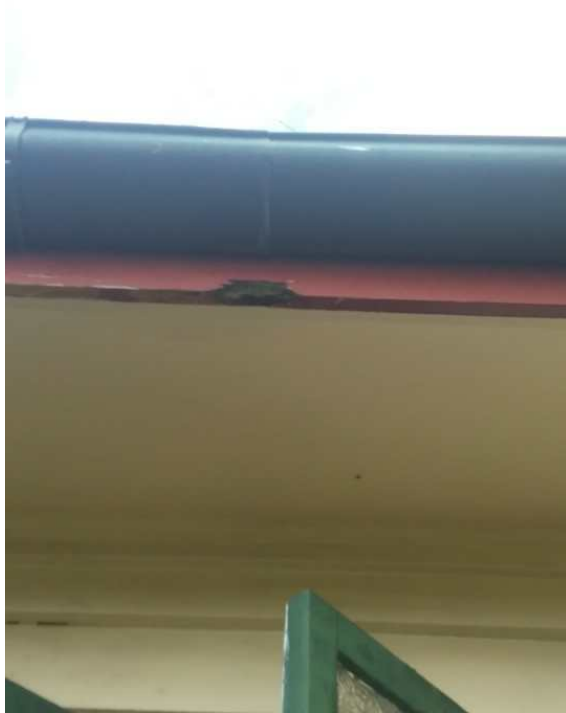
Gutters and downpipes have leak stains and minor rust that indicate joins may be leaking. A licensed Roofer should further investigate this matter and provide a quotation for the necessary rectification.

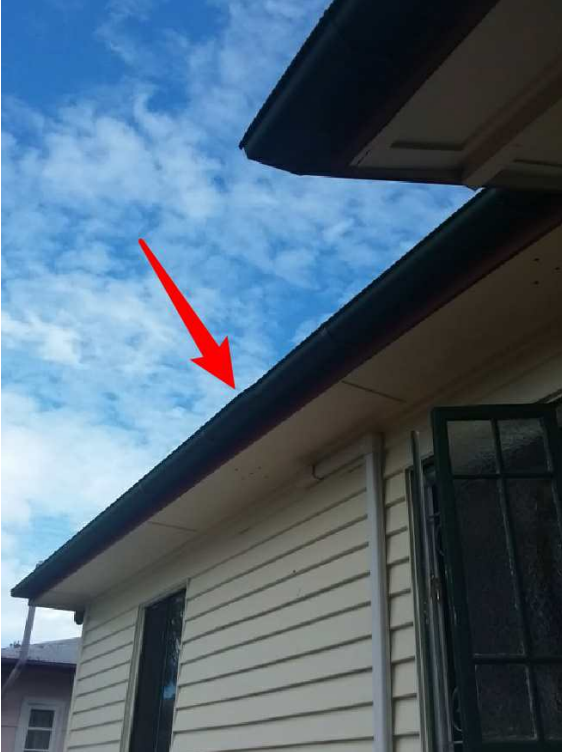
Gutters are damaged or rusting in sections. This will cause water leaks that can cause damage to other parts of the building. These should be repaired or replaced by a licensed Roofer or Plumber as necessary.

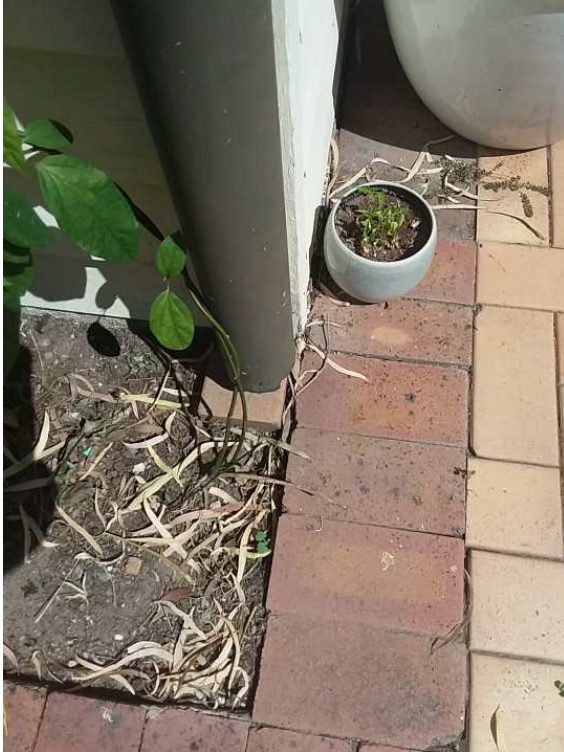
Some downpipes do not appear to be connected to an approved point of discharge such as council stormwater drains, rubble pits, or street kerb and channel. This can cause damage to buildings or be a nuisance. This should be rectified by a licensed plumber.

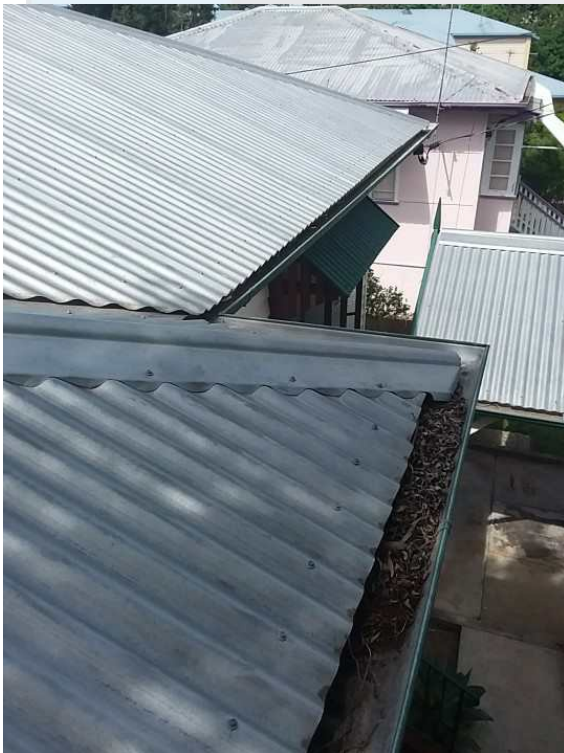
The spacing between downpipes exceeds 12m. Insufficient downpipes may cause problems with leaks or drainage. A downpipe must be installed at least every 12m. Recommend installing additional downpipes.

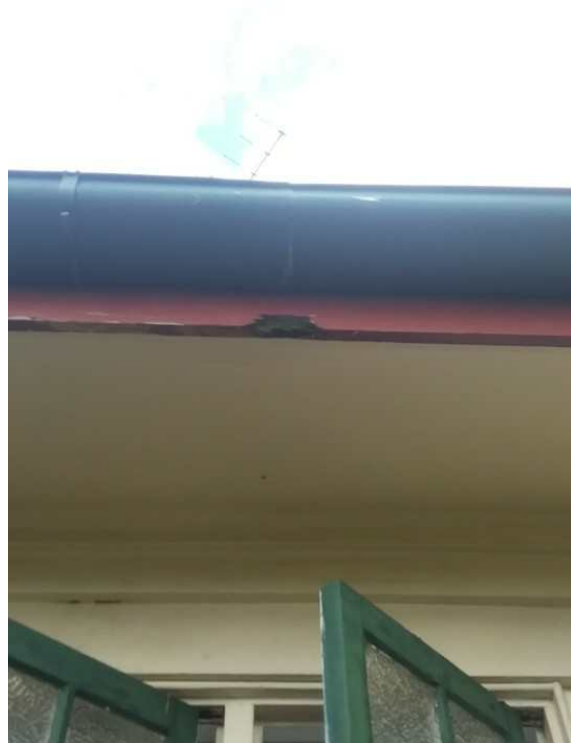
Minor fungal decay is present to sections of timber fascias or barge boards. Repair or replacement is required as decay can get worse and cause more damage. Consult a licensed tradesperson about the scope of works and cost to rectify.

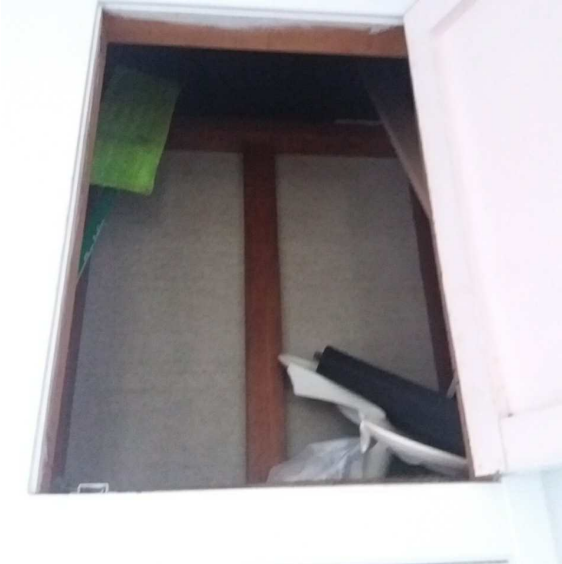
The suspected presence of Asbestos dust prevented me from accessing the roof space as I thought there was a risk of significant exposure to Asbestos dust. No Inspection of the Roof Space was carried out and no report will be provided on the Roof Space. I recommend that, as a matter of Health and Safety you arrange to have an Asbestos Specialist audit the property for the presence or absence of Asbestos.

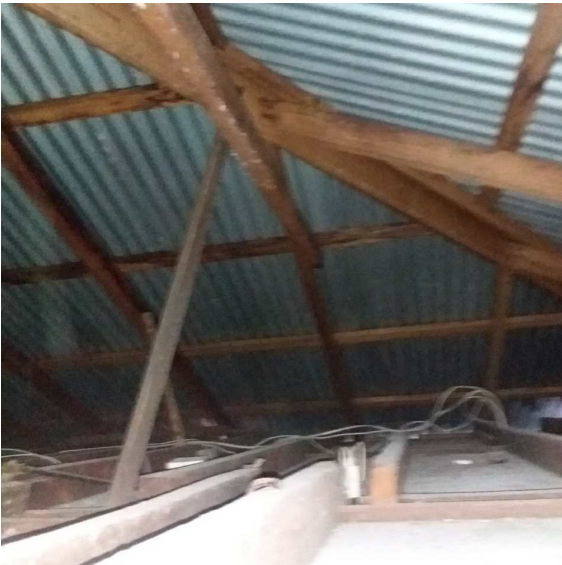
Timbers, connections, bracing and tie downs should all have been upgraded to current code when the roof was replaced. I recommend the Roof structure be assessed by a Structural engineer and then upgraded by a licensed Builder as necessary.

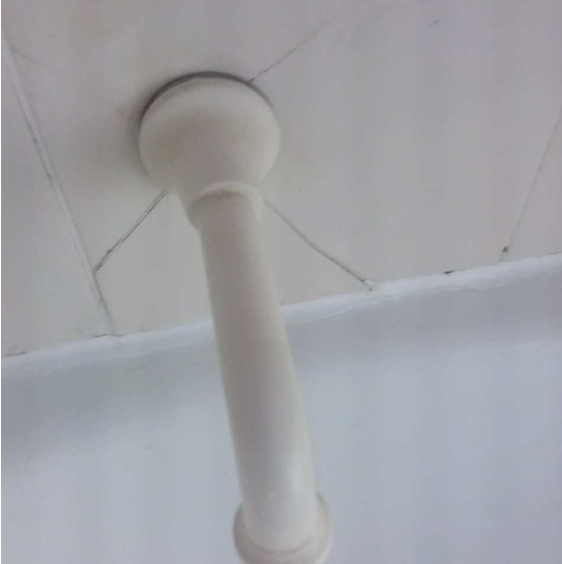
Tiles cracked and loose around the bath spout. This can result in water damage to the wall cavity. Consult a licensed tradesperson to determine an adequate scope of works and associated costs to rectify this defect.

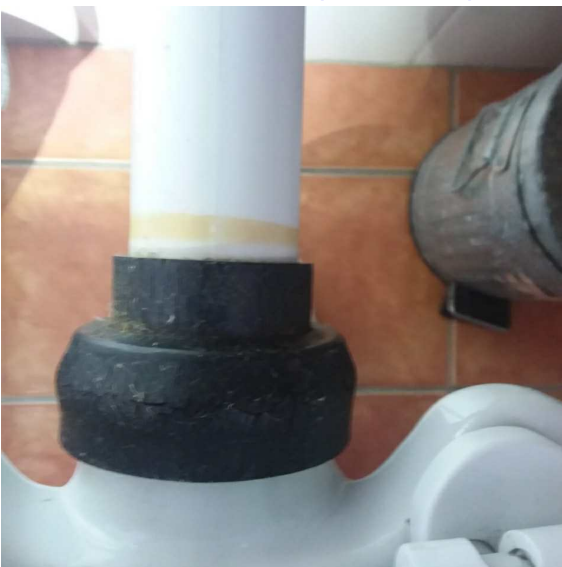
The Flush cone rubber at the rear of the toilet has perished. This can allow water leaks that can waste water and cause damage to other parts of the building. A licensed plumber should be called to make further evaluation and repairs as required.

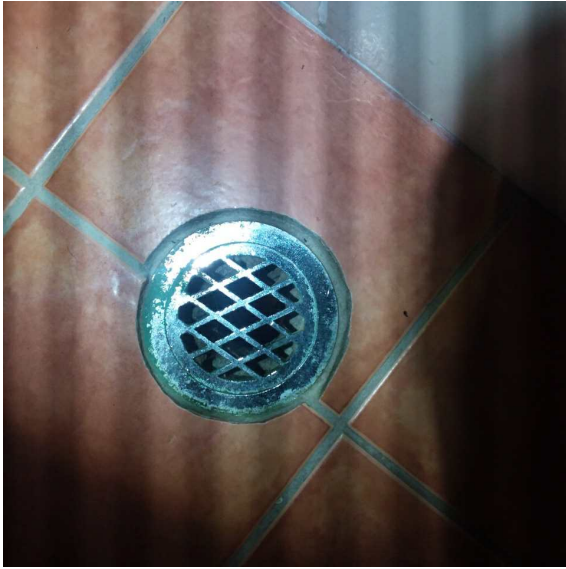
The floor waste discharges onto the ground/floor below, recommend having the pipe connected to the sewer system.

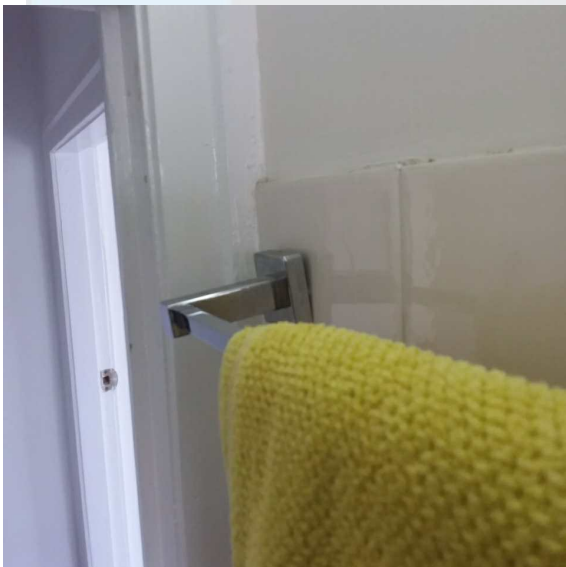
The towel rail is loose and will require repair. This a minor defect. Handyman to rectify.

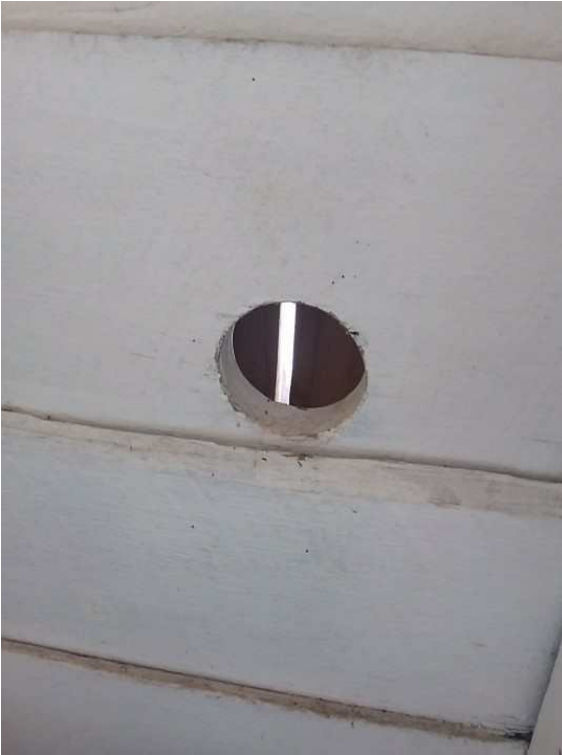
Hole in wall. This is a minor defect that should be rectified as part of a normal maintenance program.

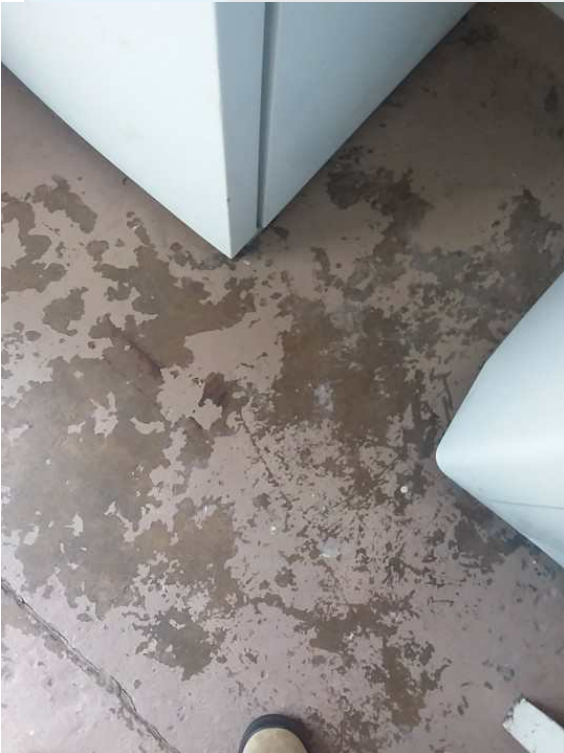
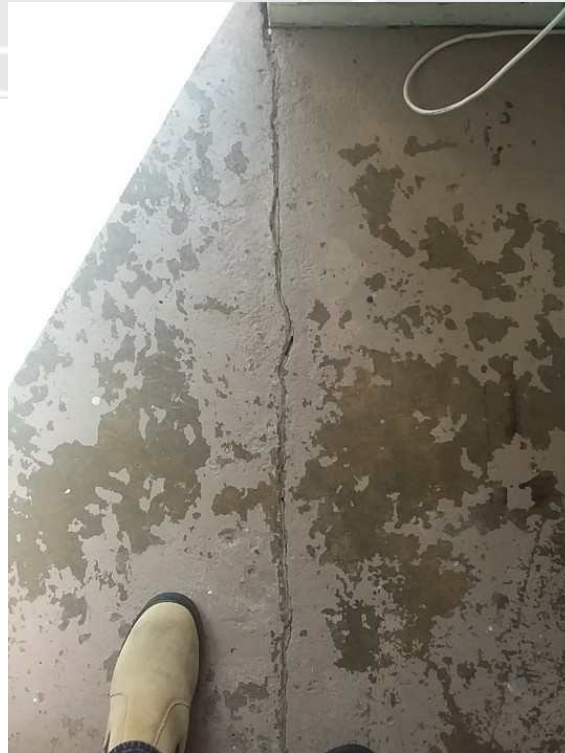
Painted concrete slab. Paint peeling off. This is a minor defect that should be rectified as part of a normal maintenance program.

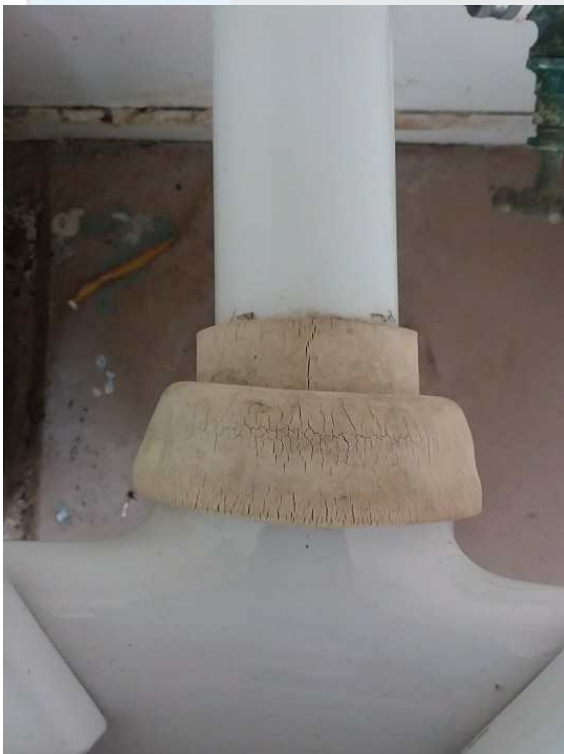
The Flush cone rubber at the rear of the toilet has perished. This can allow water leaks that can waste water and cause damage to other parts of the building. A licensed plumber should be called to make further evaluation and repairs as required.

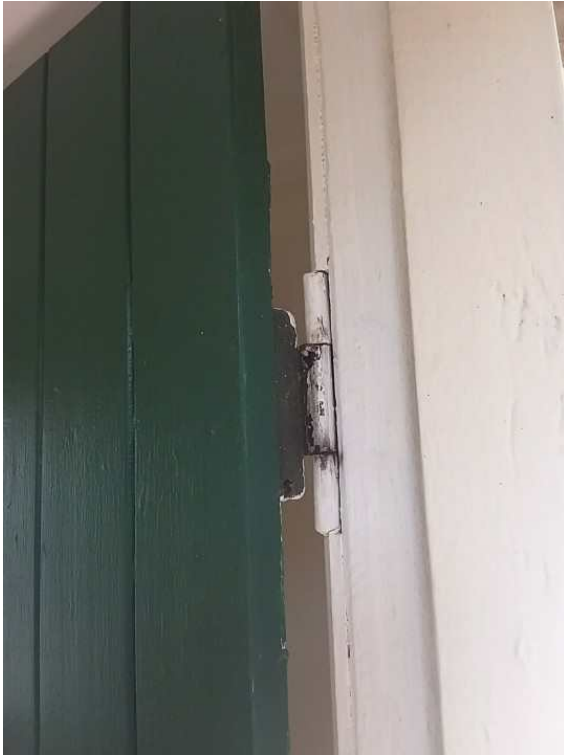
The toilet door opens inwards, and does not have demountable hinges. Demountable hinges allow the door to be removed in the event that a person becomes unconscious and faints against the door, trapping themselves inside the water closet. The current Building Code requires that demountable hinges be installed on all new dwellings. It is recommended that the current door be altered to incorporate demountable hinges for safety.
