Building and Pest Inspection Reports

In accordance with AS 4349

Property Address:
101 Sample Street
Sampleville

Report Number:
13155

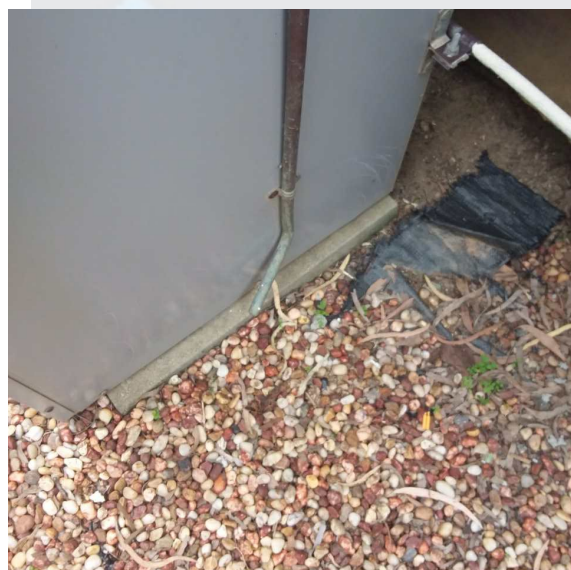
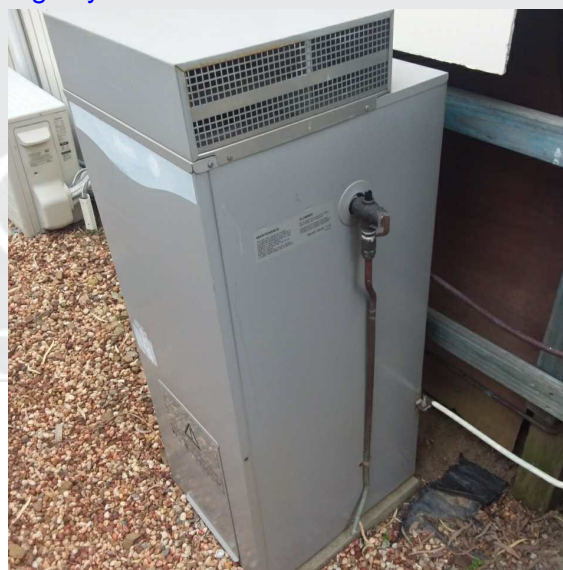
Overflow not connected to the stormwater drainage system.

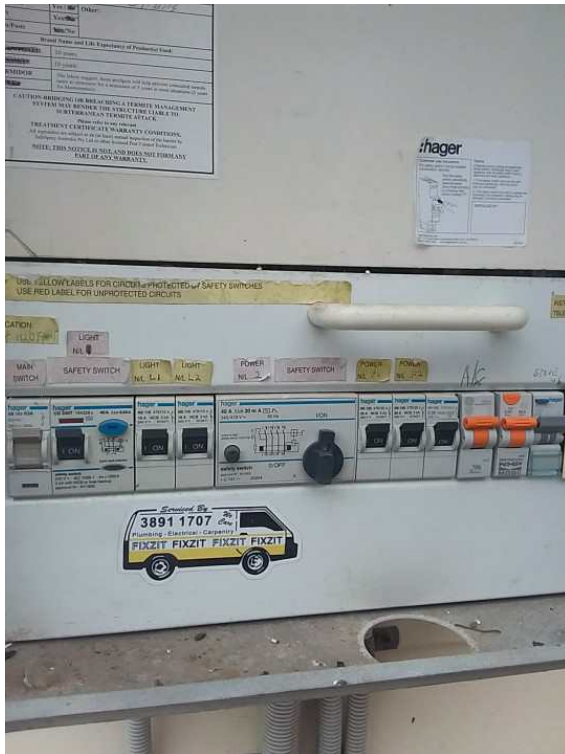
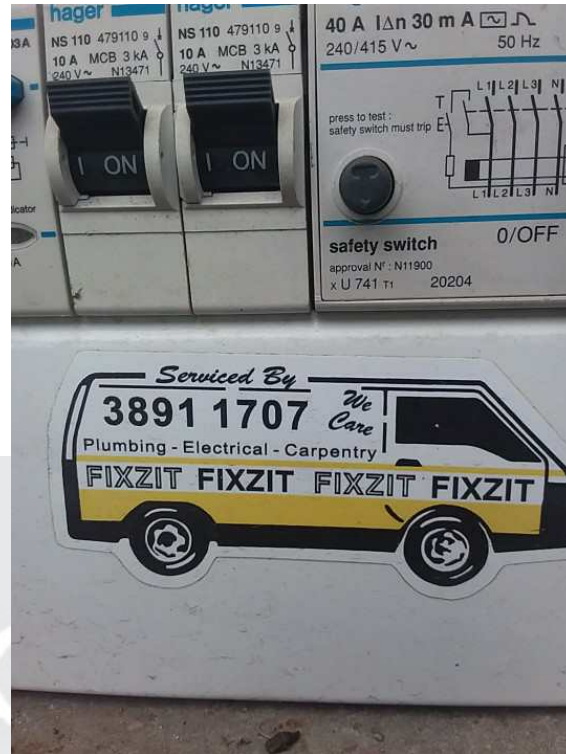
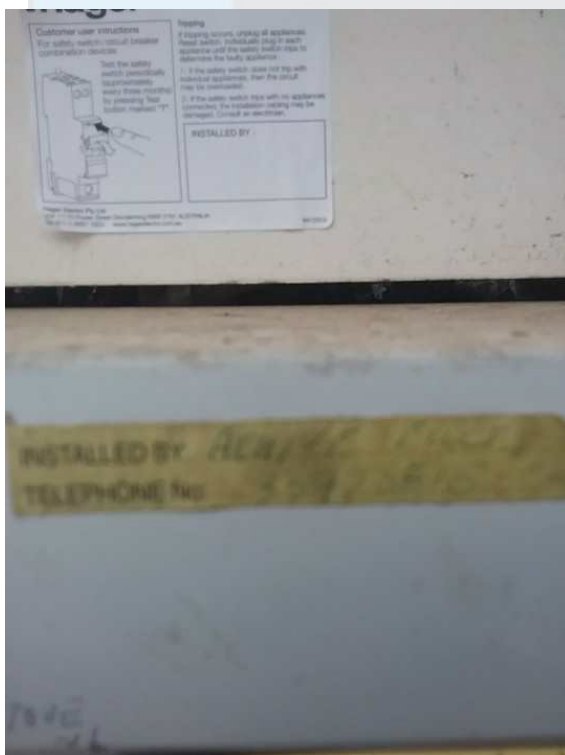
There is an Earth Leakage Circuit Breaker (Safety Switch) installed however, the operation or adequacy was not tested and is not commented on. I recommend that you have a licensed Electrician check that the Safety Switch is installed correctly and works. NB A Safety Switch should be tested monthly (please make arrangements for testing as required).

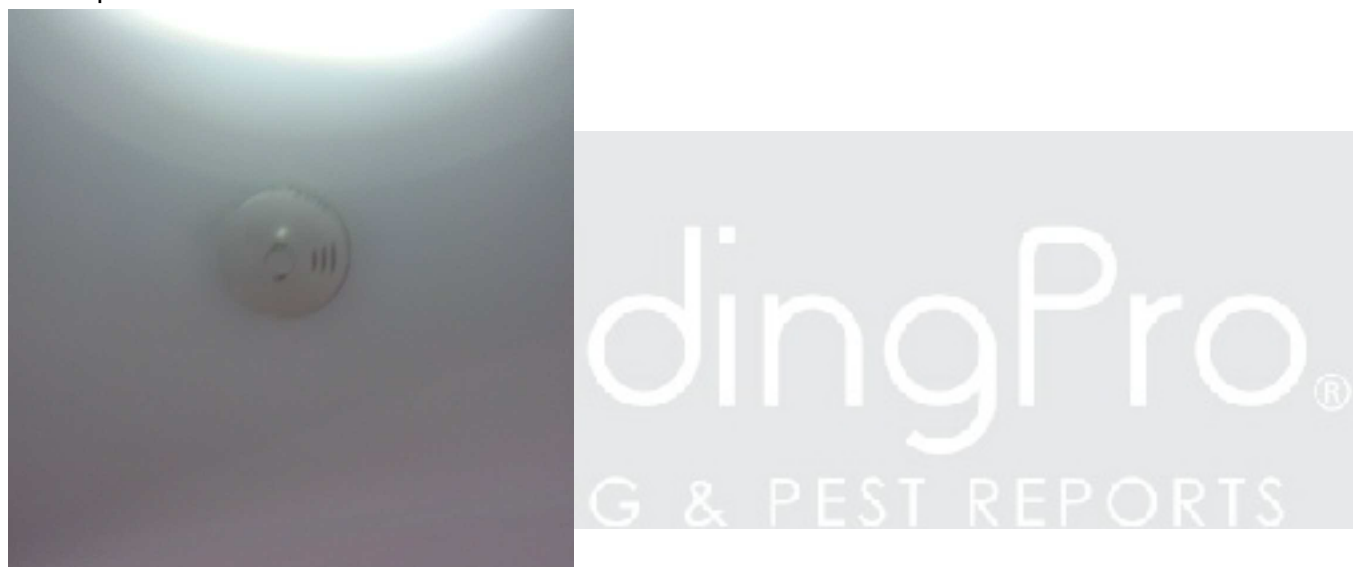
Smoke alarm(s) are fitted however the operation or adequacy was not tested and is not commented on. I recommend that you arrange for Smoke Alarms to be checked by a licensed Electrician or suitably qualified Smoke Alarm Technician and then maintained annually on a maintenance contract. NB Current law requires Hardwired and interconnected Photoelectric Smoke alarms.

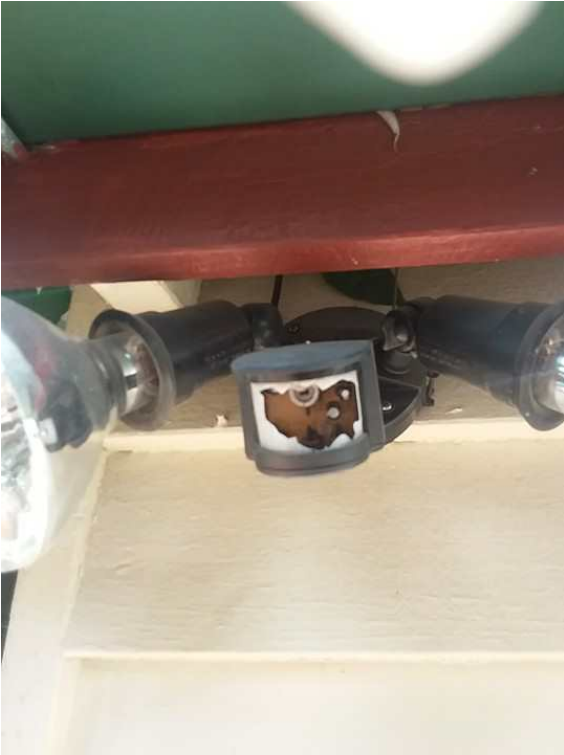
Electrical cabling is not encased within conduit. This is a potential Major Safety Hazard and should be rectified by a licensed Electrician without delay.

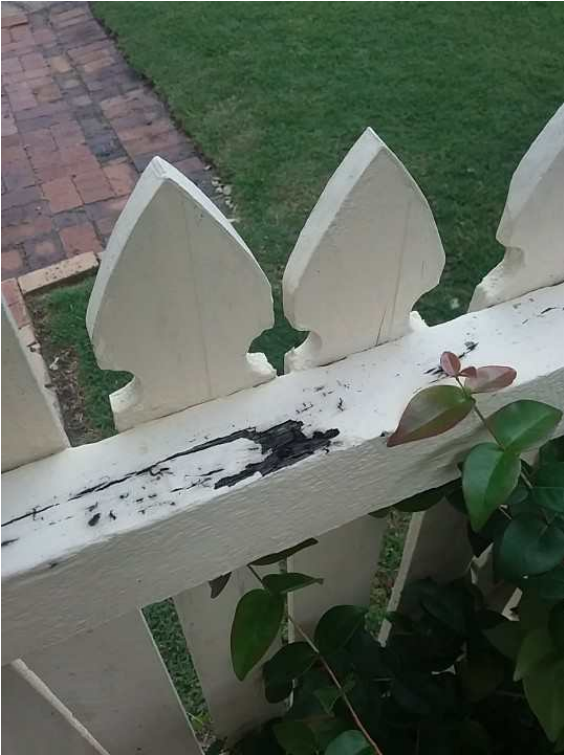
Evidence of damage resulting from active wood decay fungi (wood rot) was found. Please read the report.

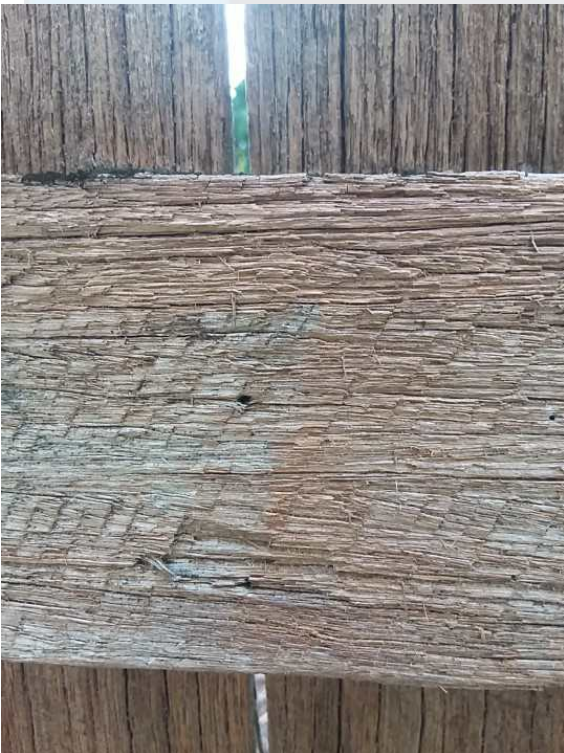
Evidence (flight holes) of borers of dry seasoned timbers or borer damage was found. Please read the report.

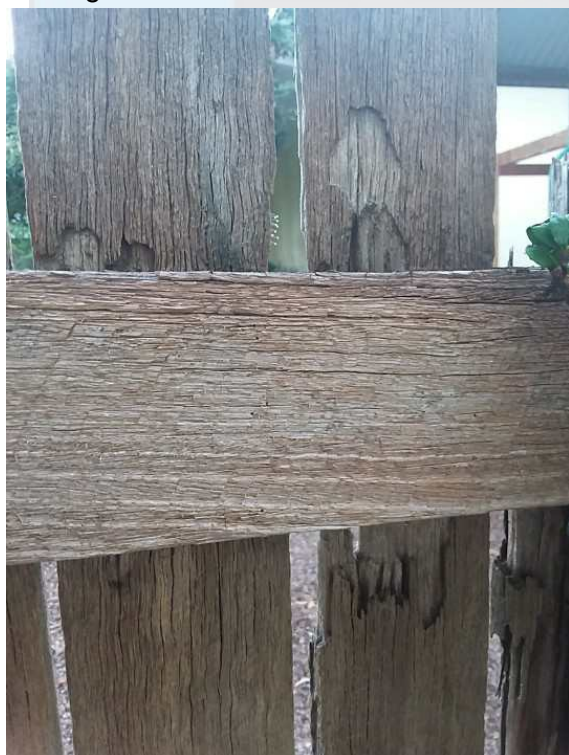
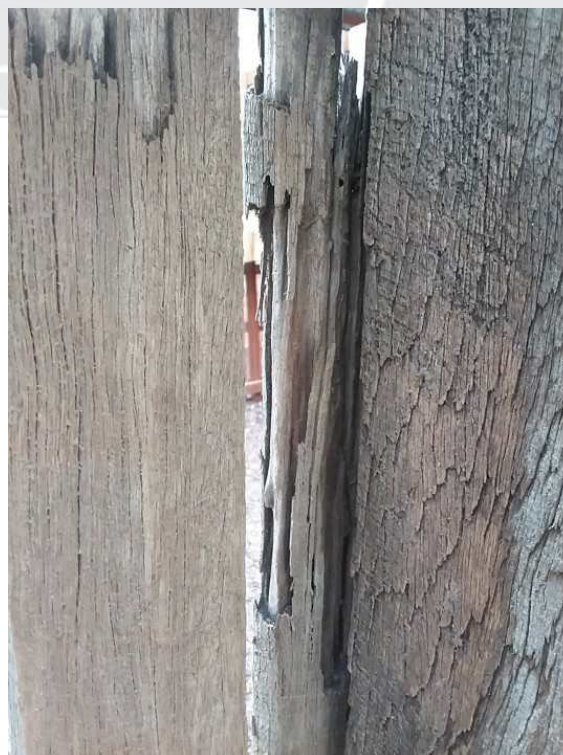
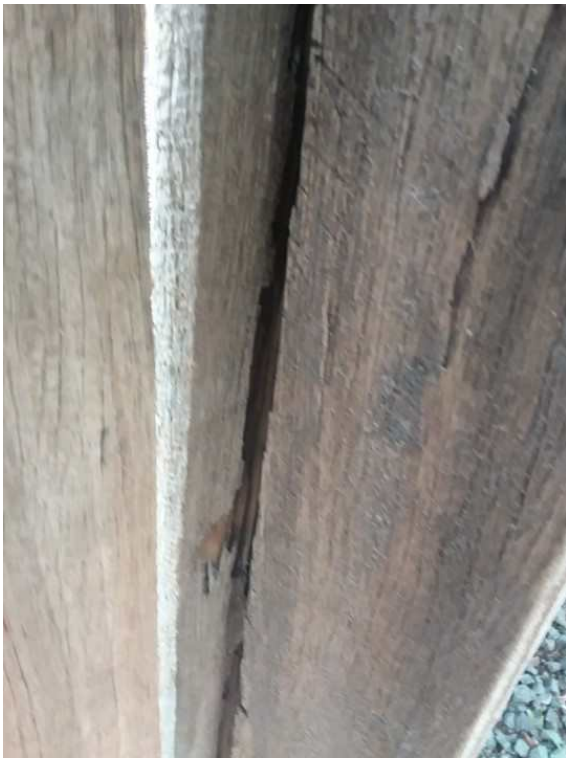
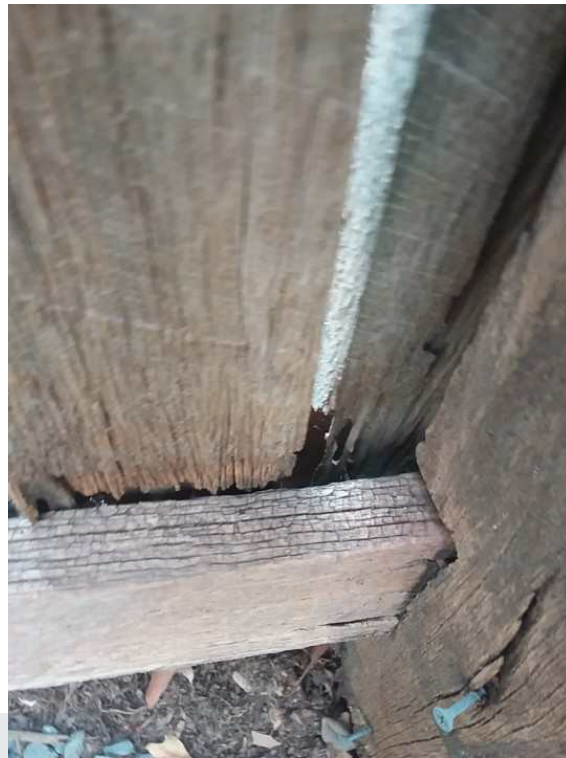
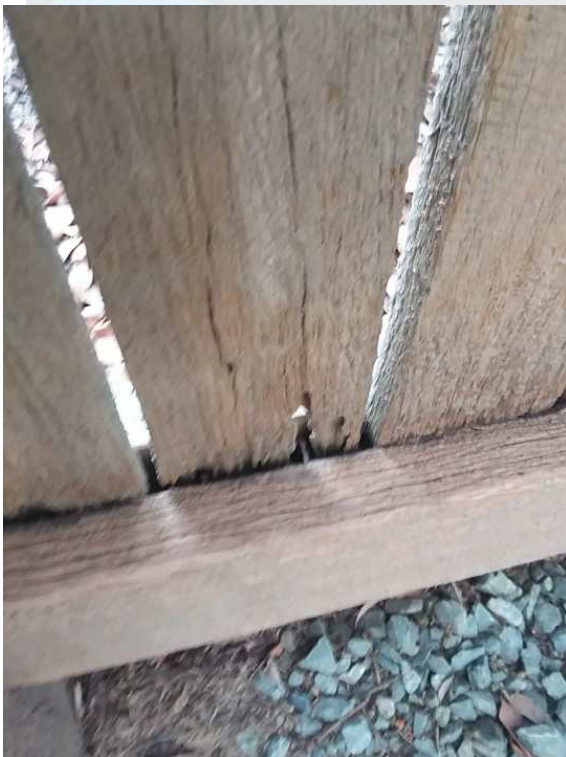
fencing timbers

Yes - Inspection revealed currently inactive termite attack (damaged timbers and/or termite workings) within this area including but not necessarily limited to the following timbers and the areas listed below.

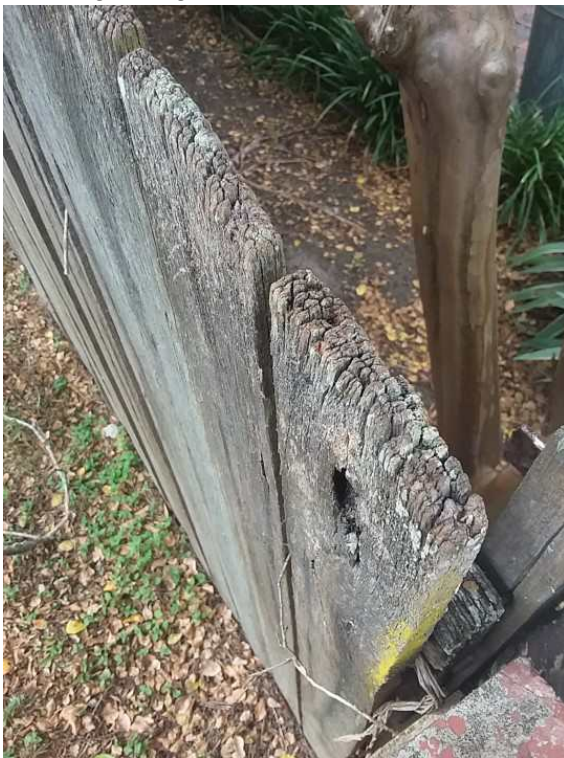
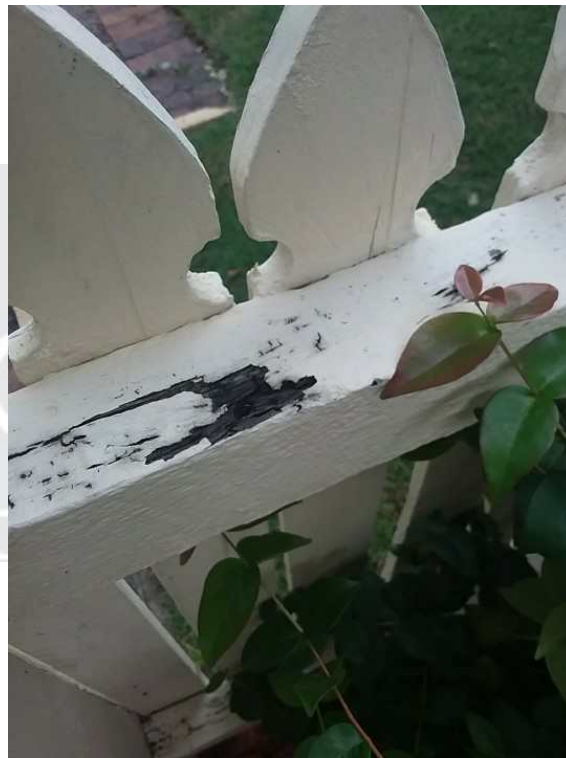
Fencing and gate timbers

Minor to Moderate fungal decay damage was found in various sections of timber, the decay is non-structural. Repair or replacement is required. Consult a licensed tradesperson about the scope of works and cost to rectify.
