## Building and Pest Inspection Reports

In accordance with AS 4349.0 and AS 4349.3

**7890 Main Street, Sample CBD**

The purpose of the inspection is to identify the Major Defects and Safety Hazards associated with  
SAMPLE Blg REPORT 100 year old 3 Storey Hotel

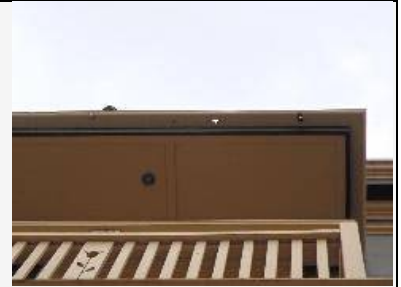
- The gutter does not have adequate fall to the roof over the front balcony area. Water does not run to the downpipe at the southern end and instead is dripping onto the footpath. A licensed Plumber should further investigate this matter and provide a quotation for the necessary rectification.
- Some rust to sections of gutter on the Northern elevation. This is a Minor Defect. Repair or replacement is required. Consult a licensed tradesperson about the scope of works and cost to rectify.

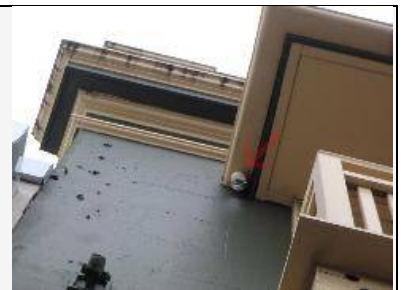
There is only one downpipe pop to the roof over the front balcony area. There is no downpipe installed. Water may drop onto people. A licensed Plumber should further investigate this matter and provide a quotation for the necessary rectification.

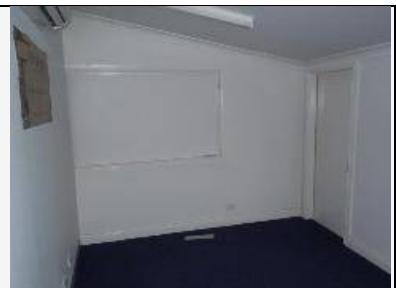
The ceiling height in this room is less than the 2.4m required by the Building Code. You should have this matter further investigated by an appropriately qualified Building Certifier prior to the contract becoming unconditional.

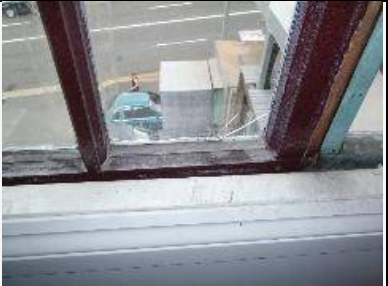
The condition of the windows is generally fair. Crack to glass pane/s. This is a safety hazard. Have a licensed Glazier replace affected glass promptly. Window opening is less than 1m above the adjacent floor level. This is a potential safety hazard because a child could climb out of the window. Repair or replacement is required. Consult a licensed tradesperson about the scope of works and cost to rectify. NB The low cost repair is for the window opening to be limited to a 120mm width opening as this would then meet the requirements of the Building Code.

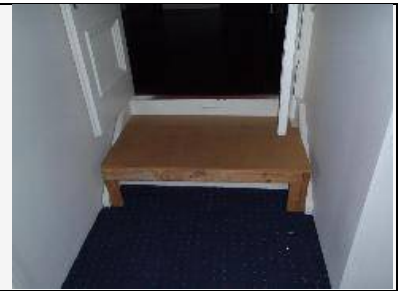
The condition of the floor is generally good. Loose step/shelf installed? Repair or replacement is required. Consult a licensed tradesperson about the scope of works and cost to rectify.

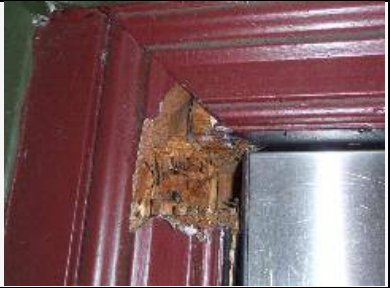
Damage to external woodwork of the door. This is a Minor Defect. Repair or replacement is required. Consult a licensed tradesperson about the scope of works and cost to rectify.

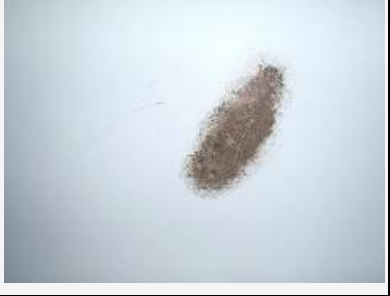
There is a water leak stain on the ceiling. The moisture meter has found that the stain contains excessive moisture. This may mean that the leak is still current. We recommend that a plumber be employed to find the cause of the leak and rectify the problem immediately to prevent further damage.

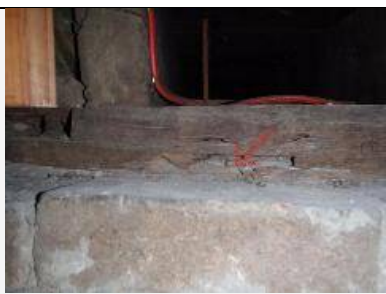
Sections of termite damage to wall frame in this area. Repair or replacement is required. Consult a licensed tradesperson about the scope of works and cost to rectify.

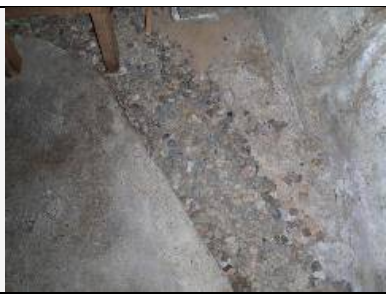
Floor has been partly dug up to install plumbing pipes. Gravel covers the trenches. Repair or replacement is required. Consult a licensed tradesperson about the scope of works and cost to rectify.

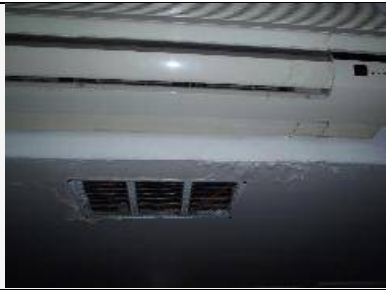
Holes in the ceiling. Item is damaged. Repair or replacement is required. Consult a licensed tradesperson about the scope of works and cost to rectify.

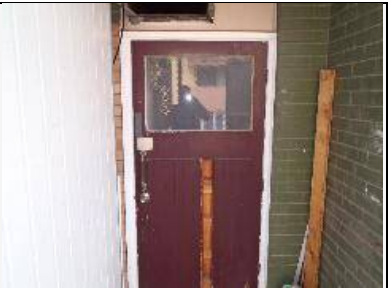
External timber door is damaged. Repair or replacement is required. Consult a licensed tradesperson about the scope of works and cost to rectify.

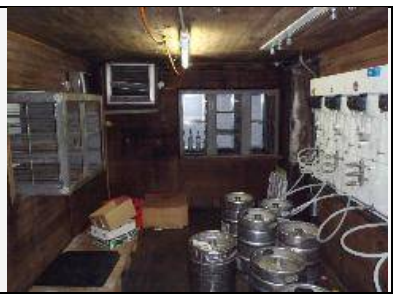
Water damage to ceiling and walls. This is a Minor Defect. Nb This equipment not included in this inspection report.

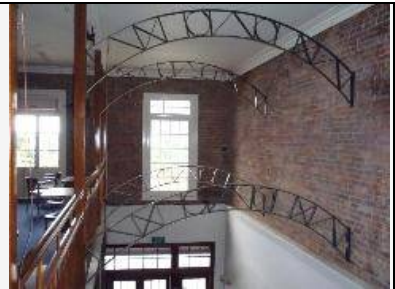
The condition of the ceiling is generally fair. Cracking is present to cornices. This will require maintenance.

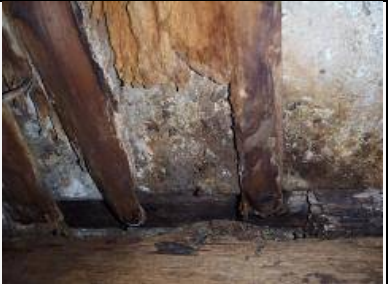
Timber floor has delignification, decay and water staining in areas. Repair or replacement is required. Consult a licensed tradesperson about the scope of works and cost to rectify.

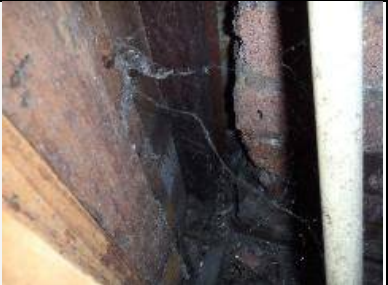
Walls are not vermin proofed and may allow concealed termite entry. Residual mould and efflorescence noted to brick walls. This creates an unhealthy environment. Small pieces of brick and dust from bricks on the floor where fretting has caused damage. Fretting is also caused by dampness. Repair or replacement is required. Consult a licensed tradesperson about the scope of works and cost to rectify.

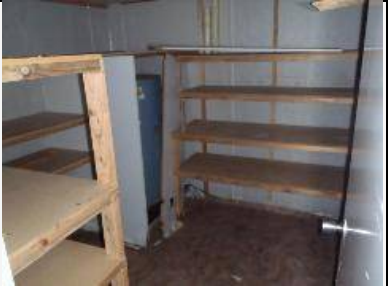
Not well built. Gaps in walls and ceiling may allow water entry. Repair or replacement is required. Consult a licensed tradesperson about the scope of works and cost to rectify.

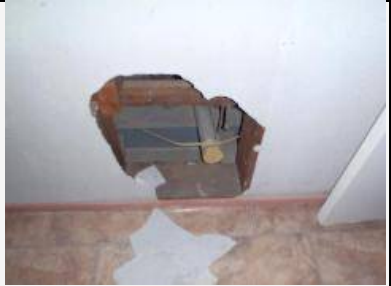
Hole in the wall. This is a Minor Defect. Repair or replacement is required. Consult a licensed tradesperson about the scope of works and cost to rectify.

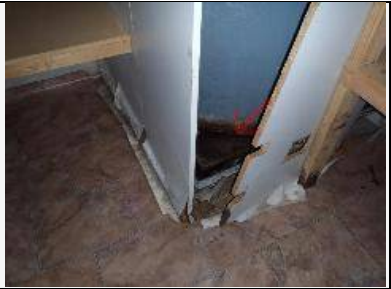
Joinery around the Hot water service is damaged from water leaks. Repair or replacement is required. Consult a licensed tradesperson about the scope of works and cost to rectify.

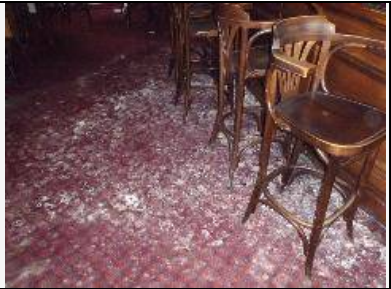
There is a lot of mould to the carpet and underlay from a leaking appliance. This is unhealthy. Repair or replacement is required. Consult a licensed tradesperson about the scope of works and cost to rectify.

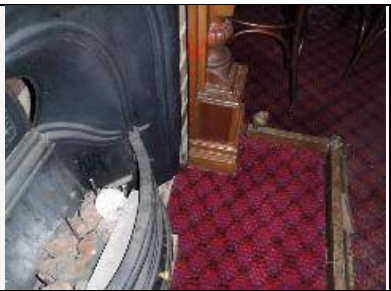
Fire place not level with the wall. Wall may be out of plumb. Damage to fire place surround. Fireplace not tested as part of this inspection. I recommend that all fireplaces be tested and checked by an expert before being put into use.

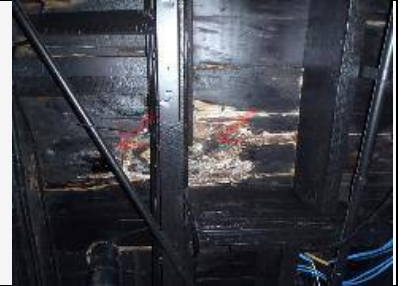
There is no ceiling lining. The underside of the floor has sections of decay and drywood termite damage that have weakened the floor. Repair or replacement is required. Consult a licensed tradesperson about the scope of works and cost to rectify.

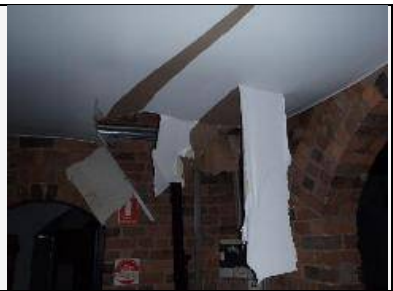
The condition of the ceiling is generally poor. A large section of the ceiling has been roughly ripped down. This may have been to access the damaged floor timbers above this area. Repair or replacement is required. Consult a licensed tradesperson about the scope of works and cost to rectify.

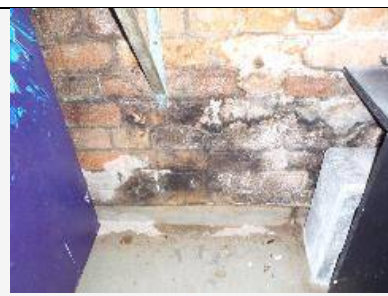
Residual mould and efflorescence noted to brick walls. This creates an unhealthy environment. Small pieces of brick and dust from bricks on the floor where fretting has caused damage. Fretting is also caused by dampness. Repair or replacement is required. Consult a licensed tradesperson about the scope of works and cost to rectify.

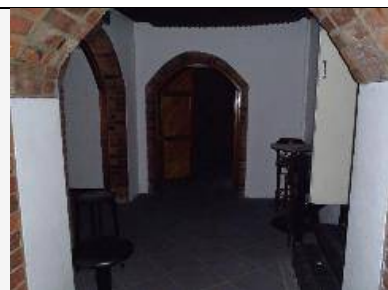
Basement level.

Corrugated steel sheet ceiling lining is in fair condition. Floor above this area has sections of timber pest damage. Repair or replacement is required. Consult a licensed tradesperson about the scope of works and cost to rectify.

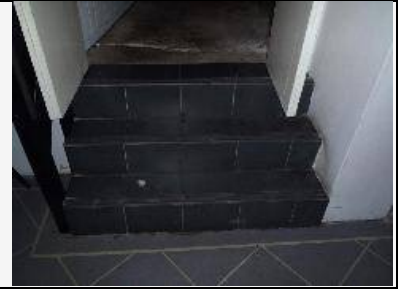
Stair risers exceed 190mm. This condition has made this component a potential safety hazard. Suitable alterations should be carried out without delay to make this component safe.

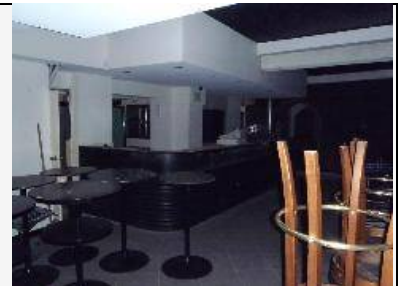
Stage covers a section of timber floor area. Inspection within this room was restricted by furniture. It is strongly recommended that full access be gained as this could be concealing building defects or faults.

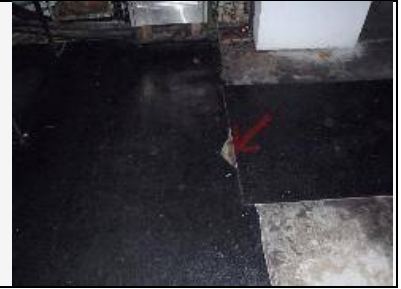
Only part of bar area floor has floor coverings. Floor coverings to the bar area are damaged in sections and could be a tripping hazard. This condition has made this component a potential safety hazard. Suitable alterations should be carried out without delay to make this component safe.

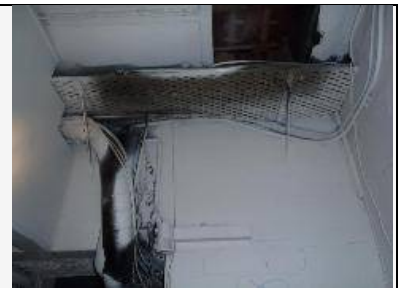
Peeling paint was noted to ceilings. Repaint is required. Holes in the ceiling. Repair or replacement is required. Consult a licensed tradesperson about the scope of works and cost to rectify.

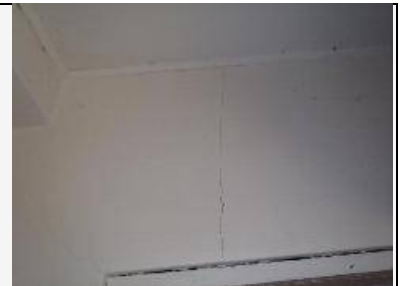
- There are some hairline Appearance cracks in walls at joins in the wall sheets. This is a Minor Defect. This defect affects the appearance of this component. Repair is required. Consult a licensed tradesperson about the scope of works and cost to rectify.
- Impact damage to cement sheet wall

sections. Repair or replacement is required. Consult a licensed tradesperson about the scope of works and cost to rectify.

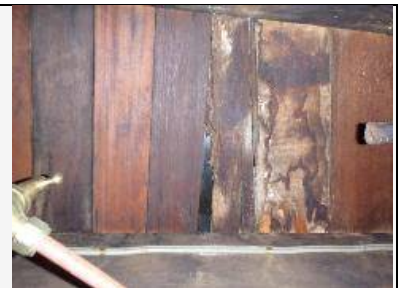
No ceiling lining. Sections of borer damage to the floor above. Repair or replacement is required. Consult a licensed tradesperson about the scope of works and cost to rectify.

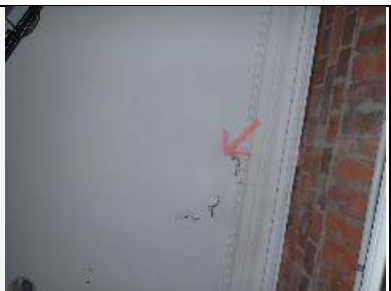
The condition of the ceiling is generally fair. A large section of leak damage noted to the Northern side of the room. Refer to sample photo. A licensed Roofer should further investigate this matter and provide a quotation for the necessary rectification.

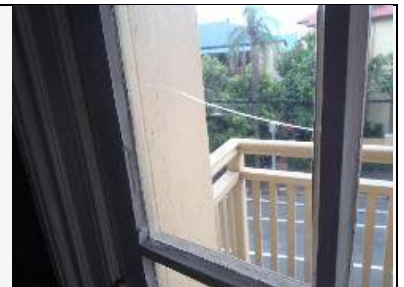
The condition of the door/s is generally fair. Some cracked glass to french doors than open to the balconies. Refer to sample photo. Repair or replacement is required. Consult a licensed tradesperson about the scope of works and cost to rectify.

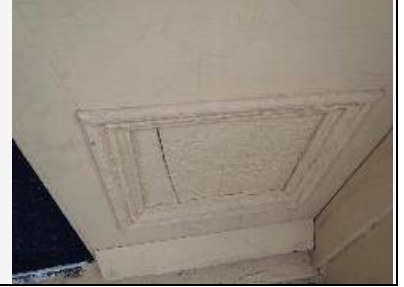
Doors are old and have much wear and tear. Refer to sample photo.

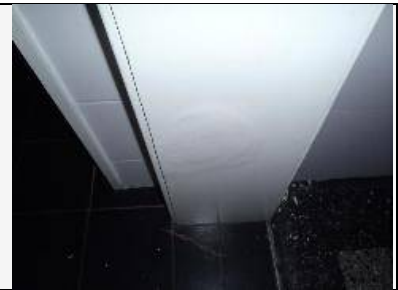
Water damage to a section of jamb. Refer to sample photo. Repair or replacement is required. Consult a licensed tradesperson about the scope of works and cost to rectify.

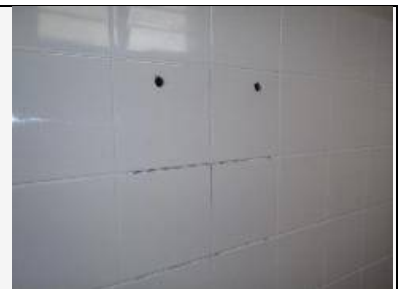
Some cracked tiles noted. Some holes in the tiled walls. Repair or replacement is required. Consult a licensed tradesperson about the scope of works and cost to rectify. Tiles are not laid in a workmanlike manner. This mainly affects the appearance of the tiles. If a better appearance is desired then the tiles will have to be removed and new tiles laid. Consult a licensed tiler for this work. Sections of grout and cracked and or missing to the wall tiles. This is likely to allow the passage of moisture that can damage other components behind the tiles. Excessive moisture can also create conditions conducive to termites. A licensed floor tiler should Re-grout tiles.

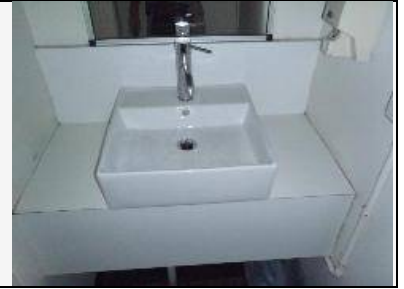
The basin and taps appear serviceable. Some loose mixers noted. This is a Minor Defect. Repair or replacement is required. Consult a licensed tradesperson about the scope of works and cost to rectify.

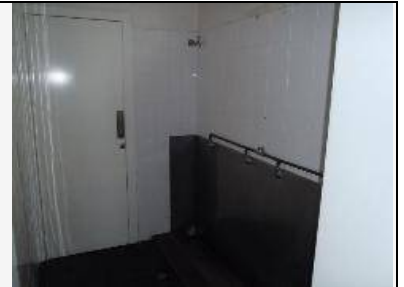
- One broken toilet seat. This is a Minor Defect. Repair or replacement is required. Consult a licensed tradesperson about the scope of works and cost to rectify.
- Cistern has been removed to the urinal. Repair or replacement is required. Consult a licensed tradesperson about the scope of works and cost to rectify. A licensed Plumber should further investigate this matter and provide a quotation for the necessary rectification.

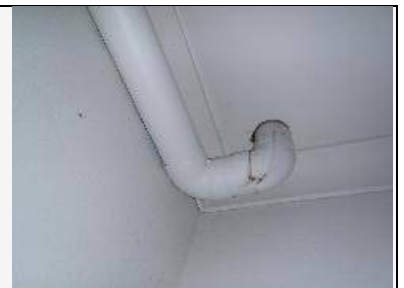
The condition of the ceiling is generally good. Leak stains around pipe penetrating through the ceiling. Refer to sample photo. A licensed Plumber should further investigate this matter and provide a quotation for the necessary rectification.

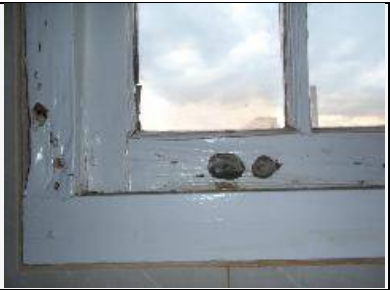
Fungal decay to rear elevation window. Repair or replacement is required. Consult a licensed tradesperson about the scope of works and cost to rectify.

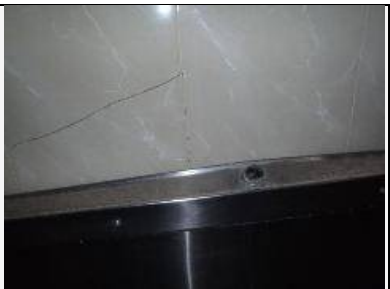
The condition of the wall tiles is generally good. A few cracked wall tiles. Repair or replacement is required. Consult a licensed tradesperson about the scope of works and cost to rectify.

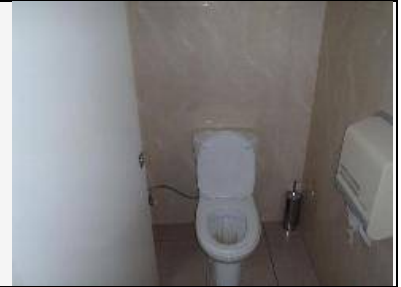
The toilet appears to be in good condition. Urinal cistern missing. A licensed Plumber should further investigate this matter and provide a quotation for the necessary rectification.

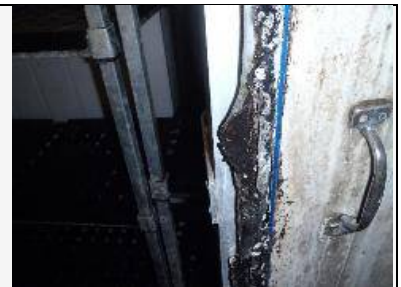
Cool room is leaking water and door seal is damaged. You should have this matter further investigated by an appropriately qualified expert prior to the contract becoming unconditional.

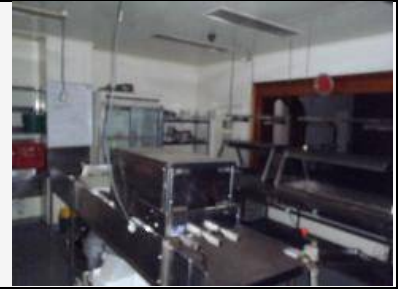
The condition of the ceiling is generally fair. Some minor damage noted.

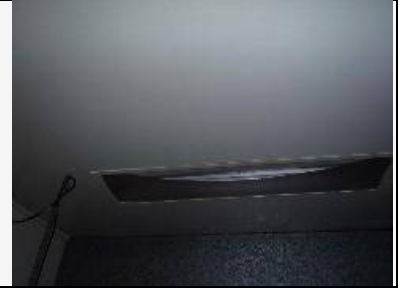
Light cover is loose. This is a Minor Defect. Repair or replacement is required. Consult a licensed tradesperson about the scope of works and cost to rectify.

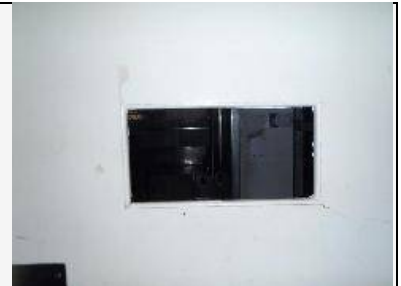
The condition of the door is generally poor. Glass is missing and door is damaged. A new door will be required.

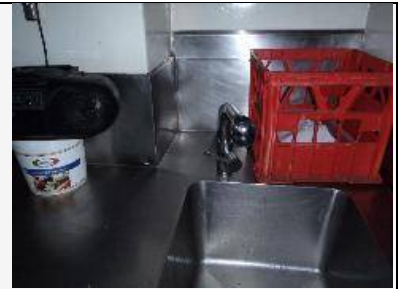
Appears serviceable. Flickmixer is leaking. A licensed Plumber should further investigate this matter and provide a quotation for the necessary rectification.

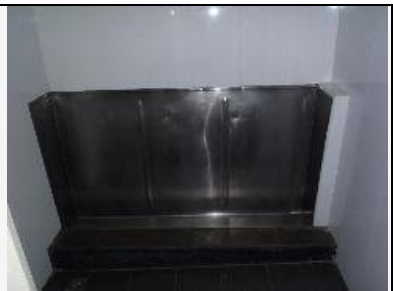
Urinal cistern is missing. Repair or replacement is required. Consult a licensed tradesperson about the scope of works and cost to rectify.

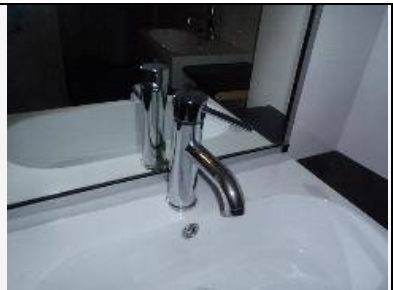
- The basin and taps appear serviceable. Spout is loose. This is a Minor Defect. Repair or replacement is required. Consult a licensed tradesperson about the scope of works and cost to rectify.
- Workmanship on basin installation is below standard. This is a Minor Defect.

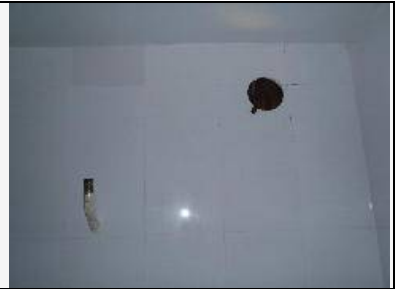
Exhaust fans missing. Repair or replacement is required. Consult a licensed tradesperson about the scope of works and cost to rectify.

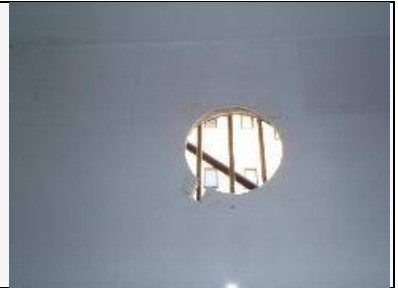
Exhaust fans missing. Repair or replacement is required. Consult a licensed tradesperson about the scope of works and cost to rectify.

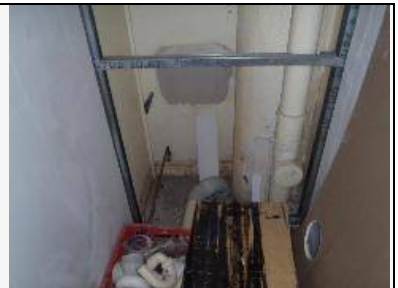
Section of wall missing to toilet that is not installed. Repair or replacement is required. Consult a licensed tradesperson about the scope of works and cost to rectify.

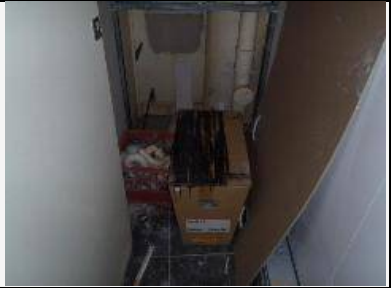
Toilet not installed. A licensed Plumber should further investigate this matter and provide a quotation for the necessary rectification.

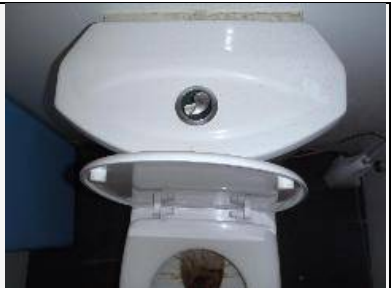
One toilet has a broken flush button and does not operate. Repair or replacement is required. Consult a licensed tradesperson about the scope of works and cost to rectify.

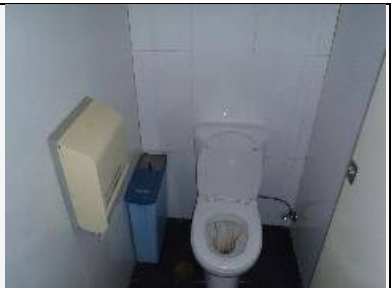
No ventilation to one toilet. Repair or replacement is required. Consult a licensed tradesperson about the scope of works and cost to rectify.

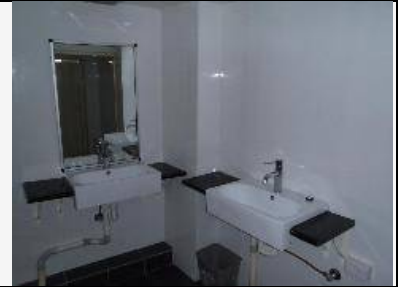
One mirror missing to a basin. This is a Minor Defect. Repair or replacement is required. Consult a licensed tradesperson about the scope of works and cost to rectify.

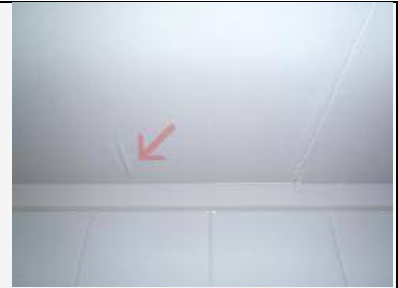
Plywood ceiling is water damaged. Hole in the ceiling. Repair or replacement is required. Consult a licensed tradesperson about the scope of works and cost to rectify.

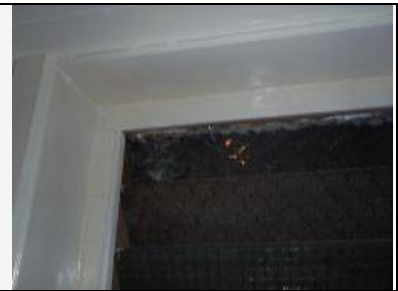
Missing louvres. This is a Minor Defect. Repair or replacement is required. Consult a licensed tradesperson about the scope of works and cost to rectify.

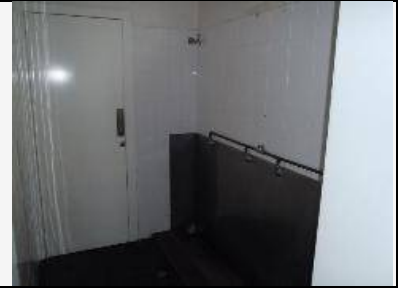
The toilet has constantly running water, a licensed plumber should be called to make further evaluation and repairs as required. Cistern missing to the urinal. A licensed Plumber should further investigate this matter and provide a quotation for the necessary rectification.

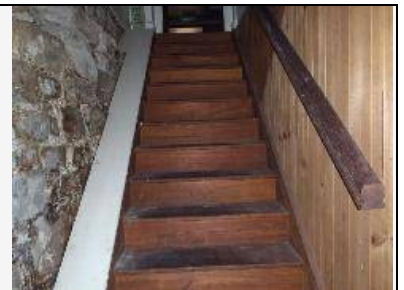
The stairs are constructed primarily from timber the overall condition of these stairs is good. Refer to sample photo of stairs from basement to Ground floor level.

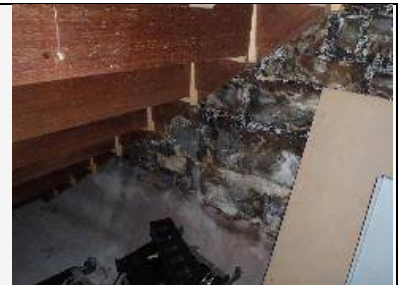
- An inspection of the storeroom/cupboard below the stairs was restricted by stored goods. I recommend that full access be gained and this area inspected as it could be concealing defects or Building faults. Refer to sample photo.
- Residual mould and efflorescence noted to stone walls. This creates an unhealthy environment. Small pieces of brick and dust from bricks on the floor where fretting has caused damage. Fretting is also caused by

dampness. Repair or replacement is required. Consult a licensed tradesperson about the scope of works and cost to rectify.

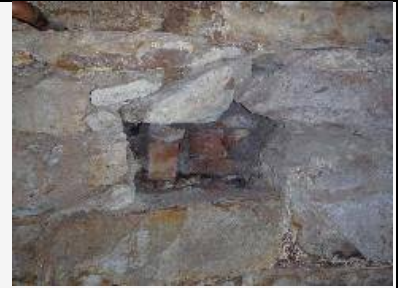
Walls to the stairwell area from Basement to first floor level. Residual mould and efflorescence noted to stone walls. This creates an unhealthy environment. Small pieces of brick and dust from bricks on the floor where fretting has caused damage. Fretting is also caused by dampness. Also there are missing stones. Refer to sample photo. Repair or replacement is required. Consult a licensed tradesperson about the scope of works and cost to rectify.

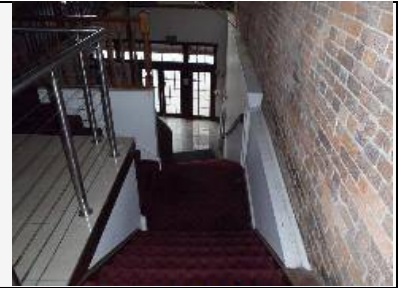
Stairs squeak when used. This is a minor defect. Repair or replacement is required. Consult a licensed tradesperson about the scope of works and cost to rectify.

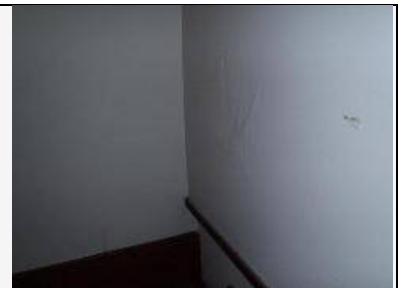
Poor patching to wall of stairwell on the Northern side of the building. This is a Minor Defect. Repair or replacement is required. Consult a licensed tradesperson about the scope of works and cost to rectify.

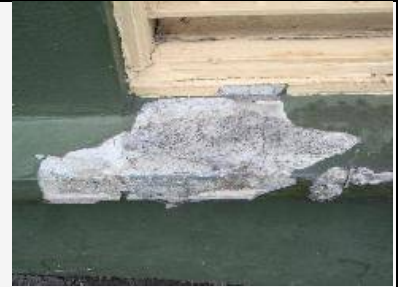
Paint is deteriorating to various sections of previously painted external surfaces. Rear extension to the building is not painted. This can expose the building element to the weather and result in accelerated deterioration and increase the costs of repair and re-painting. I recommend you consult a licensed Painter about the necessity and cost of repainting. Refer to sample photo.

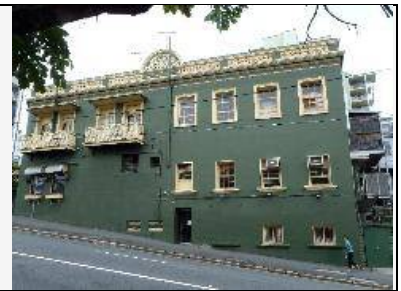
The height of some walls limited the ability to closely inspect the condition of the building elements that are more than 3.6m above the ground level.

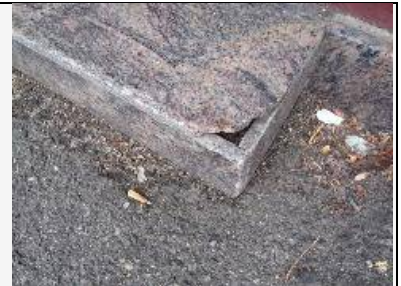
- Small section of cracked concrete plinth to the SE corner. This is a Minor Defect. Repair or replacement is required. Consult a licensed tradesperson about the scope of works and cost to rectify.
- Small section of cracked stone step to the SE corner entry at Ground level. Refer to sample photo. This is a Minor Defect. Repair or replacement is required. Consult a licensed tradesperson about the scope of works and cost to rectify.

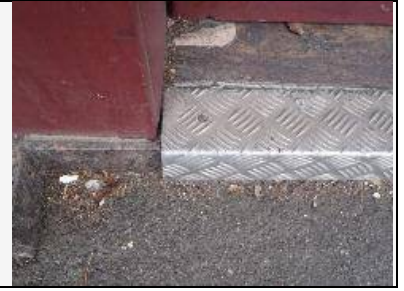
Section of folded chequerplate to the threshold at the SE corner is bent. Item is damaged. This is a Minor Defect. Repair or replacement is required. Consult a licensed tradesperson about the scope of works and cost to rectify.

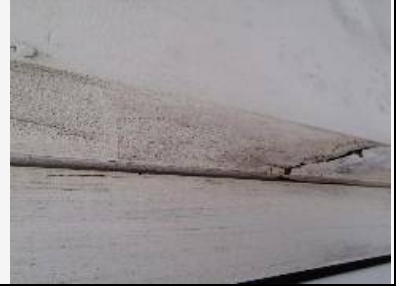
Decay to wall trims on the Southern elevation. Refer to sample photo. Repair or replacement is required. Consult a licensed tradesperson about the scope of works and cost to rectify.

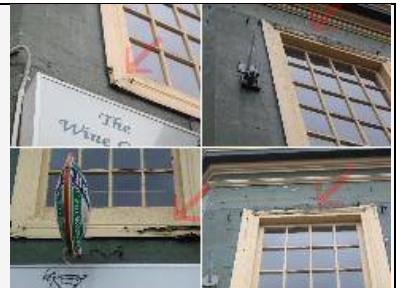
Fungal decay to architrave around the large feature window to the NE corner of the building. Refer to sample photos. This is a Minor Defect. Repair or replacement is required. Consult a licensed tradesperson about the scope of works and cost to rectify.

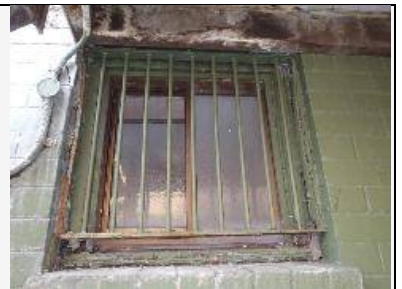
Fungal decay to window reveals and sills on the Western elevation. Repair or replacement is required. Consult a licensed tradesperson about the scope of works and cost to rectify.

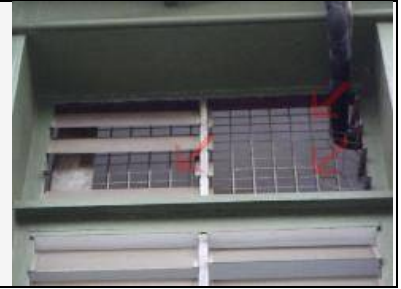
Glass louvres are missing to steel windows on the Northern elevation. Refer to sample photo. This is a Minor Defect. Repair or replacement is required. Consult a licensed tradesperson about the scope of works and cost to rectify.

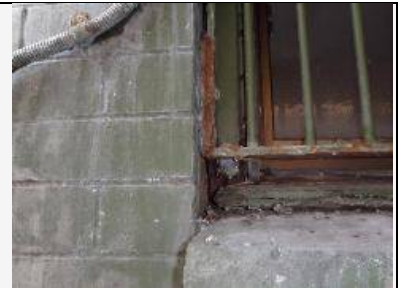
Rust to sections of security bars. Item is damaged. Repair or replacement is required. Consult a licensed tradesperson about the scope of works and cost to rectify.

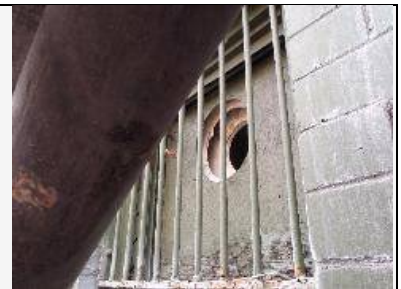
Holes in boarded up windows to toilets will allow entry of vermin and water. Repair or replacement is required. Consult a licensed tradesperson about the scope of works and cost to rectify.

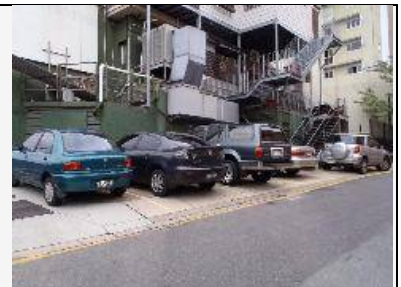
There is a concrete parking area located to the rear (Western) elevation. The concrete driveway has various shrinkage cracks. These cracks occur when the concrete dries out too quickly after being poured. This is generally considered to be a minor defect. No action required at this time. If concrete subsides this will be a tripping hazard. This area should be monitored to ensure that the condition does not further deteriorate. If further deterioration is noted then replace concrete.

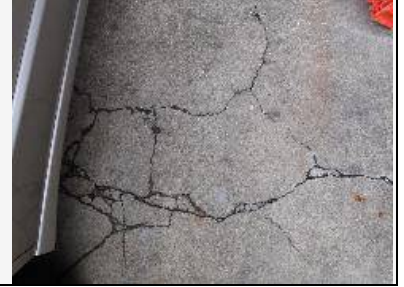
Refer to sample photo of concrete. Linemarking has faded. Repair or replacement is required. Consult a licensed tradesperson about the scope of works and cost to rectify.

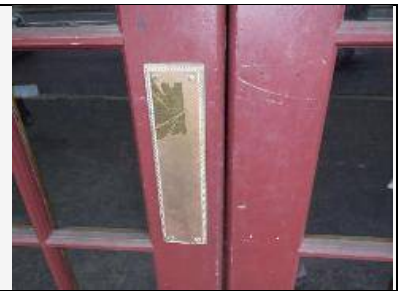
A few doors to the eastern elevation have missing brass push plates. This is a Minor Defect. Repair or replacement is required. Consult a licensed tradesperson about the scope of works and cost to rectify.

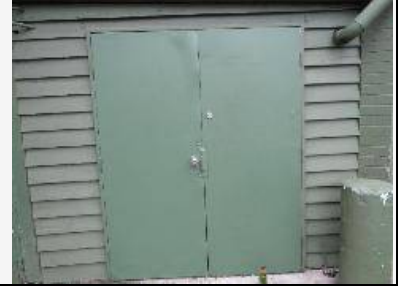
Pair of doors serving the Switchboard room are water damaged and warped. Refer to sample photo. Repair or replacement is required. Consult a licensed tradesperson about the scope of works and cost to rectify.

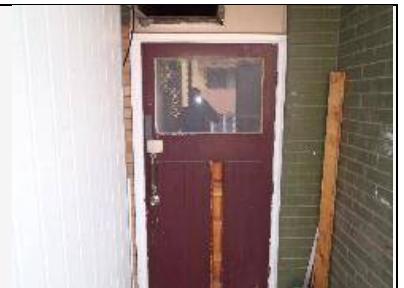
Rear door to the dining area is damaged on the ground level. Repair or replacement is required. Consult a licensed tradesperson about the scope of works and cost to rectify.

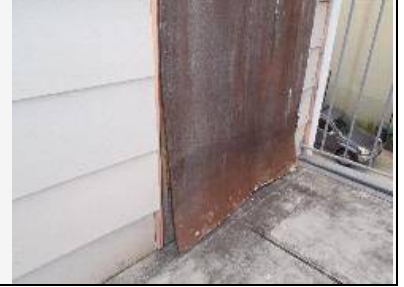
Rear door to the rear elevation (west) is damaged. Repair or replacement is required. Consult a licensed tradesperson about the scope of works and cost to rectify.

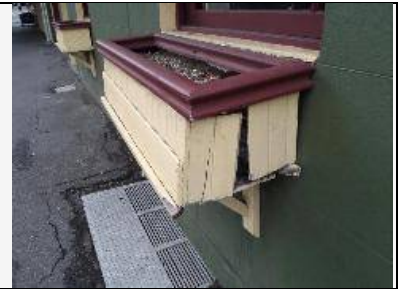
Timber planter boxes are damaged in sections and may collapse. These could be a safety hazard. Repair or replacement is required. Consult a licensed tradesperson about the scope of works and cost to rectify.

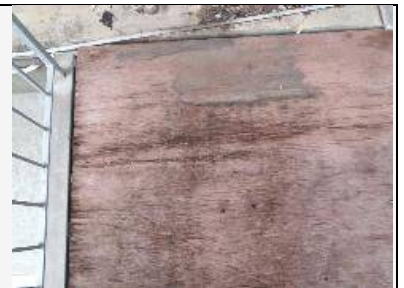
At the rear of the building (Western elevation). Galvanised steel stairs are generally in a good condition. Landings are made of plywood and cement sheet. Plywood is decaying and cement sheets have large gaps. This condition has made this component a potential safety hazard. Suitable alterations should be carried out without delay to make this component safe.

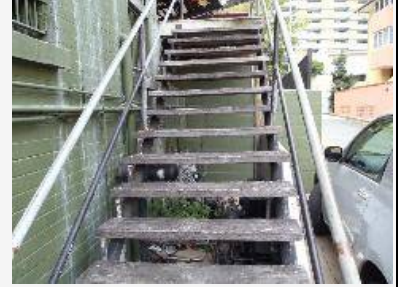
- The paintwork is deteriorating to the sections of the stairs, repaint is required. Refer to sample photo.
- The gap between each tread is excessive. This is unsafe and may cause a person to fall and injure themselves. It is recommended that the tread gaps be reduced to less than 125mm to reduce the risk of an accident. I recommend that you contact a licensed tradesperson and have this problem rectified without delay.
- The gap between the handrail and the stairs is excessive. This may allow a small child to fall through the handrail. An intermediate rail with gaps not exceeding 125mm should be installed for safety or a young child could fall through the gap. I recommend that you contact a licensed tradesperson and have this problem rectified without delay.

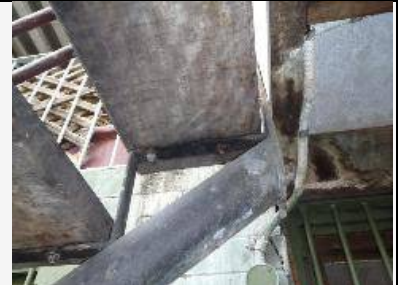
Various sections of steel have moderate to extensive rust. Replace rusted sections immediately for safety. This is unsafe and may cause a person to fall and injure themselves. Repair or replacement is required. Consult a licensed tradesperson about the scope of works and cost to rectify.

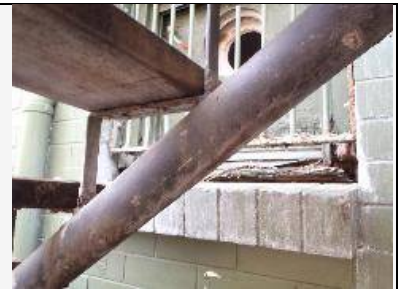
Some loose stair treads to the rear stairs. This condition has made this component a potential safety hazard. Suitable alterations should be carried out without delay to make this component safe. Repair or replacement is required. Consult a licensed tradesperson about the scope of works and cost to rectify.

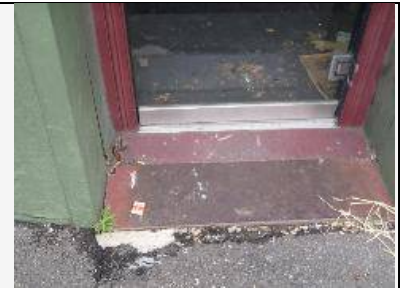
Surface water is likely to run into the building in various locations. i.e. Western elevation to the Ground floor level where external concrete deck is the same level as the internal floor level (and timber is embedded below floor level, the Northern elevation door to the Basement level, The Old Keg delivery shaft to the Eastern (front) elevation (accessible from the door in the basement level. Refer to sample photo. A licensed Plumber/Drainer should further investigate this matter and provide a quotation for the necessary rectification.

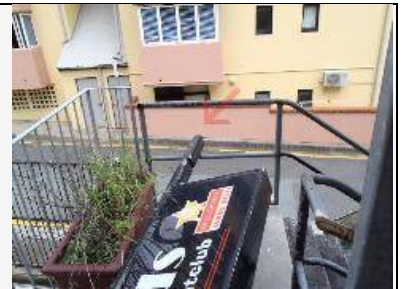
The balustrades either do not appear to comply with safety standards or could pose a safety hazard. The height of railings and spacing between railings should be checked to ensure that they comply. This must be further investigated and rectified as required.

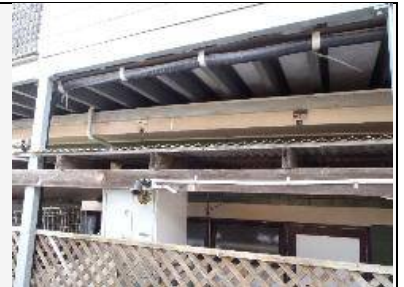
No gutter fitted to the rear elevation of the roof. Refer to sample photo. Repair or replacement is required. Consult a licensed tradesperson about the scope of works and cost to rectify. Balustrade is made of lattice which is not strong enough to be used as a balustrade. This condition has made this component a potential safety hazard. Suitable alterations should be carried out without delay to make this component safe. Repair or replacement is required. Consult a licensed tradesperson about the scope of works and cost to rectify.

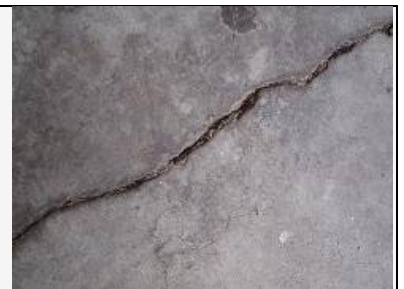
There are Appearance cracks up to 3mm in width to the suspended concrete floor slab. This area should be monitored to ensure that the condition does not further deteriorate. If further deterioration is noted then refer the matter to a Structural Engineer for further investigation.

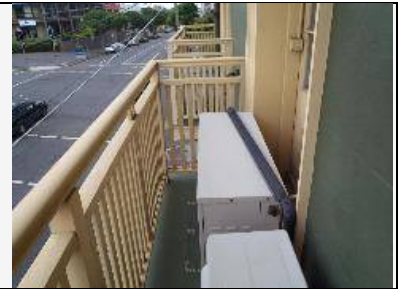
The balustrades are not strong enough in my opinion. I recommend replacing them with steel balustrades (with Council permission). Brackets could be used to connect handrails to posts and balusters could be connected to rails with stronger connections as an interim measure to improve safety.

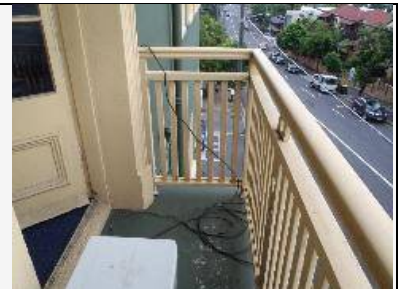
There are gaps in the cement sheet flooring panels that will allow penetration of water that will eventually damage the floor joists. Repair or replacement is required. Consult a licensed tradesperson about the scope of works and cost to rectify.

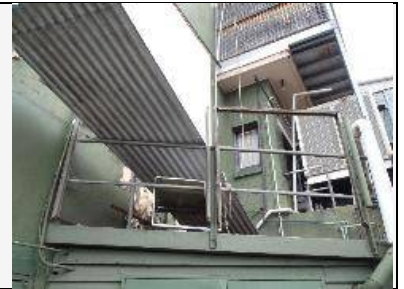
The balustrades either do not appear to comply with safety standards or could pose a safety hazard. The height of railings and spacing between railings should be checked to ensure that they comply. This must be further investigated and rectified as required.

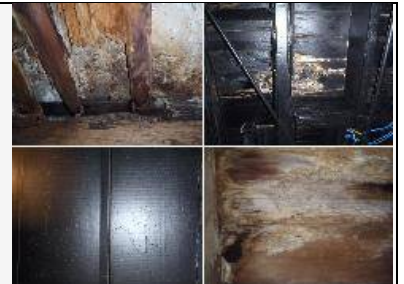
The accessible subfloor framing appears to be adequate. The flooring to the ground floor level (visible in sections from the Basement level) has large sections of decay, delignification, water damage, mould, drywood termite damage, and borer damage. As this floor is painted black and there were no lights to this area at the time of inspection it made finding defects more difficult. An invasive inspection is recommended to determine the full extent of

damage. A licensed Builder should provide a scope of works and quote to rectify this defect.

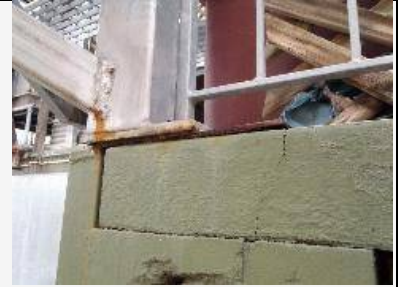
The steel posts/stumps have surface rust at the base of various posts. The rust should be treated with a proprietary rust treatment system i.e. Rust Inhibitor, Rust primer and paint to prolong the life of these steel posts/stumps. Surface drainage should be improved by a licensed plumber to reduce the likelihood of further damage to steel posts/stumps.

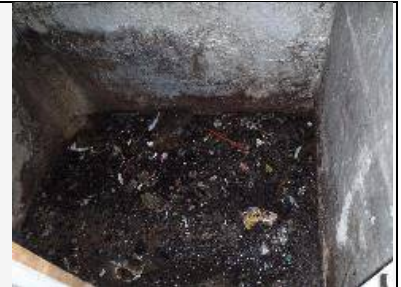
The old keg delivery chute? is collecting water and debris. Refer to sample photo. Water is penetrating through the walls to the basement interior and causing mould damage. Repair or replacement is required. Consult a licensed tradesperson about the scope of works and cost to rectify.

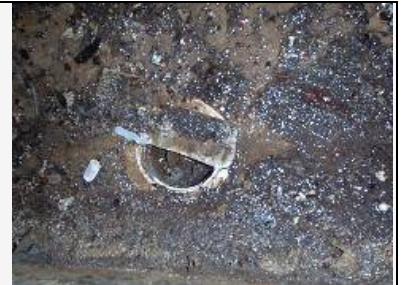
Drain to the old keg delivery chute is blocked. Repair or replacement is required. Consult a licensed tradesperson about the scope of works and cost to rectify.

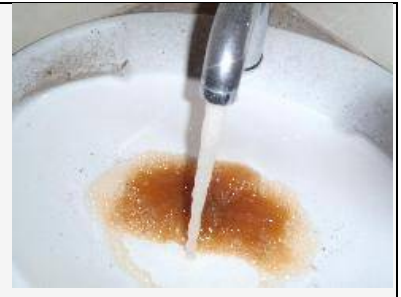
Very light brownish coloured water came out some taps for a second after tap was turned on. This is usually an indication that there is some rust somewhere in the pipes. Have water pipes checked by a licensed plumber as pipes that have rusted internally may have to be replaced. This fault is common in older buildings that have galvanised pipes.

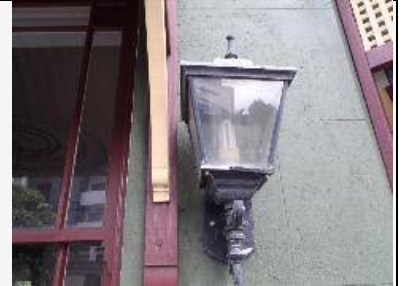
Some damage to coach lights. This is a Minor Defect. Repair or replacement is required. Consult a licensed tradesperson about the scope of works and cost to rectify.

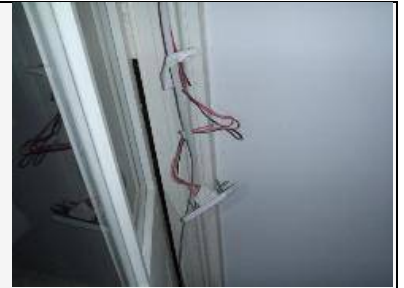
Electrical wiring is suspect/dangerous in areas and should be checked by a licensed Electrician. Refer to sample photo.

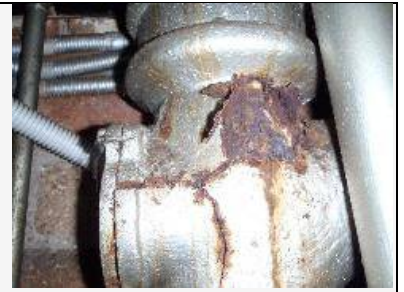
Due to the age of the building, a separate plumbing inspection should be carried out prior to the contract becoming unconditional. Refer to sample photo of rusted cast iron sewer pipes. Rust will eventually cause leaks. A licensed Plumber should further investigate this matter and provide a quotation for the necessary rectification.

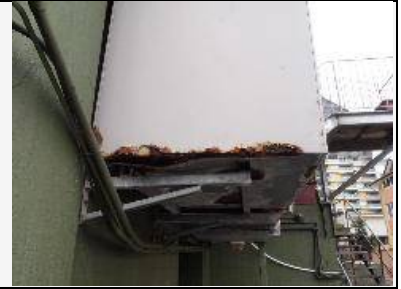
Ductwork to the base of the Mechanical Air handling System is badly corroded. Repair or replacement is required. Consult a licensed tradesperson about the scope of works and cost to rectify.

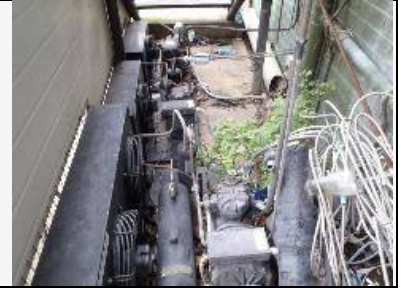
Other pub equipment looks to be in poor condition. You should have this matter further investigated by an appropriately qualified expert prior to the contract becoming unconditional.

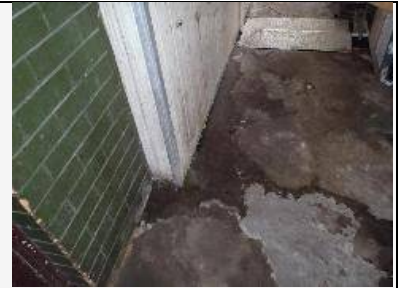
Cool room to first floor level is leaking water. You should have this matter further investigated by an appropriately qualified expert prior to the contract becoming unconditional.
