Building and Pest Inspection Reports

In accordance with AS 4349.0 and AS 4349.3

4567 Sample Hwy, Sampleville

The purpose of the inspection is to identify the Major Defects and Safety Hazards associated with
SAMPLE Blg REPORT 50 year old Factory and Offices

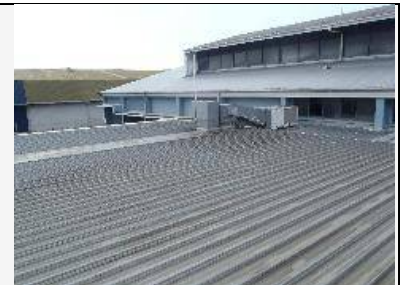
The overall condition of the reasonably accessible roof coverings to the front Office area and Western plane of the factory roof appears to be good. The balance of the roof (and this is most of the roof area) there is extensive surface rust to the roof sheets. Rust can result in roof leaks that can cause damage to the building and stored items within it. Rust will shorten the life of the roof. I suspect that the rusted sections of roof sheets are the original roof and therefore could be approximately 50 years old. This roof may be nearing the end of its serviceable life. A licensed Roofer should further investigate this matter and provide a quotation for the necessary rectification i.e. repair rust or replace rusting roof sections if necessary.

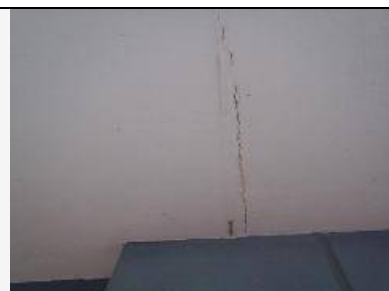
Concrete sun shade to front elevation is cracked in sections and this is allowing the penetration of some dampness. This is a Minor Defect. Repair or replacement is required. Consult a licensed tradesperson about the scope of works and cost to rectify. Refer to sample photo.

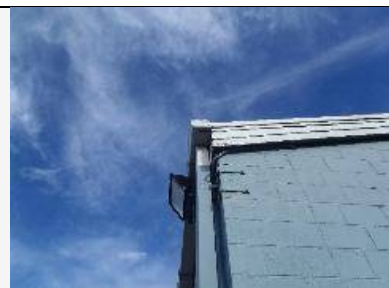
The fascia/bargeboards are mostly constructed of timber. The paint work is deteriorating in sections and repainting is required. Moderate decay is present to small sections of timber fascias or barge boards at corners. This has damaged the timber. This could get worse and decay can spread to more timbers.. Repair or replacement of damaged timber by a licensed Carpenter is recommended.

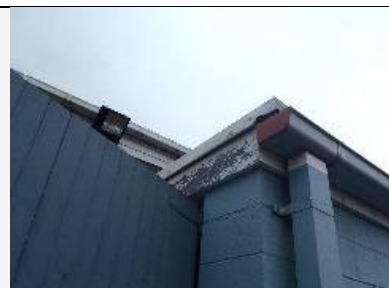
The paint work is deteriorating and maintenance is required. Refer to sample photo.

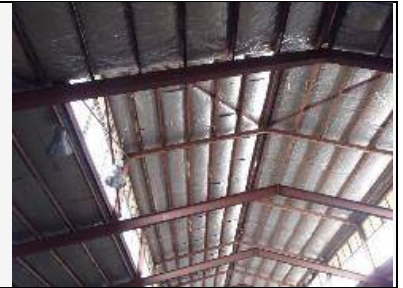
There is no Safety Mesh below roof sheeting. This was not a requirement when the original Building was built but newer sections of roofing should have had safety mesh installed. A licensed Roofer should further investigate this matter and provide a quotation for the necessary rectification.

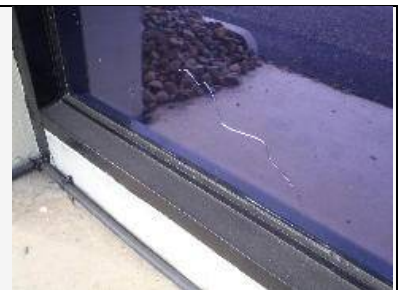
The condition of the windows is generally fair. Crack to glass pane. This is a safety hazard. Have a licensed Glazier replace affected glass promptly.

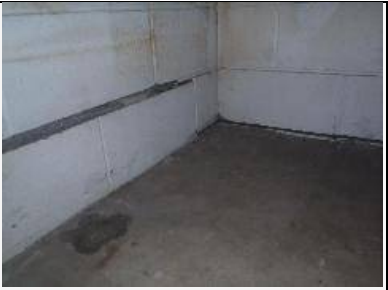
There is a crack of approx. 20mm wide to the Western block wall and a crack of approx. 5mm wide to the Northern wall of the Strong room. This appears to have been caused by subsidence. You should have this matter further investigated by an appropriately qualified Structural Engineer prior to the contract becoming unconditional.

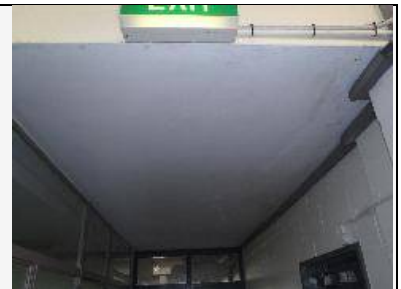
Water leak stain noted to the concrete ceiling. This area was tested with an Electronic Moisture Meter. The moisture level recorded was within a normal range. This area should be monitored to ensure that the condition does not further deteriorate. If further deterioration is noted then refer the matter to a relevant accredited specialist for further investigation.

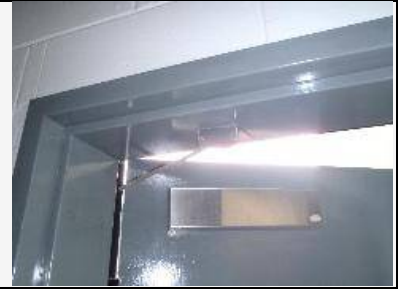
The condition of the door/s is generally good. Door closer missing to external door. Refer to sample photo.

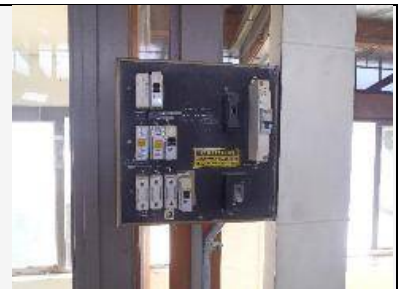
Switchboard is not covered. This condition has made this component a potential safety hazard. Suitable alterations should be carried out without delay to make this component safe.

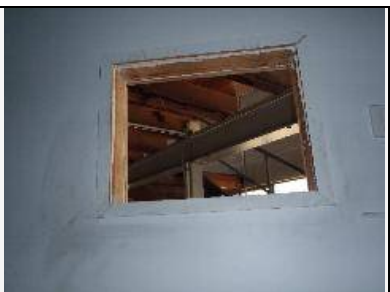
<p>The condition of the walls is generally good. Hole in wall from where Air con box type unit was removed. This is a Minor Defect. Repair or replacement is required. Consult a licensed tradesperson about the scope of works and cost to rectify.</p>

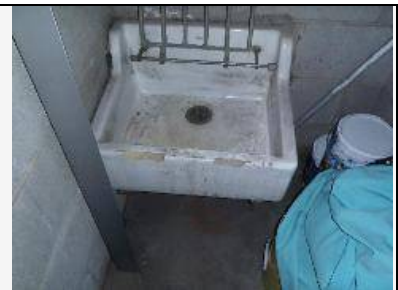
Slop Hopper (Basin) is chipped. This is a Minor Defect. No action is required at this time.

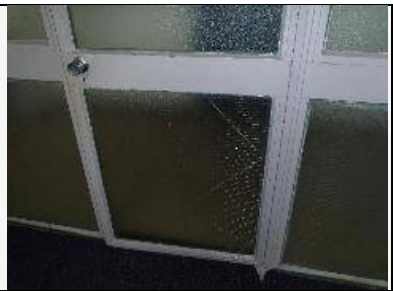
The glass in the door is cracked. Replace as required. The door rubs slightly on the frame and minor adjustments are required to ensure smooth operation.

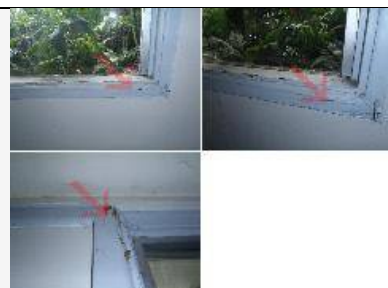
Sections of woodwork are termite damaged. Corner trim, architrave and cornice all affected in areas. No active termites seen. There may be more damage present that is concealed. A further invasive Pest Inspection by a licensed Timber Pest inspector is recommended to determine the full extent of the termite damage. Refer to sample photos. Repair or replacement is required. Consult a licensed tradesperson about the scope of works and cost to rectify.

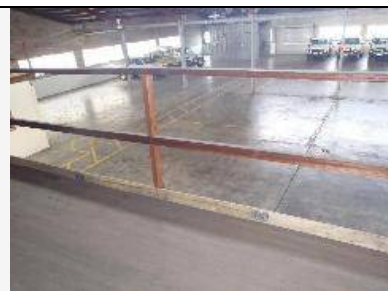
The condition of the walls is generally good. Handrails have large gaps and are loose. This condition has made this component a potential safety hazard. Suitable alterations should be carried out without delay to make this component safe.

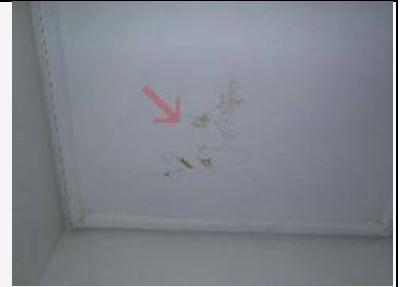
The condition of the ceiling is generally good. Nails are popping and are visible. This is generally due to movement in the timber framing. Periodic maintenance may be required and ceilings may need to be re-secured. Water leak stain noted to the ceiling. Recommend having a licensed Roofer determine the cause of the leak and rectify immediately to prevent further damage.

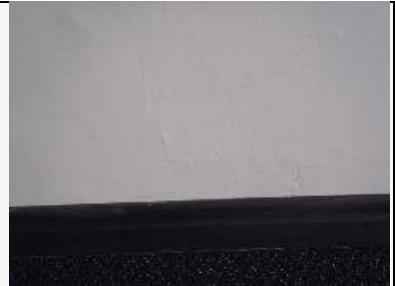
The condition of the walls is generally fair. The condition of the walls is generally fair. Appearance cracks are evident to walls. Visible cracks are hairline in width only. Read the attached information sheet from the CSIRO on Foundation Maintenance and Footing Performance: A Homeowner's Guide and apply the recommendations therein. These cracks are relatively minor at this time but they could get worse and be very costly to rectify. For peace of mind I recommend that you obtain an assessment of these cracks by a registered Consulting Structural Engineer with relevant residential experience. Refer to sample photo.

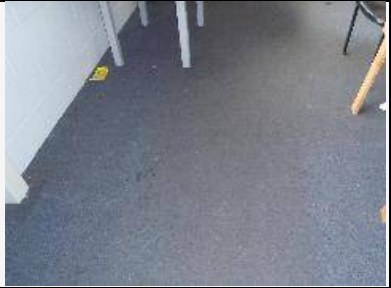
The carpets are badly soiled and stained.
Repair or replace as required.

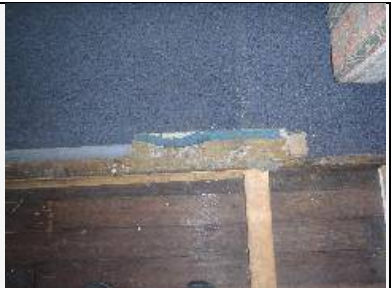
Section of floor is timber. There is no access under the timber floor to check framing.

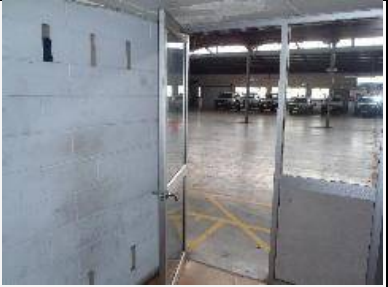
- Door to the Northern end rubs onto the frame. This is a Minor Defect. Repair or replacement is required. Consult a licensed tradesperson about the scope of works and cost to rectify.
- One door handle is loose and one handle is missing. This is a Minor Defect. Repair or replacement is required. Consult a licensed tradesperson about the scope of works and cost to rectify.

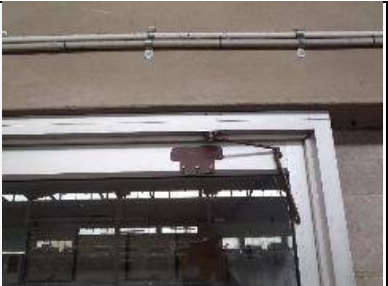
Self closer has been removed from the door. Replace as required.

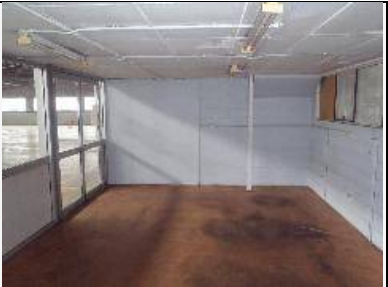
Carpets are badly worn and should be replaced.

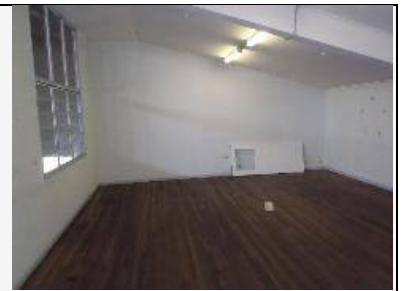
The condition of the ceiling is generally good. Roof beams could be a safety hazard as a taller person could hit their head on the beams where they project less than 2m above floor level. Consult a safety expert about suitable safety precautions for this hazard.

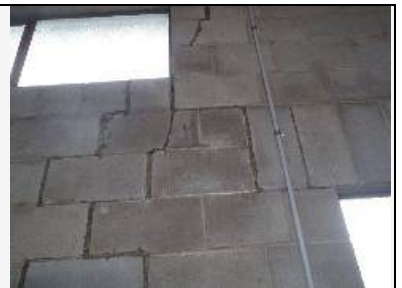
- There are cracks in the blockwork. Refer to External Wall notes. Refer to sample photo.

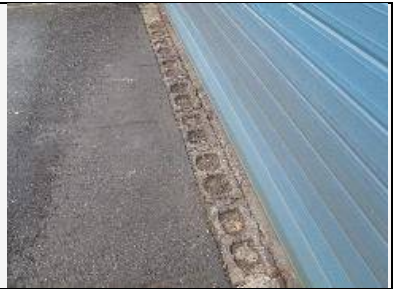
Concrete missing to top of blockwork under roller door openings. This could cause a person to trip. This condition has made this component a potential safety hazard. Suitable alterations should be carried out without delay to make this component safe.

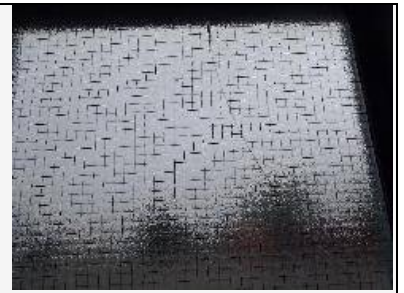
- Windows are stiff to operate and some do not open at all. Repairs are required to windows to ensure smooth operation.
- There are many cracked and broken wired glass and ordinary glass windows. The cost to replace broken glass with suitable safety glass will be significant.

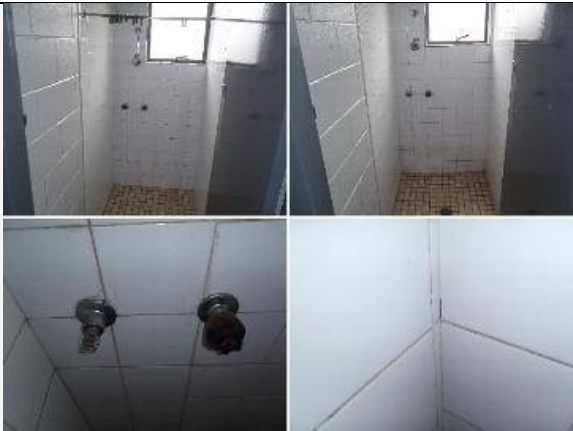
- There are two showers present in this area. The Shower closest to the Southern end has a missing Hot water tap handle.
- The grout between the tiles has deteriorated in sections. This may cause moisture to penetrate into the wall cavity and damage other components. Recommend that you contact a tiler to regROUT and re-seal.

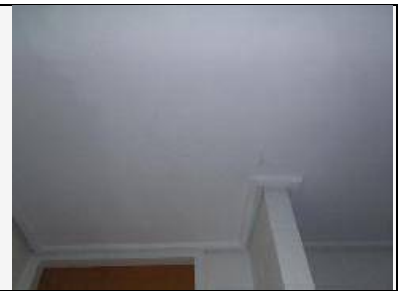
Water leak stain noted to the ceiling. Recommend having a licensed Roofer determine the cause of the leak and rectify immediately to prevent further damage.

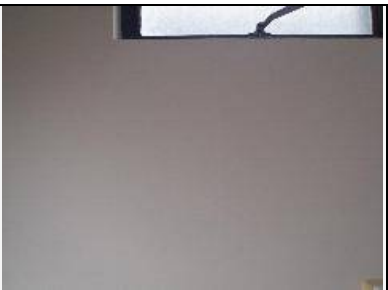
The condition of the walls is generally fair. Appearance cracks are evident to walls. Visible cracks are hairline in width only. Read the attached information sheet from the CSIRO on Foundation Maintenance and Footing Performance: A Homeowner's Guide and apply the recommendations therein. These cracks are relatively minor at this time but they could get worse and be very costly to rectify. For peace of mind I recommend that you obtain an assessment of these cracks by a registered Consulting Structural Engineer with relevant residential experience.

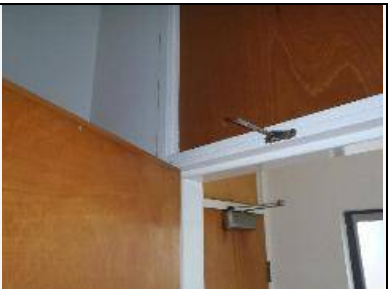
Self closing devices are missing to some doors.

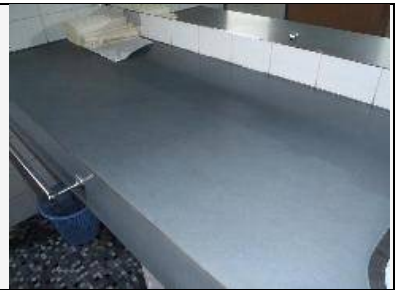
The condition of the vanity unit is generally fair. Wear and tear to vanity cabinet. This is a minor defect. No action required at this time.

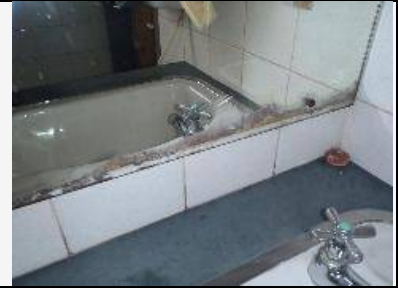
The mirror is desilvering. This is a minor defect.

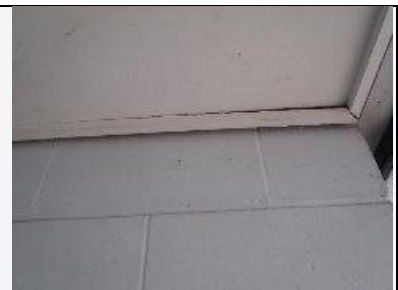
Some loose trims. This is a Minor Defect. Repair or replacement is required. Consult a licensed tradesperson about the scope of works and cost to rectify.

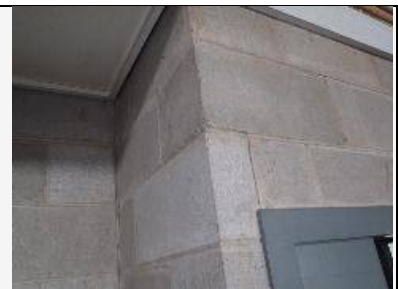
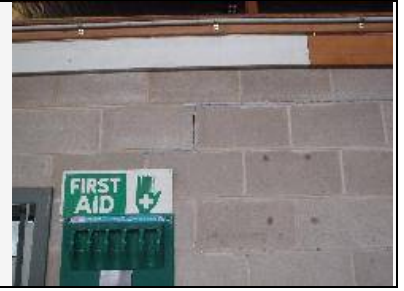
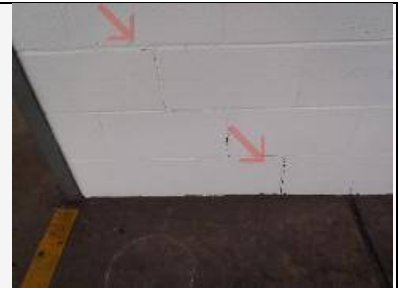
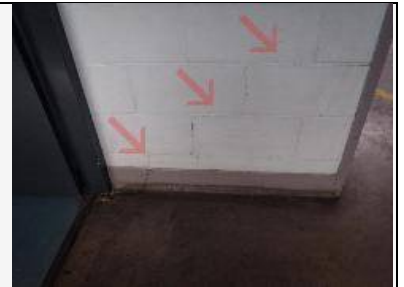
The condition of the walls is generally fair. Appearance cracks are evident to wall/s. Visible cracks are hairline to 1mm in width only. Read the attached information sheet from the CSIRO on Foundation Maintenance and Footing Performance: A Homeowner's Guide and apply the recommendations therein. These cracks are relatively minor at this time but they could get worse and be very costly to rectify. For peace of mind I recommend that you obtain an assessment of these cracks by a registered Consulting

Structural Engineer with relevant residential experience. Refer to sample photo.

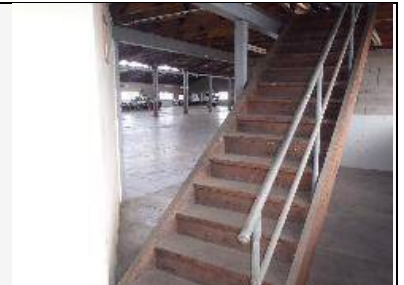
- The stairs are constructed primarily from timber the overall condition of these stairs is good.
- The gap between the handrail and the stairs exceeds 125mm. This does not conform to the Building Code, and may allow a small child to fall through the handrail. An intermediate rail with gaps not exceeding 125mm should be

installed for safety or a young child could fall through the gap. Recommend that you contact a licensed Carpenter and have this problem rectified without delay.

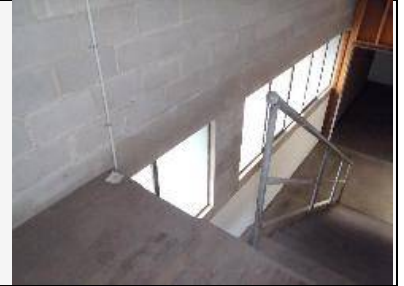
Top of stairs is particularly dangerous as there is no balustrade. Refer to sample photo. This condition has made this component a potential safety hazard. Suitable alterations should be carried out without delay to make this component safe.

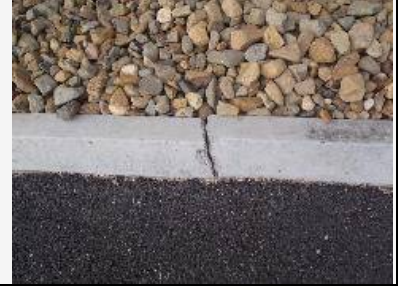
Section of concrete kerb cracked to front elevation of office. This is a Minor Defect. Repair or replacement is required. Consult a licensed tradesperson about the scope of works and cost to rectify. Refer to sample photo.

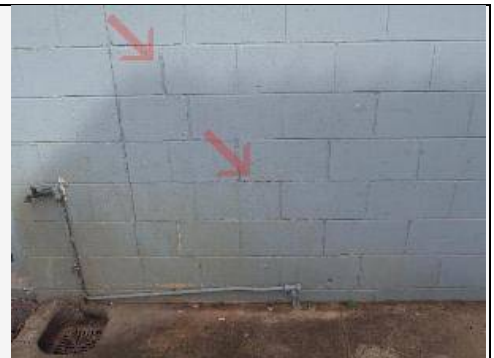
NE corner. Refer to sample photo.

The majority of the external walls are built of concrete blocks. The condition of the block walls is generally fair. 'Appearance' cracks of up to 5mm in width are evident to blockwork. There has been patching of almost all of the cracks. Almost all the cracks have had patching done with mortar and some with flexible fillers. These cracks common for a building of this age (approximately 50 years) and type (hollow concrete block) but they could get worse over time and be very costly to rectify, therefore I recommend that you should have the cracks further investigated by an appropriately qualified Structural Engineer prior to the contract becoming unconditional.

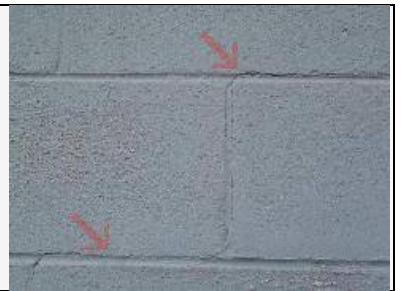
Southern elevation of the factory. Refer to sample photo.

One damaged block to the Southern elevation. Appears to have been caused by impact damage. Repair or replacement is required. Consult a licensed tradesperson about the scope of works and cost to rectify.

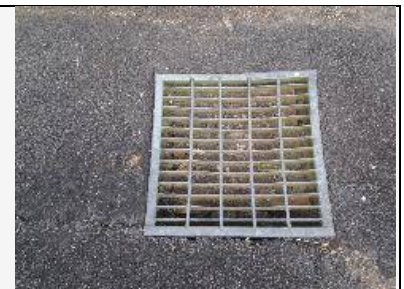
- Surface drainage appears to be acceptable. However, the site should be monitored during and after heavy rain to determine whether the existing drains can cope. If they cannot cope, and excess water becomes a problem then additional drains will be required.
- Pit lid cover to the NW corner is damaged. Replacement with a heavy duty grate is required. Consult a licensed tradesperson about the scope of works and cost to rectify.

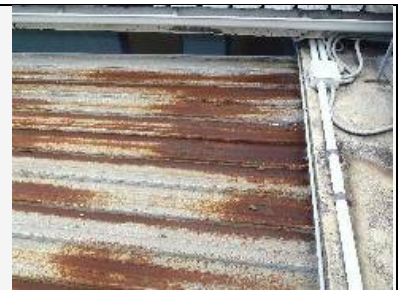
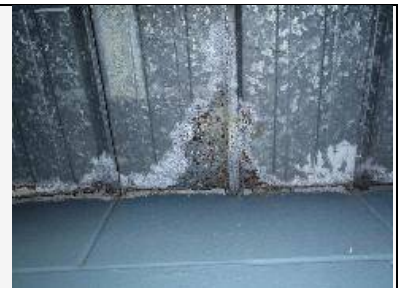
The metal roofing is badly rusting and dented in sections and this will eventually result in roof leaks. A licensed Roofer should further investigate this matter and provide a quotation for the necessary rectification.

Refer to sample photo taken to underside of roof.

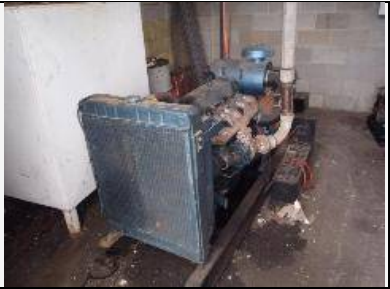
Generator not tested. You should have this equipment further investigated by an appropriately qualified expert prior to the contract becoming unconditional.

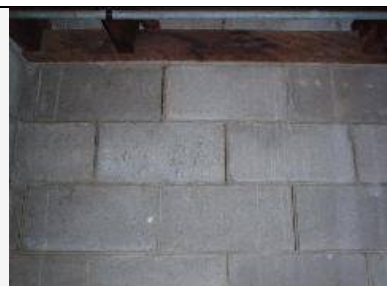
Concrete block: Photo shows a Stepped crack to the rear elevation of the factory. Refer to external wall notes in this report.

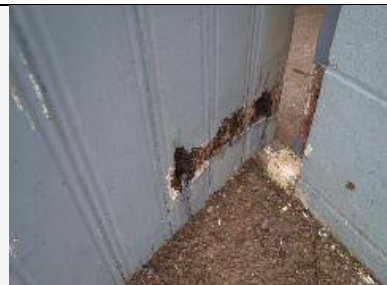
The condition of the walls is generally good. Door hinges are damaged and missing. This is a Minor Defect. Repair or replacement is required. Consult a licensed tradesperson about the scope of works and cost to rectify.

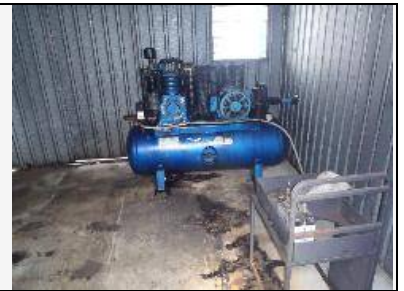
Compressor not tested. You should have this equipment further investigated by an appropriately qualified expert prior to the contract becoming unconditional.

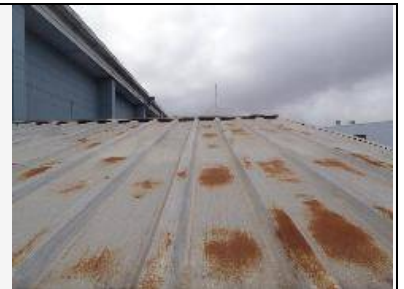
The metal roofing is dented and rusting and requires treatment to limit further deterioration.

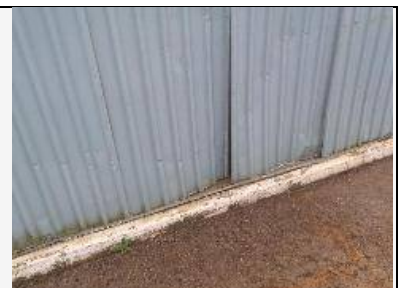
External walls are rusting and badly dented. Repair or replacement is required. Consult a licensed tradesperson about the scope of works and cost to rectify.

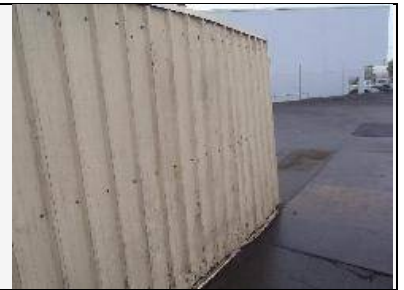
The condition of the walls is generally poor. Some dents, Repair or replacement is required. Consult a licensed tradesperson about the scope of works and cost to rectify.

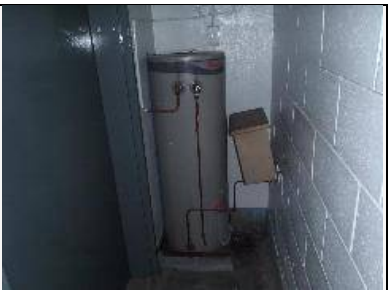
- Mains electric hot water system located next to the toilet block to the Eastern end of the factory. The hot water system was not in service at the time of inspection and accordingly no comment on this system is offered.
- 'Zip' hydroboil system to Tea room at the western end of the building was working well when tested.

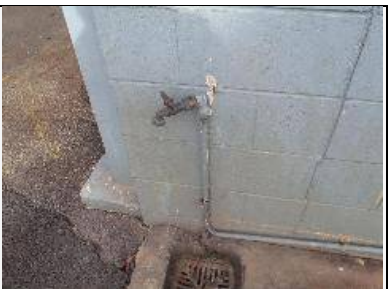
Water pressure appears to be normal however, this is not an opinion of a licensed plumber. One external tap located to the NE corner is not clipped to the wall. This is a Minor Defect. A licensed Plumber should further investigate this matter and provide a quotation for the necessary rectification.

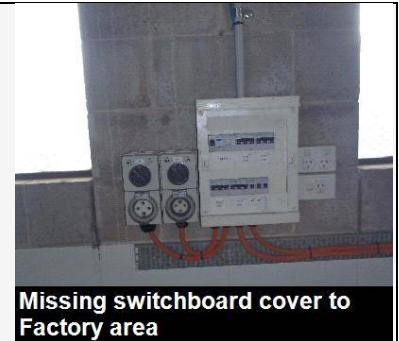
- There is a Earth Leakage Circuit Breaker (Safety Switch) installed however, the operation or adequacy was not tested and is not commented on.
- Two switchboards are missing covers. This condition has made this component a potential safety hazard. Suitable alterations should be carried out without delay to make this component safe.
