Building and Pest Inspection Reports

In accordance with AS 4349.0 and AS 4349.3

1234 Sample Street, Sample Town

CLIENT 3333

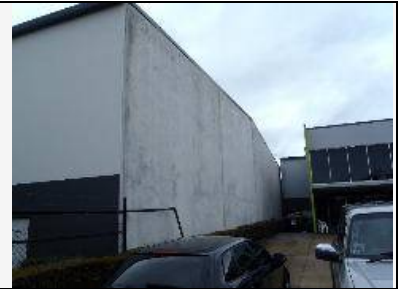
The ability to inspect external rear wall located in close proximity to title boundaries was limited due to insufficient access.

Further Inspection and Reporting of these areas is Essential once access has been obtained and prior to a decision to Purchase to determine if any Major Defect/Safety Hazard exists in these areas/sections.

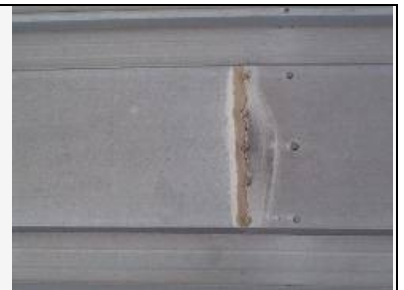
Small section of flashing to the Eastern side of the roof is holding water. This is not leaking at this time but will probably leak if silicone deteriorates. Silicone should be maintained to this area and to the entire roof for that matter.

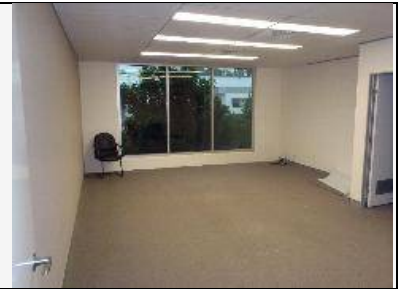
Section of window rubber seal is loose to the interior and exterior of one window located to the large office on the top floor front (North) elevation of the office area. This may allow water penetration. Not leaking at the time of inspection. Repair or replacement is required. Consult a licensed tradesperson about the scope of works and cost to rectify.

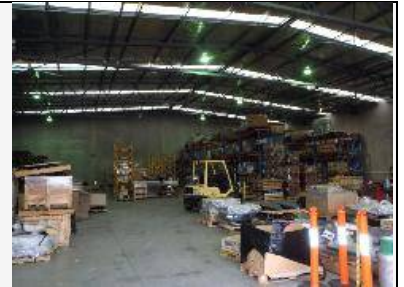
Example of crack

The condition of the walls is generally good. Appearance cracks are evident to walls especially at the top of door openings and near corners of some panels. Visible cracks are hairline to 1mm in width only. These cracks appear to be only minor shrinkage cracks at this time but they could get worse over time and be very costly to rectify. These cracks should be monitored to ensure that the condition does not further deteriorate. If cracks get worse then refer the matter to a Structural Engineer for further investigation.

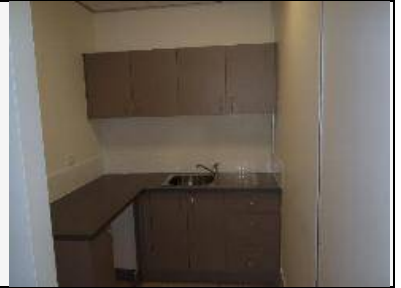
The condition of the fixtures is generally good. Small gap between joinery and side wall due to some minor settlement. No action is required at this time. If further movement occurs the overhead cupboard may need to be re-fixed to the wall.
